# **Lake Julia Stewardship Project: Aquatic Plant Management Plan**

**Lake Julia Lake Association - 2012**

Date: February 2012

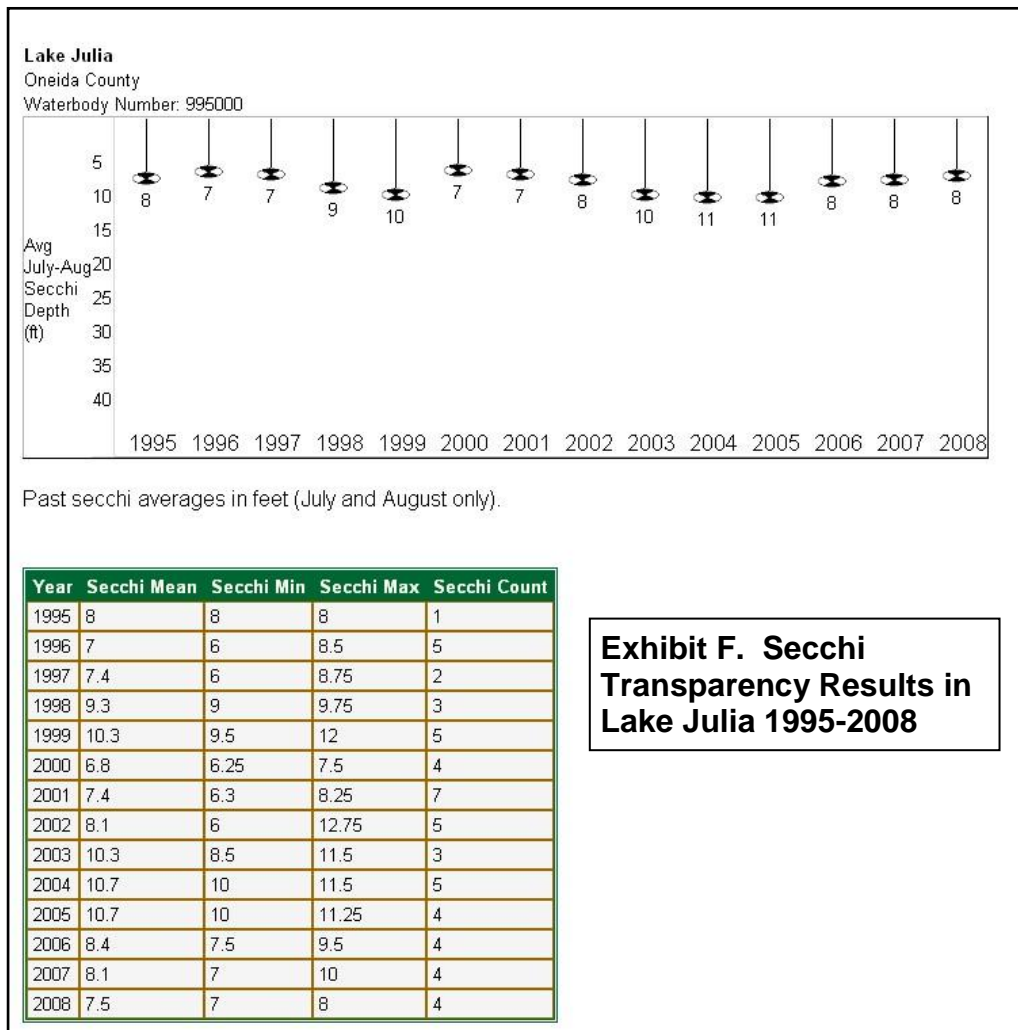
Secchi depth (a measure of water transparency) has been monitored annually on Lake Julia since 1995. Over these years, the Secchi depth transparency has averaged 8.6 feet. Exhibit F shows the results of the Secchi depth monitoring.

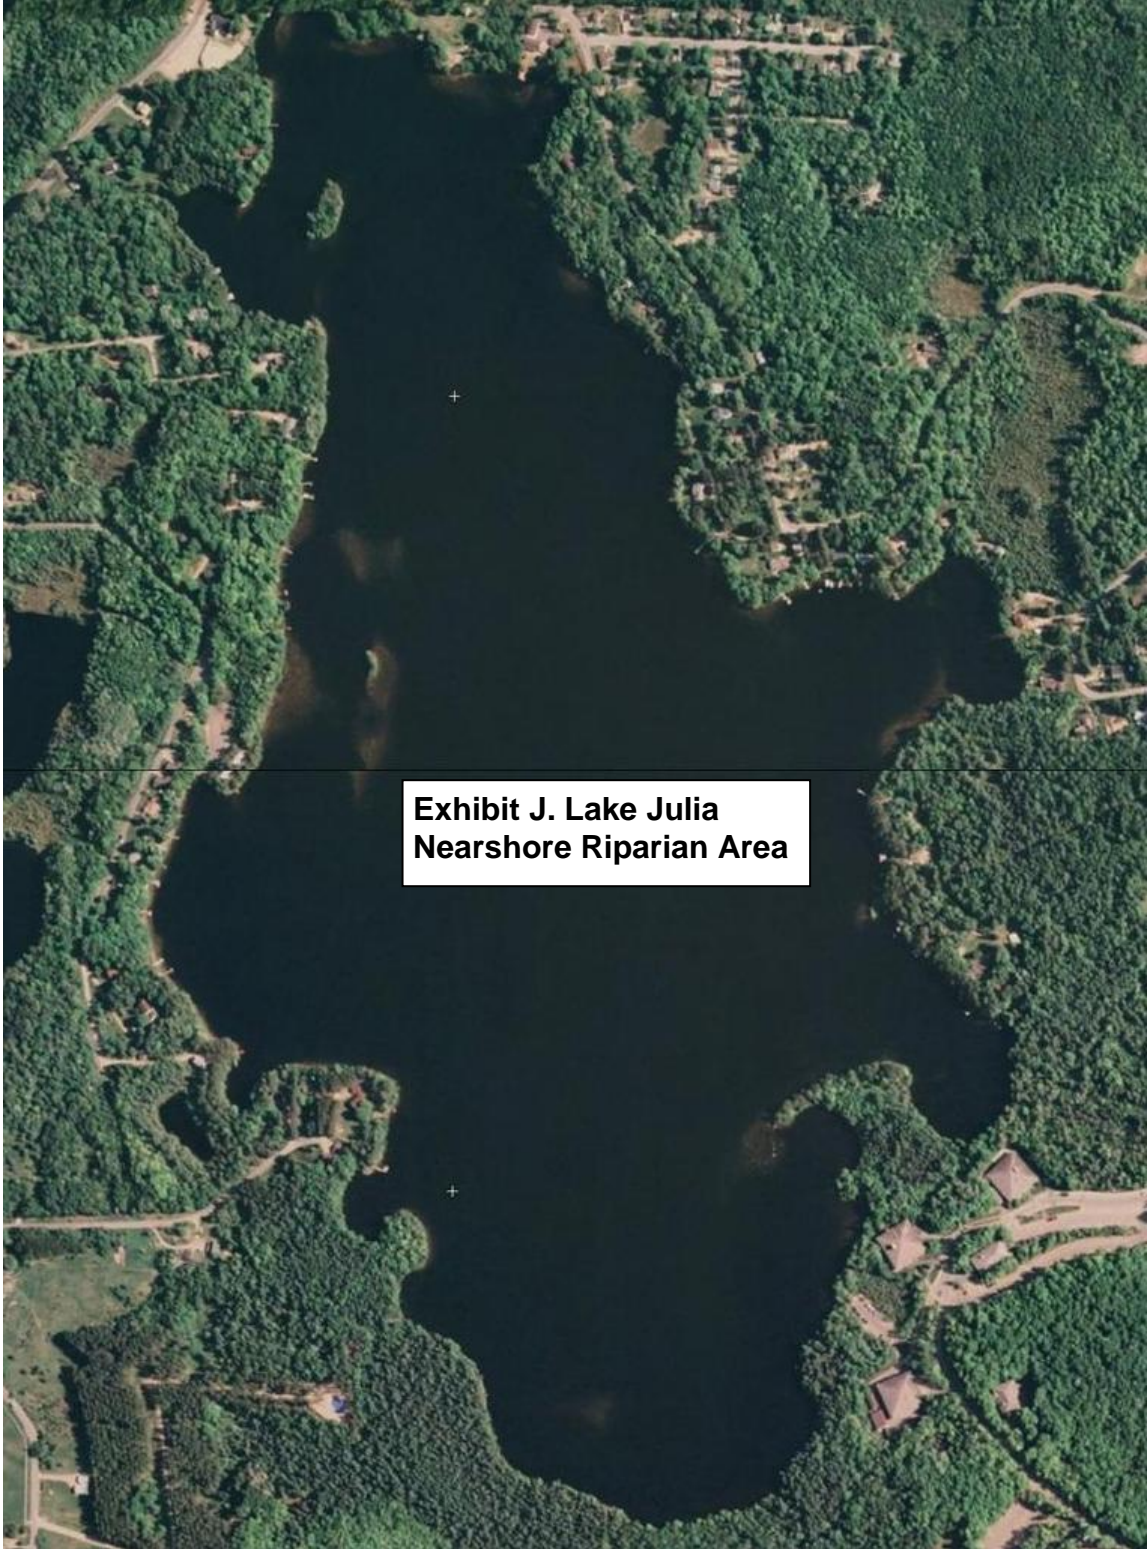
**Exhibit J. Lake Julia  
Nearshore Riparian Area**

Exhibit J (following page) presents a fairly high resolution view of the nearshore riparian area of Lake Julia. The limited human development in this area is noteworthy and serves to buffer Lake Julia from higher than wanted nutrient inputs (e.g., nitrogen and phosphorus). This intact condition is very important to maintain for the long-term health of Lake Julia.

We examined 2005 aerial photography of the shoreline and riparian area around Lake Julia. We established three categories of riparian area condition for this analysis: (1) “natural with broad riparian zone” (at least 500 feet deep), (2) “lightly developed with intact riparian zone,” and (3) densely developed with some riparian forest but more buildings and impervious surfaces. Lake Julia has approximately four miles of shoreline (about 21,000 feet). Only 6% of this shoreline was classified as “densely developed” with 78% being “lightly developed” and 16% classified as “natural with broad riparian zone.” A count of docks (piers) from this aerial photography resulted in a total of forty-seven (47). It should be noted that in the 2010 direct count of piers (see later in this section) a total of 64 was recorded. This higher number most likely reflects a more accurate count possible at “ground level” but could also include some new piers installed since 2005. The “shoreline development index” for Lake Julia was calculated as 1.63. The shoreline development index is a quantitative expression derived from the shape of the lake. It is defined as the ratio of the shoreline length to the length of the circumference of a circle of the same area as the lake. A perfectly round lake would have an index of 1. Increasing irregularity of shoreline development in the form of embayments and projections of the shore is shown by numbers greater than 1. For example, fjord lakes with extremely irregularly shaped shorelines sometimes have SDI’s exceeding 5.
