**Alma/Moon Lake District Lake Protection Grant
Restoration of Shoreline Habitat Project Performance Report
April 10, 2011**

Project Title: Restoring Shoreline Habitat on Moon Lake, Vilas County, to Improve Lake Water Quality and to Evaluate Ecological Benefits

**Michael W. Meyer
Wisconsin DNR Science Services
107 Sutliff Avenue
Rhineland, WI 54501**

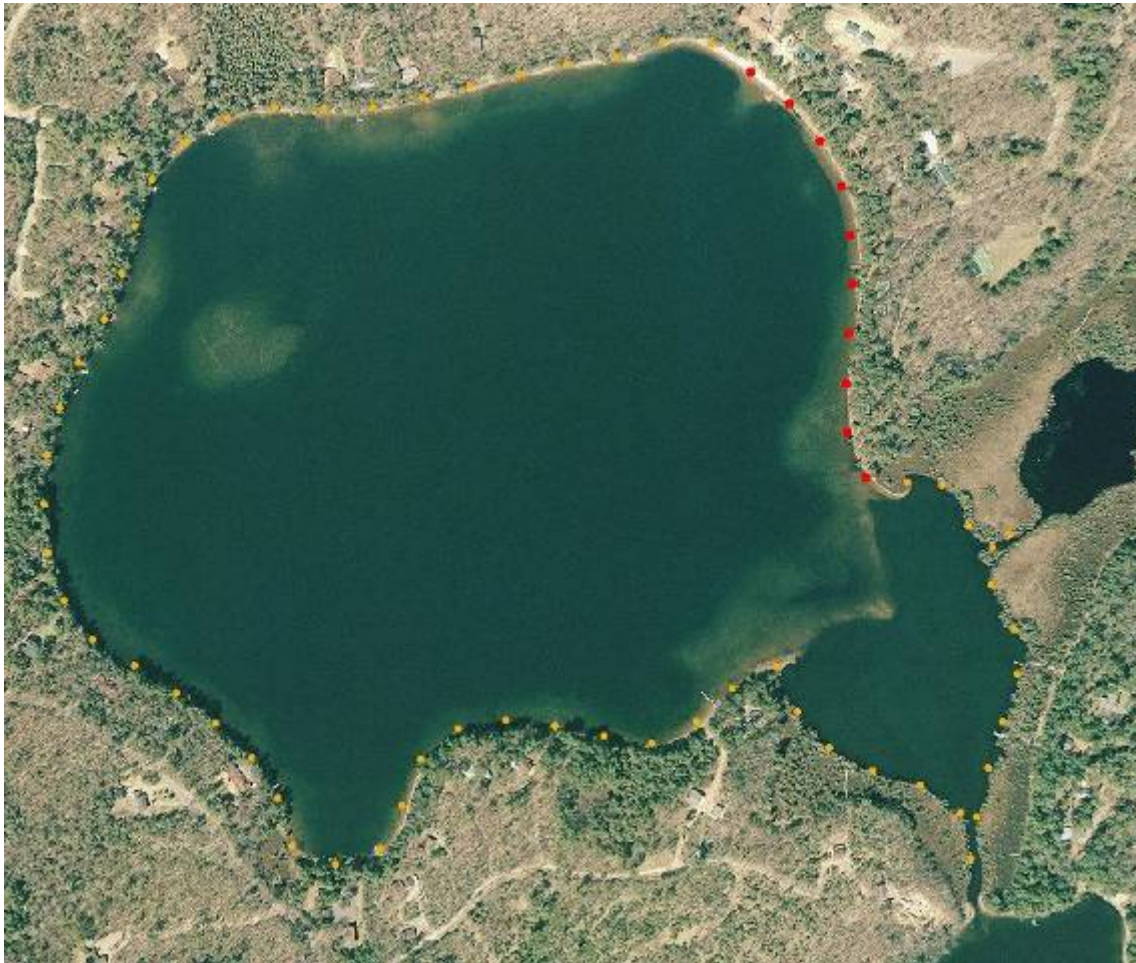
**Map 1. Moon Lake Restoration Vegetation Plot Locations
Red = Treated (Restored) Yellow = Control**

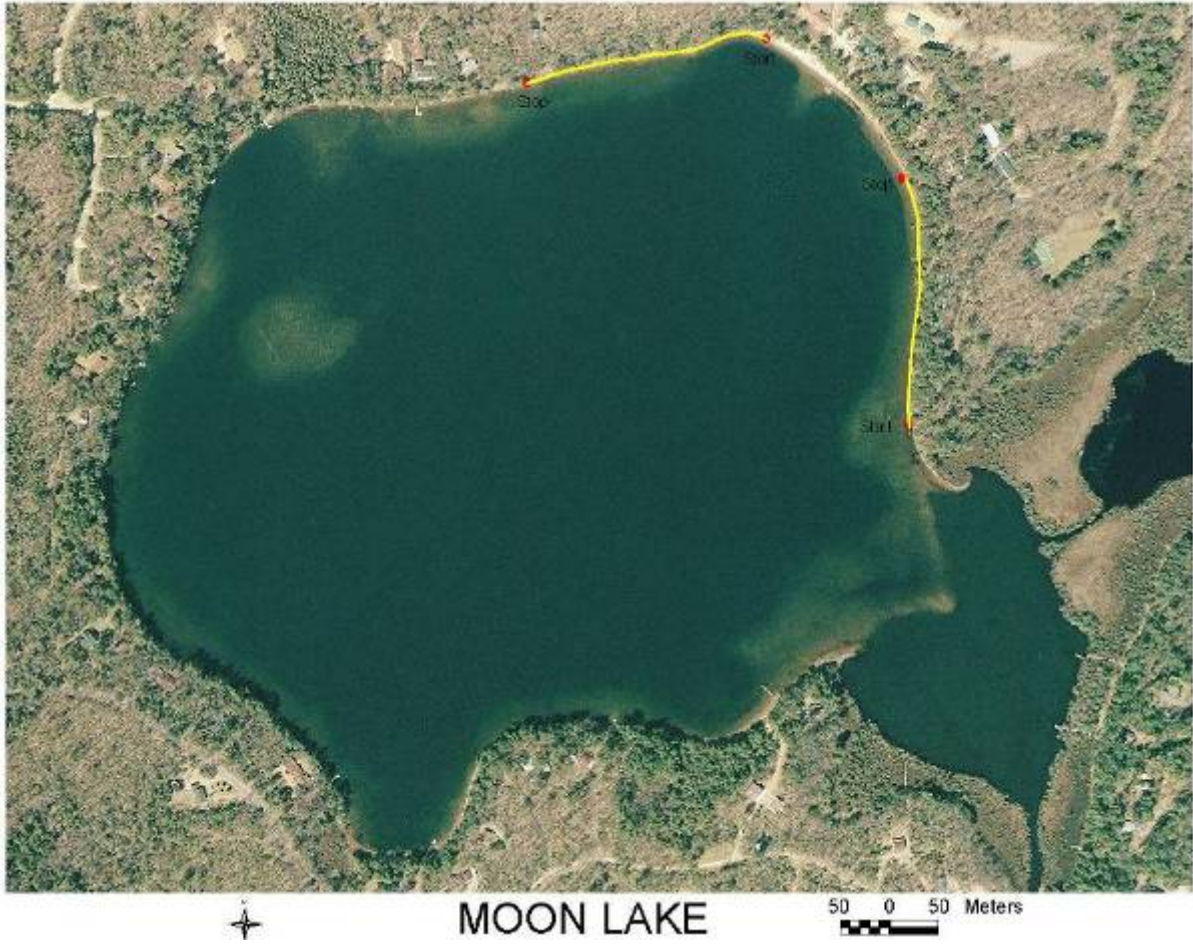
Map 2. Moon Lake Restoration Wildlife Survey Locations

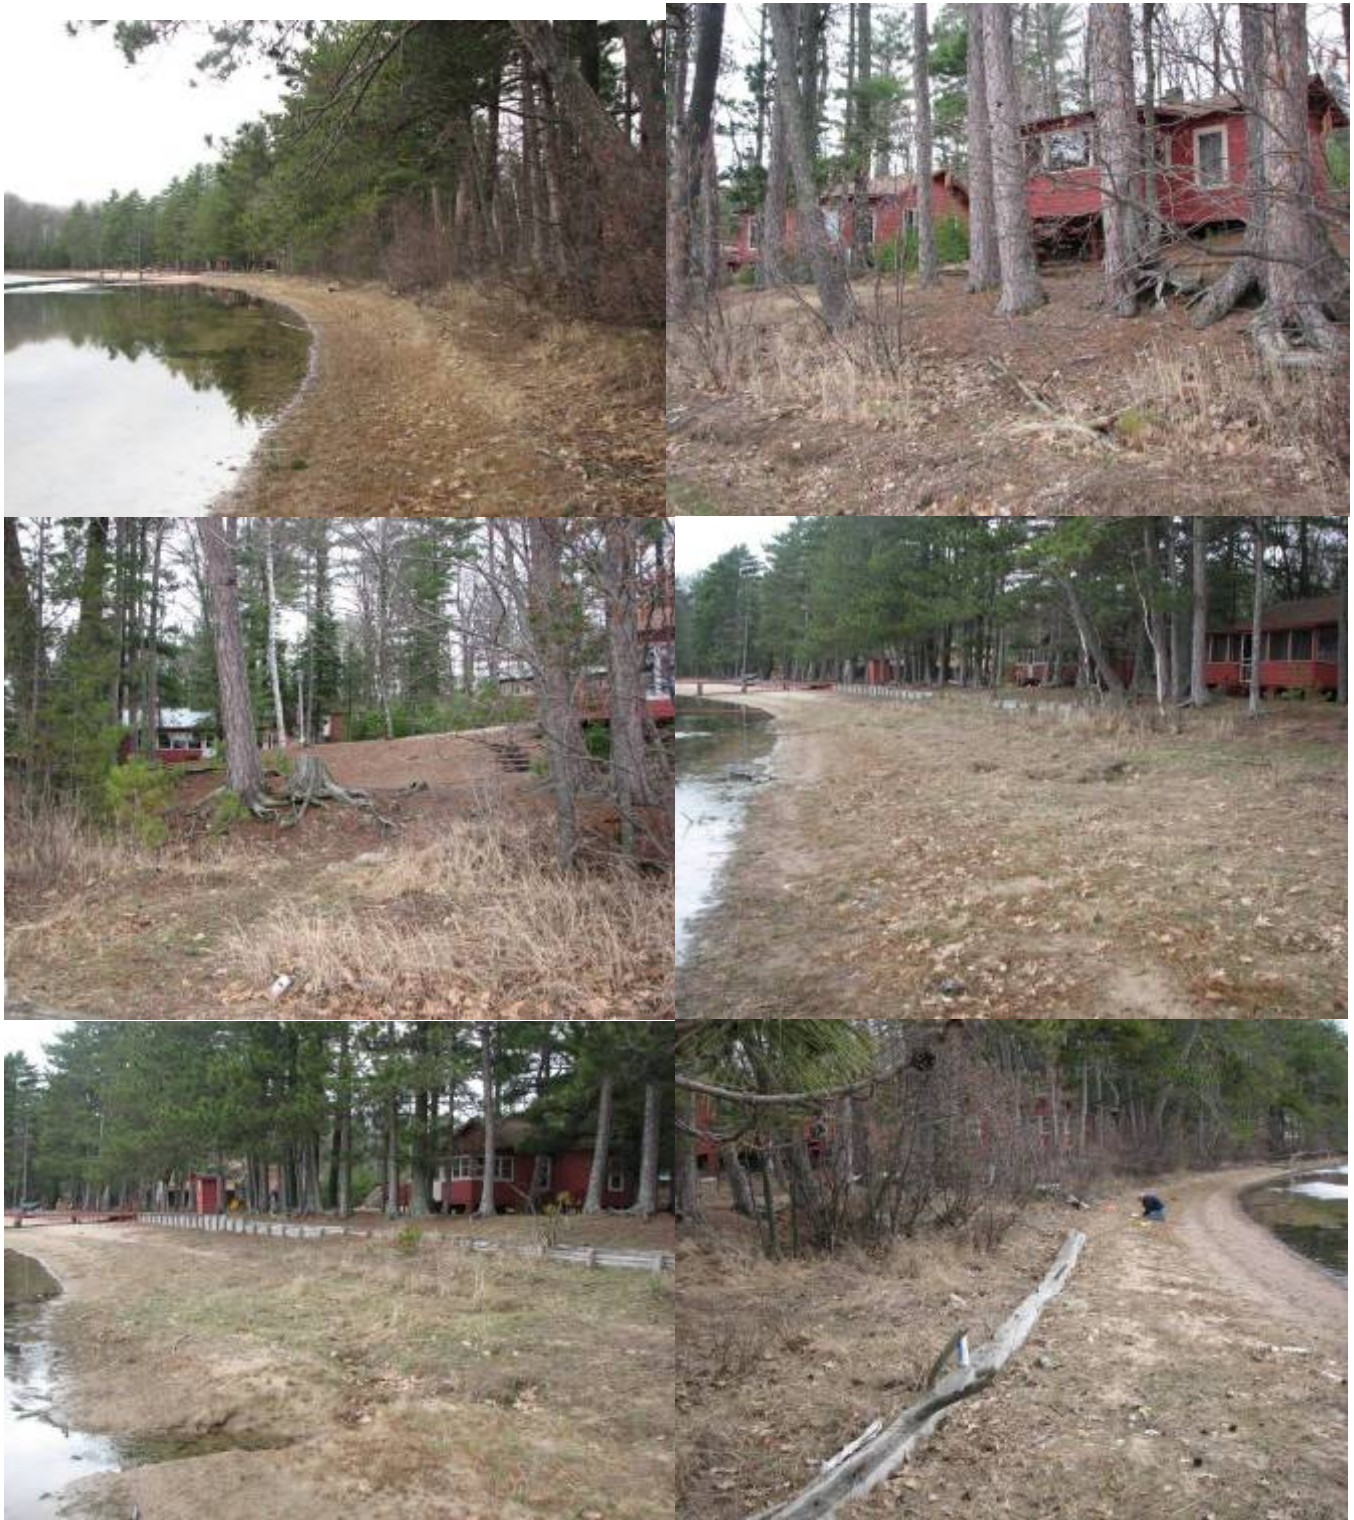
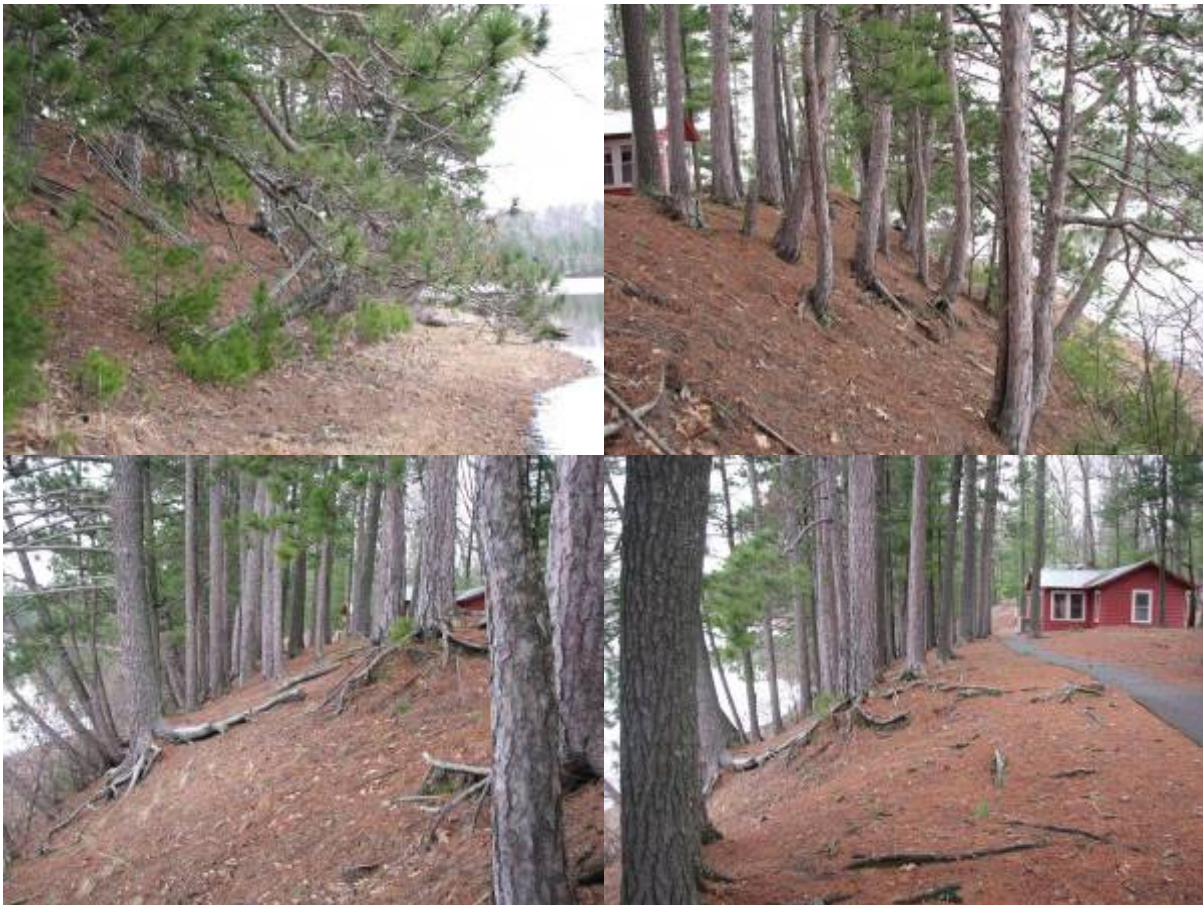
Photo Series 1 – Moon Beach Camp Shoreline – Before Restoration

Photo Series 1 (cont.) Moon Beach Camp Shoreline – Before Restoration

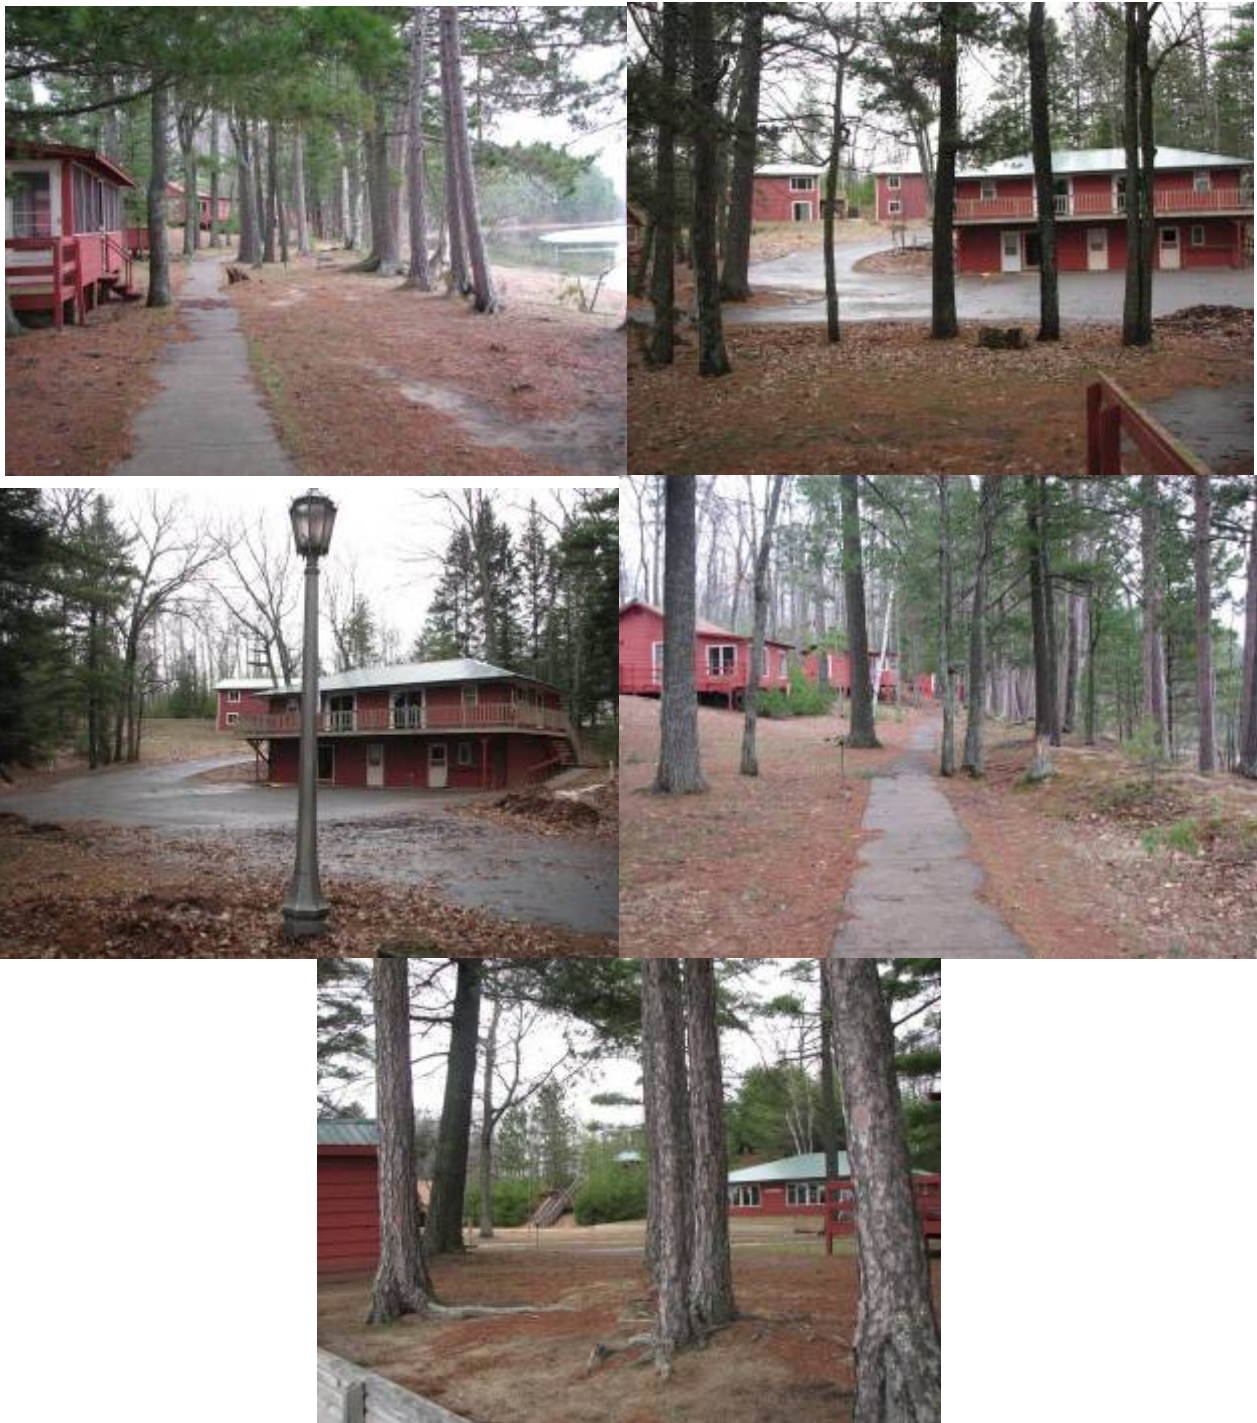
Photo Series 2 – Extensive Impervious Surface and Compacted Soil near Lodge Area

Total Moon Beach Camp acreage is just under 100. Used/developed acreage is best estimated at 23 acres. Estimated Camp shoreline on Moon Lake is in the neighborhood of 4,800 feet with the Lodge to Vesper Point accounting for 2,000 of that. A high level of use and pedestrian traffic has led to loss of vegetation from the shoreline beginning to the south of the Camp beach to Vesper Point. Also, a high level of run-off from roof-tops and asphalt drives occurs after moderate-heavy rainfalls and has led to bank erosion and sediment run-off. A narrow concrete walkway leads from the Lodge to several Cabins along the shoreline. This entire stretch of shoreline is lacking proper vegetation and is experiencing bank erosion. The roots of mature pines are also exposed, and several of the mature trees are likely to fall lakeward over the next few years. These will be used for fish habitat enhancement when appropriate (see below).

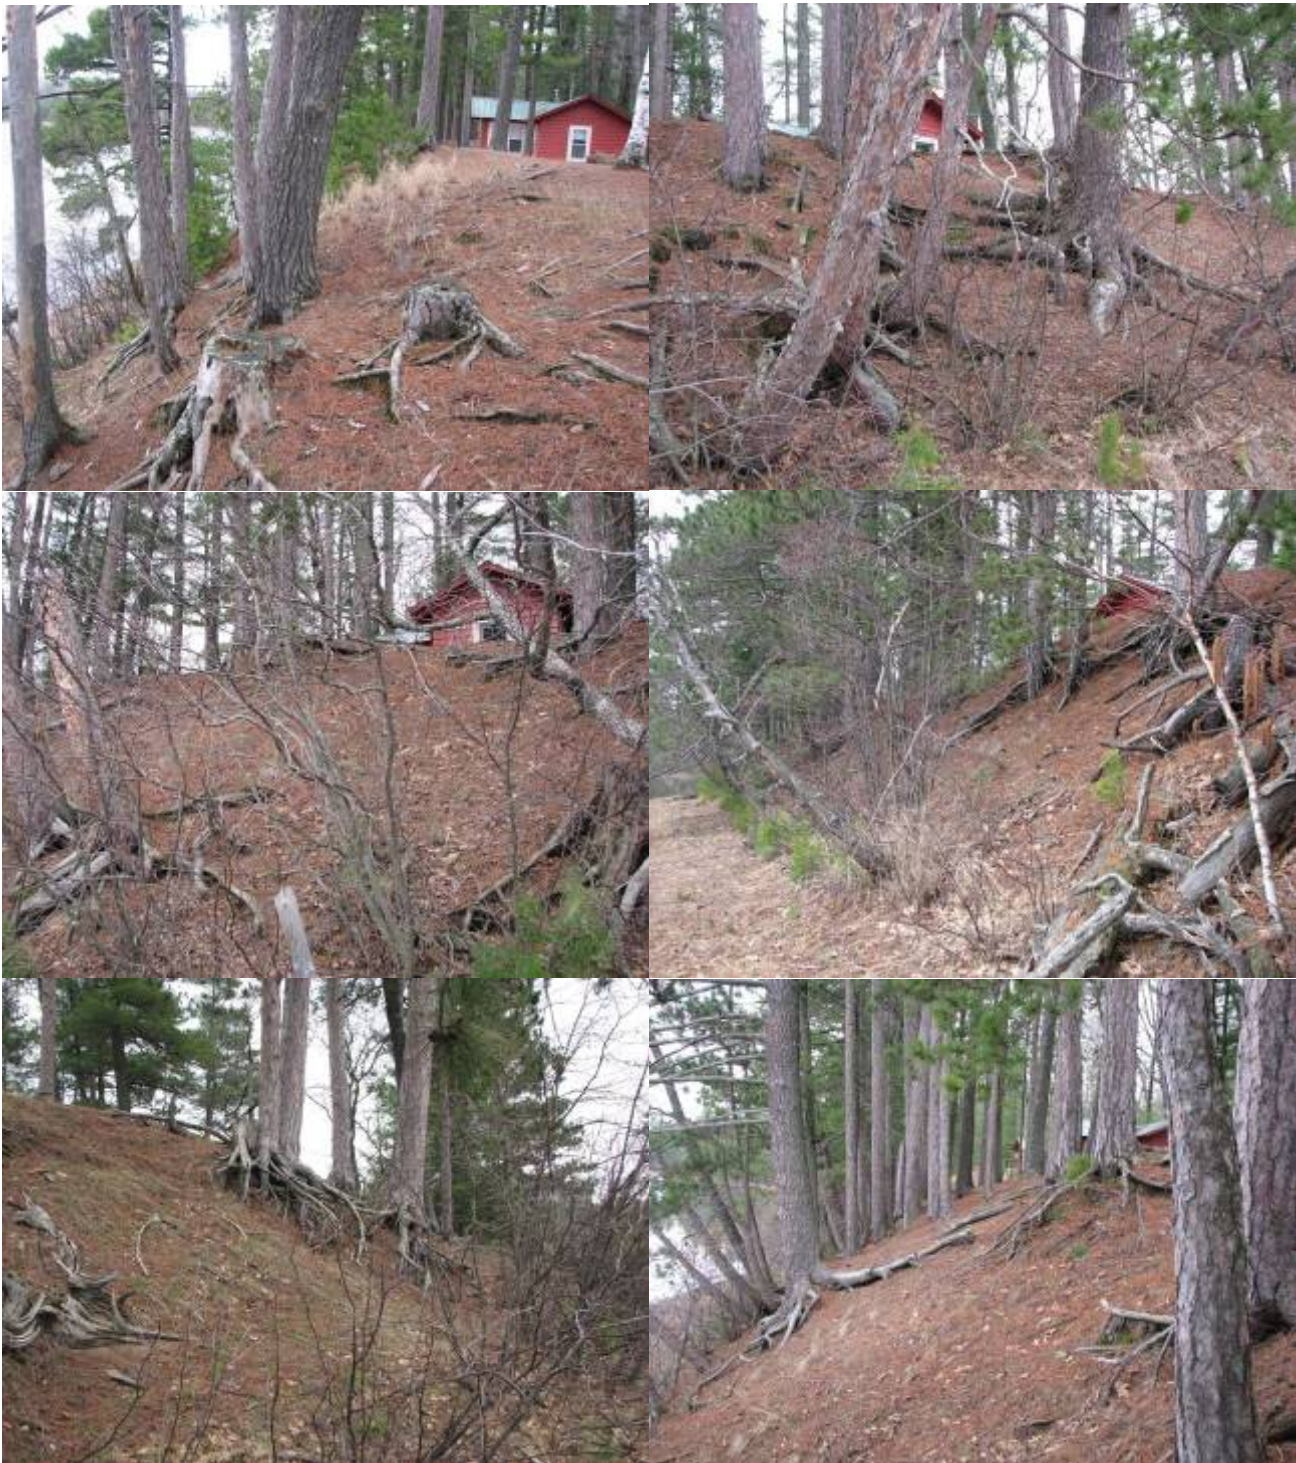
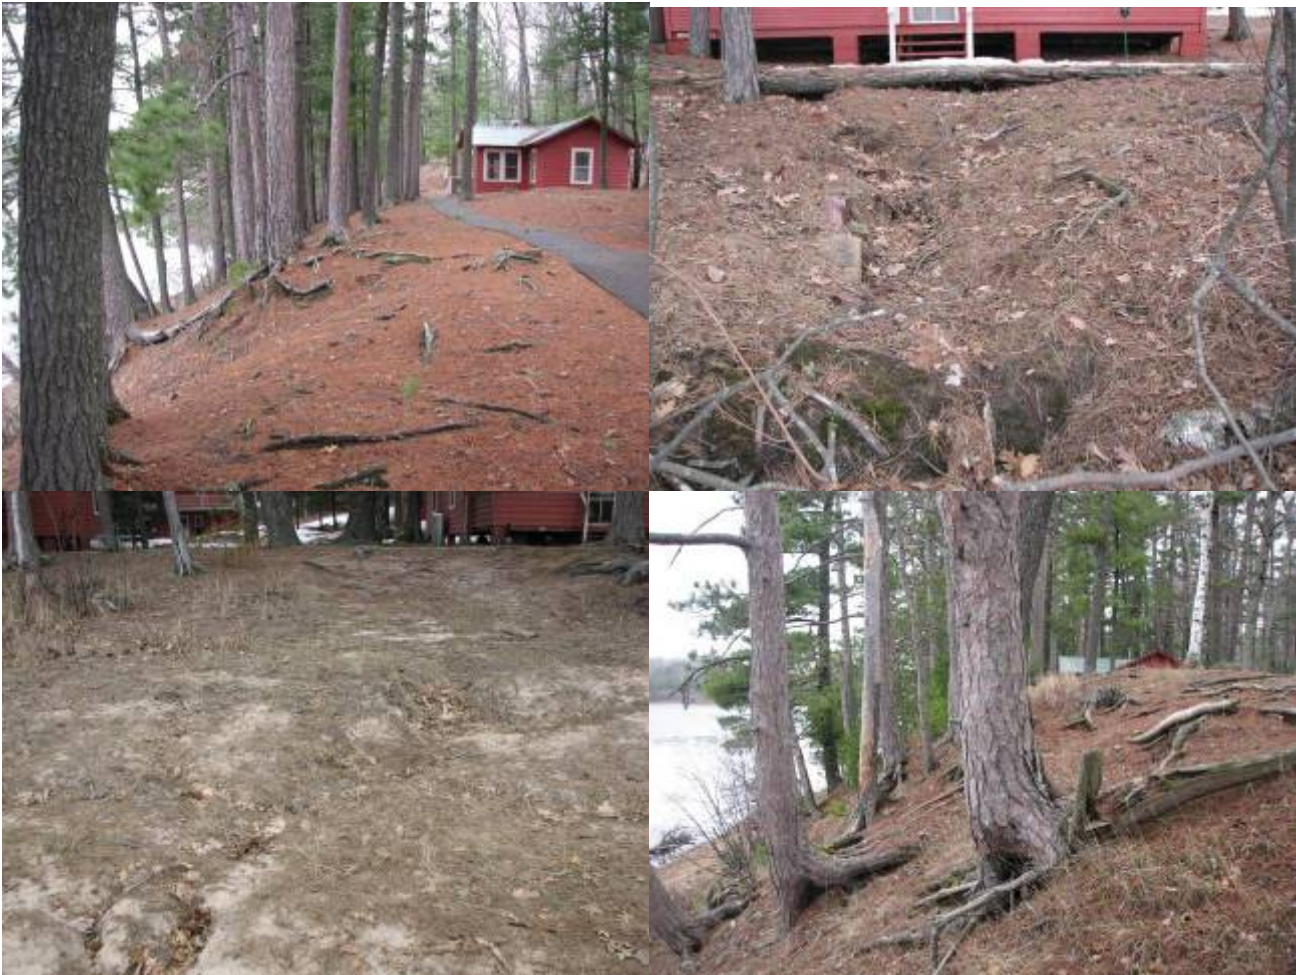
Photo Series 4 – Moon Beach Camp Significant Erosion Areas

Photo Series 4 (cont.) – Moon Beach Camp Significant Erosion Areas

We corrected erosion problems through development of rain gardens to prevent run-off as well as use of biodegradable erosion control products to reduce bank erosion. We planted the shoreline into native vegetation, including native trees, shrubs, and ground cover that are appropriate for the Moon Lake ecosystem.

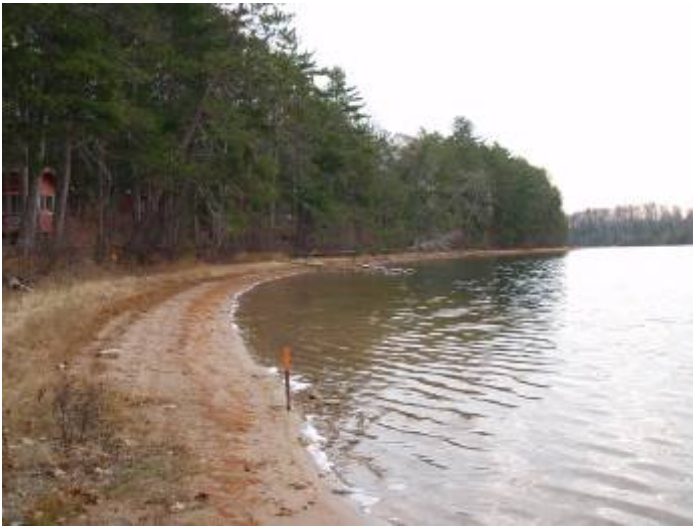
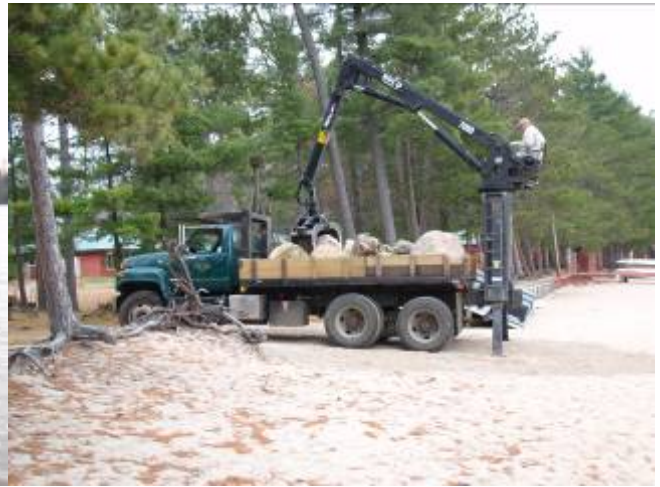
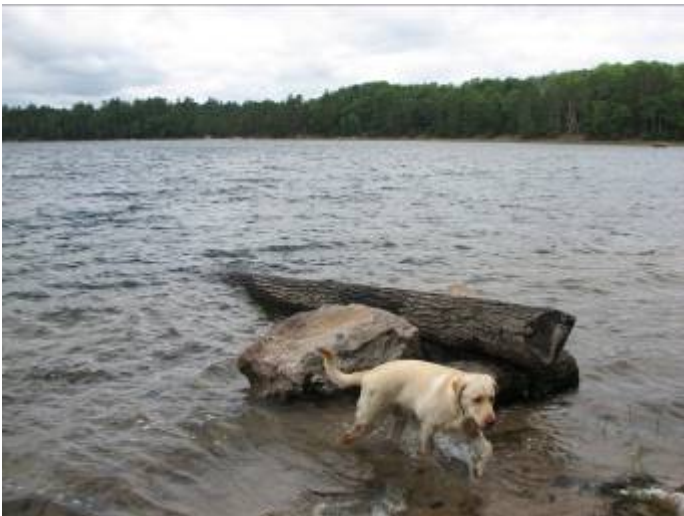
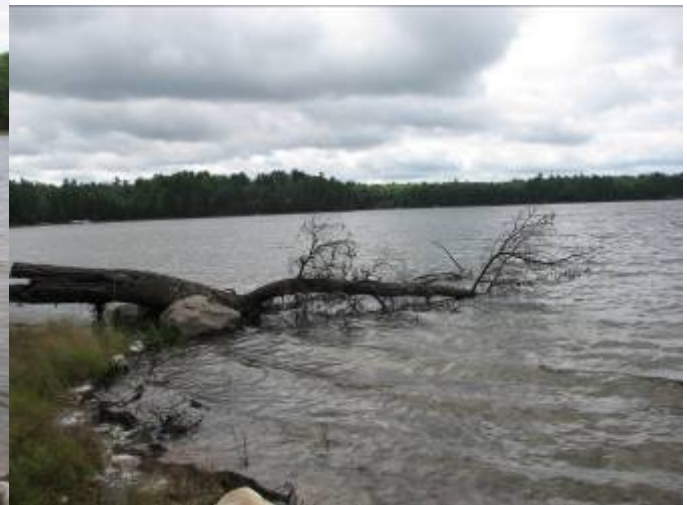
Photo Series 5 Tree Drops

The restoration project was initiated at Moon Beach Camp during the winter of 2008/2009 through installations of a series of tree drops designed to improve fish habitat. Five trees were moved to the shoreland area from a timber harvest on Moon Beach Camp property during the winter of 2009. Boulders were placed on site during the fall of 2008 and trees were placed between the boulders and secured in place with duck-billed anchors. Tree drop installation was supervised by Steve Gilbert, WDNR Fisheries Biologist. Half-log small mouth bass breeding territories were also established between the tree drops. An electroshocking survey was conducted by S. Gilbert in the fall of 2008 prior to installation of the habitat improvements

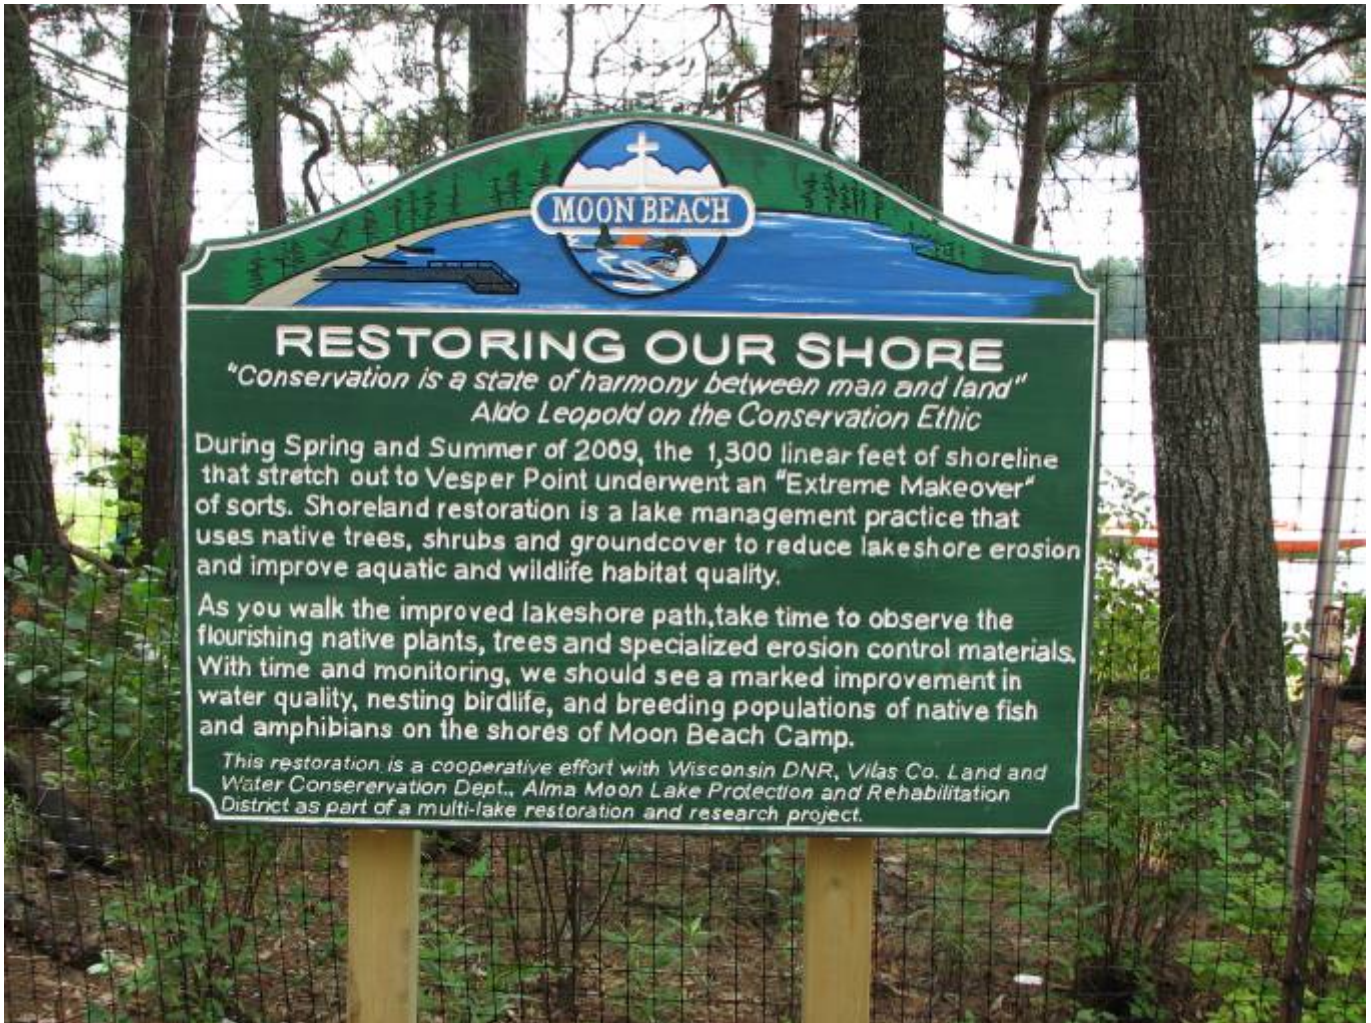
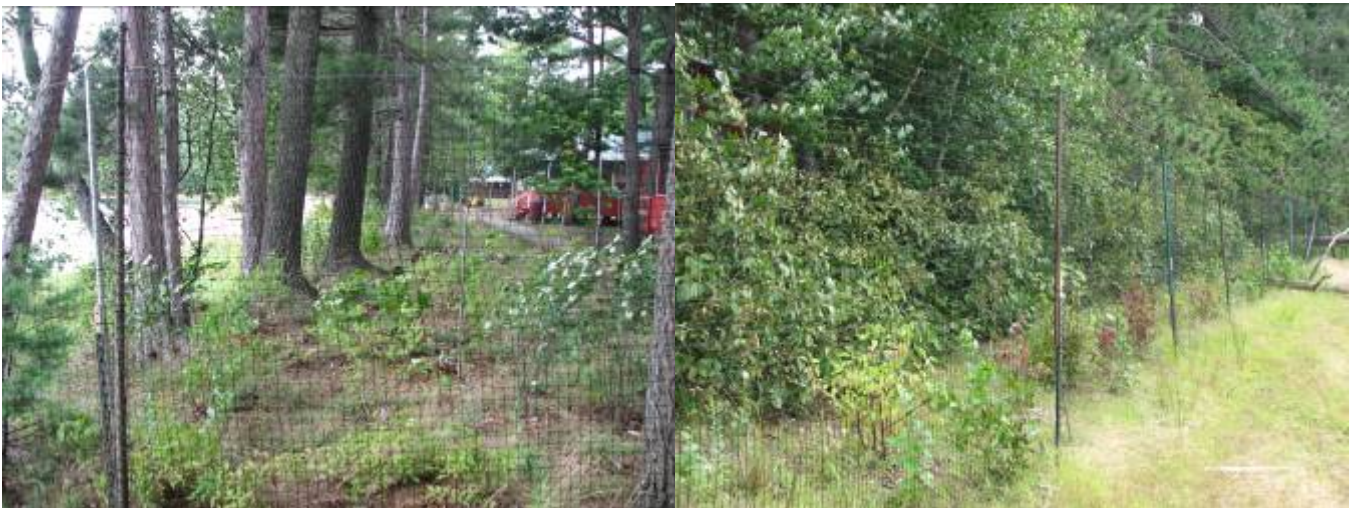
Photo Series 6 – Moon Beach Camp Shoreline - After Restoration

Installation of fencing and irrigation occurred during 2009, as did the majority of the native plant restoration and erosion control. Sidewalks were also widened with material designed to lessen impervious run-off. Final plantings occurred during the spring of 2010, along with installation of rain gardens, rain barrels, cabin gutters, signage, and final erosion control enhancements. Dan Haskell, Michigan Technical University, Houghton, MI was contracted to conduct the project installations and to conduct the wildlife and vegetation surveys. His Performance Report follows this Project Summary

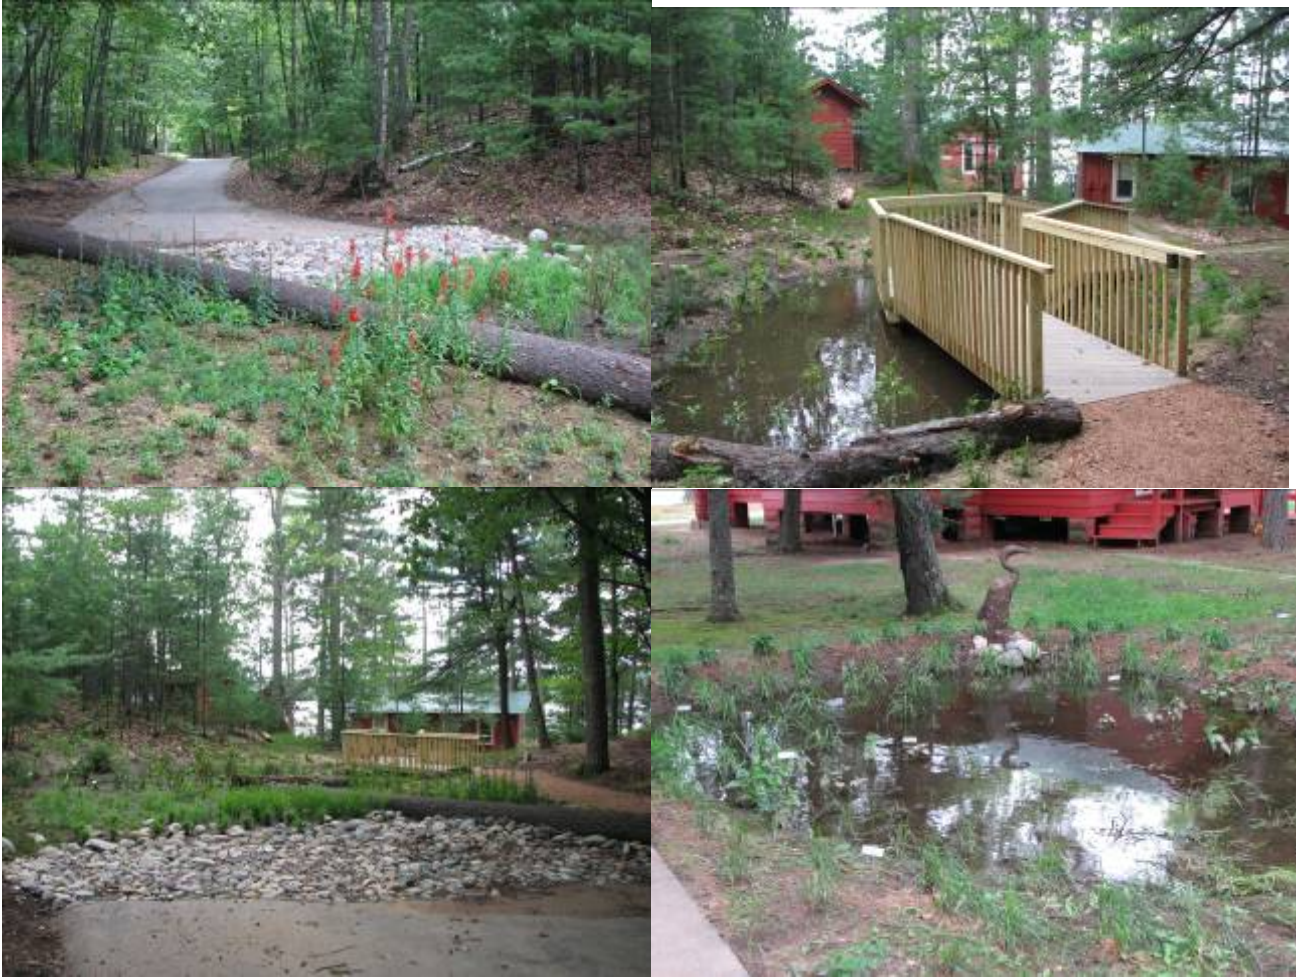
Photo Series 7 – Rain Gardens

During the spring and summer of 2009, 184 trees of 16 species, 1558 shrubs of 23 species, 21 vines of two species, 9684 forbs and grasses of 89 species were planted within the 35' buffer zone and along approximately 1300' of linear lakeshore. Two rain gardens were also installed, designed to intercept rainwater run-off from asphalt drives and parking areas. Rain barrels were also installed to reduce water run-off from roof-tops

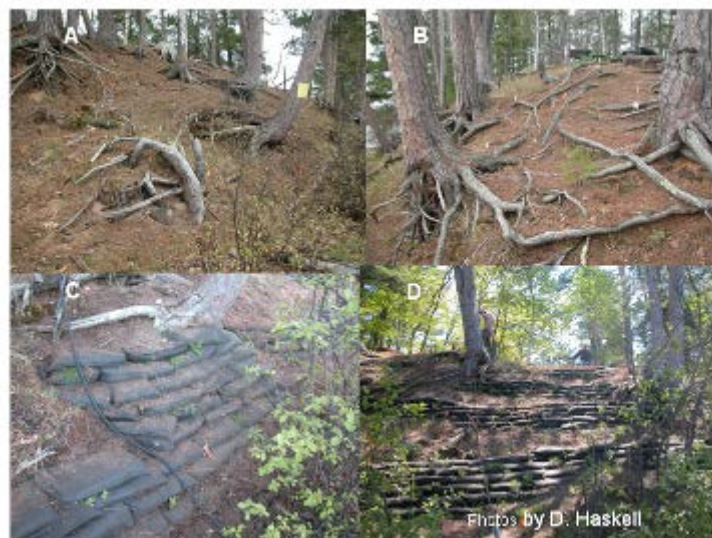
Figure 1. Photos A & B: before EnviroLok™ bags were installed. Photos C & D: after EnviroLok™ were installed on Moon Beach during the spring and summer of 2009.

EnviroLok Bags: The EnviroLok™ bag system is bio-engineered vegetated retaining wall and these walls are strong, environmentally-friendly, and create beautiful natural landscapes. In addition, the EnviroLok™ system is an erosion control and slope stabilization system that utilizes ecologically advanced soil bag and interlocking grid technologies. Approximately 400 EnviroLok™ bags were installed in May 2009 and another 400 bags in July 2009 at areas that were experiencing severe erosion on steep slopes and with the threat of losing mature white & red pines along the lakeshore. These bags were integrated into the contour of the slopes and native shrubs, forbs and grasses were planted within the bags. Approximately 400 bare root and gravel culture shrubs of 4 species, and 1008 forbs and grasses of 20 species were planted in May and July into the EnviroLok™ bags (Figure 1).

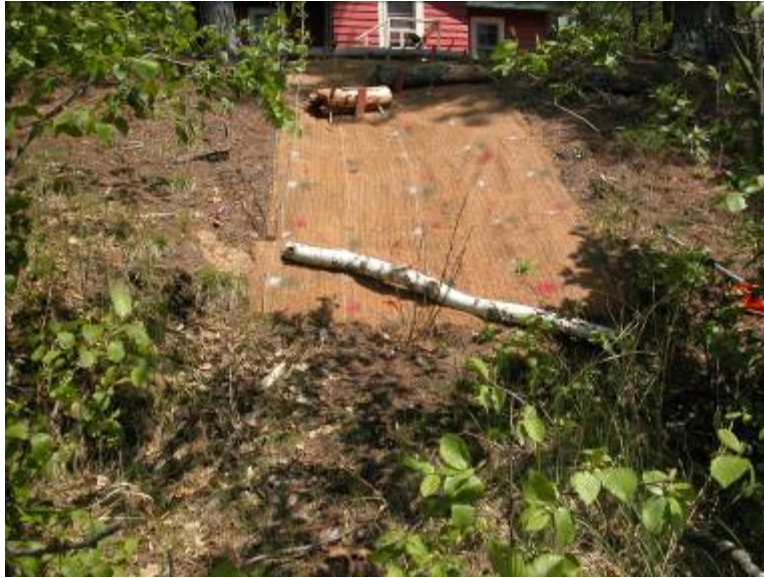
Figure 2. Coconut Erosion Control Blanket installed at Moon Beach during the summer of 2009 at moderate erosion areas (Photo by D. Haskell).

Coconut Erosion Control Blanket: Approximately 300 square yards of coconut erosion control blanket was installed at various places along the lakeshore at moderate erosion areas. Blankets were secured by six and eight inch sod staples and various shrubs, forbs and grasses were planted into the blanket (Figure 2).

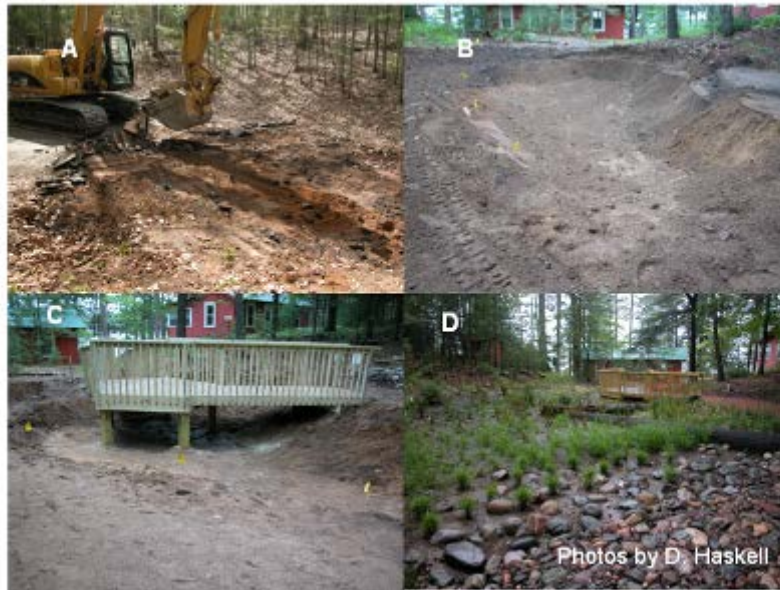
Figure 3. Construction of Rain Garden at Moon Beach in June of 2009. Photo A: asphalt being removed, photo B: excavation of rain garden, photo C: wooden bridge constructed over depression, Photo D: completed rain garden holding water during and after rain event.

Rain Garden: Water run-off from large asphalt driveway, parking lot and surrounding wooded upland was channeling around cabins and into the restoration area. This run-off was causing severe erosion to occur in the upland and on the beach area directly below the cabins. Approximately, 2000 square feet of asphalt was removed by local contractor and area excavated to specification by consultant. The goals of this rain garden are listed:

A local contractor was hired to excavate the rain garden to specification and to delivery and install additional materials. Elevation grades were established for water to run through rock cobble at the end of asphalt driveway and then into an area planted with native sedges, shrubs, forbs and ferns. Water run-off would be guided through this area by means of 30' long log, anchored approximately in the center of rain garden and angled towards planted area. After water reached the planted area, a gradual grade of three feet deep (depression) and 10 feet wide was excavated to hold water until it filter through the soil. A gravel pathway along the edge of rain garden and a wooden bridge over the depression was constructed to allow access to cabins (Figure 3).

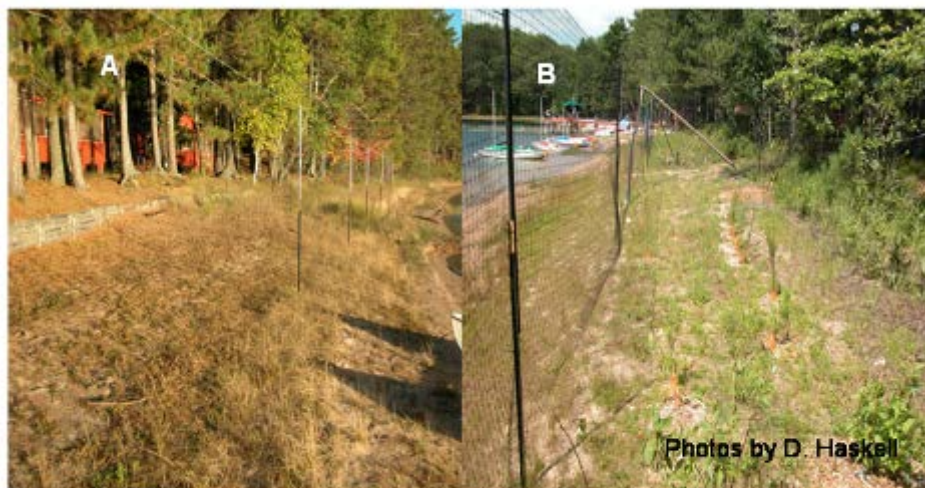
Figure 4. Fence constructed in 2009 to prevent herbivory by white-tailed deer on restoration plants at Moon Beach. Photo A: showing placement of T-post and steel cable, photo B: showing nylon mesh attached to T-post and cable.

Fence: Approximately 3000 linear feet of eight foot tall, nylon mesh, UV protected fence was constructed along the lakeshore which enclosed the restoration area. This fence protected the new sweet tender plants from the over abundant deer in the area. To hold the fence upright, 5.5 foot steel T-post were pounded into the ground every 16 feet apart. A five foot long, $\frac{3}{4}$ inch diameter, steel electrical conduit was attached to T-post with six inch long, 16 gauge tie wire. A $\frac{1}{8}$ inch diameter, 7x7 braided steel cable was attached to the top of post assemblies and strung the entire length of fence. The cable was attached to corner posts with a $\frac{5}{16}$ inch diameter by six inch long turn-buckle which was attached to a $\frac{1}{4}$ inch diameter by two inch long eye bolt. The cable then was secured to the turn-buckle by two cable clamps. Wooden braces were installed at each 90 degree corner and at various places along fence and gate entrances which strengthen and provided rigidity to the fence encase of high winds, wind driven rain, freezing precipitation, monstrous blizzards, crashing wave action, and crushing ice heaves throughout the seasons. These braces were secured to the post assemblies by $\frac{1}{4}$ inch diameter by 2 $\frac{1}{2}$ inch long hex bolts, nuts and flat washers. After the post assemblies, corner braces and cable were erected, then the nylon mesh fence was strung up to the post assemblies and attached with six and eight inch long, UV protected zip-ties. The nylon mesh fence was also zip-tied to the cable securing the top of the fence and six and eight inch long sod pins secured the bottom of the fence to the ground. Entrance gates were placed in various places along fence (Figure 4).

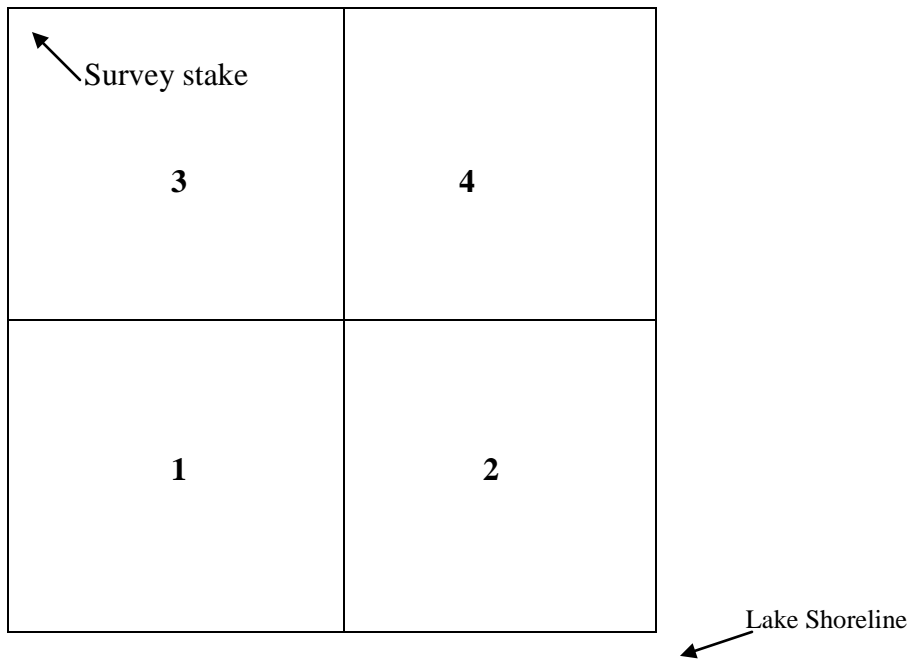
Figure 5. Example of 10 m × 10 m vegetation sampling plot with four 5 m × 5 m subplots Jag and Moon Lakes in 2007. All live trees ≥ 5 cm DBH were recorded in plot and live saplings and shrubs were recorded in two subplots. Figure 5 shows location of survey stake.

survey plot always began to the right of the point (start of 10 m × 10 m plot at point, end of plot to the right when facing shore from the lake). However, if a point fell on a usage area or access area to the lake then a sub-segment was randomly picked, using a random number table, until the vegetation plot did not fall on usage or access area. For example, if plot 3a fell on a usage area then another point was randomly picked such as 3b, 3c, 3d or 3e. A metal rebar (1.25 cm × 15 cm) with a 1.25 cm flat washer welded to one end was used for a permanent survey stake and driven flush with the ground at an inland corner of the vegetation plot. The metal stakes can be relocated in subsequent years with a metal detector to resample the plots. Each plot was divided into four 5 m × 5 m subplots (Figure 5).

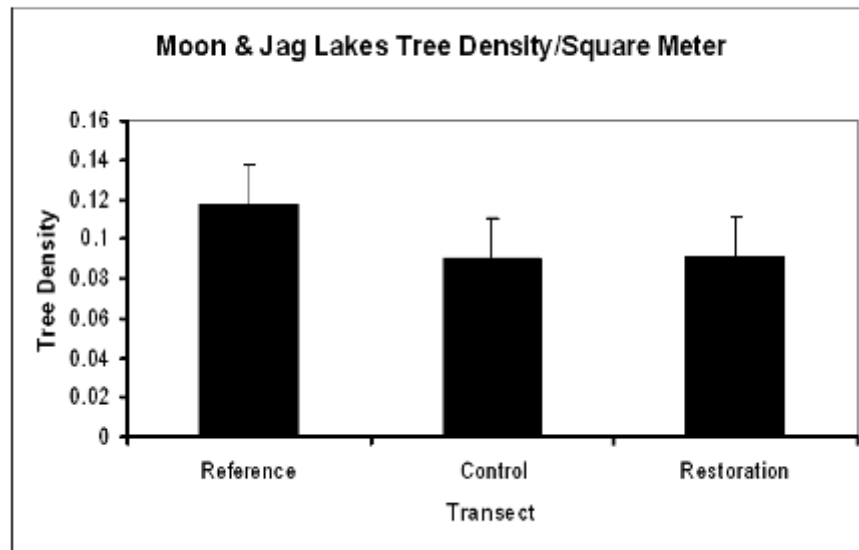
Figure 6. Moon and Jag Lakes tree density/hectare on each transect, data recorded in 2007.

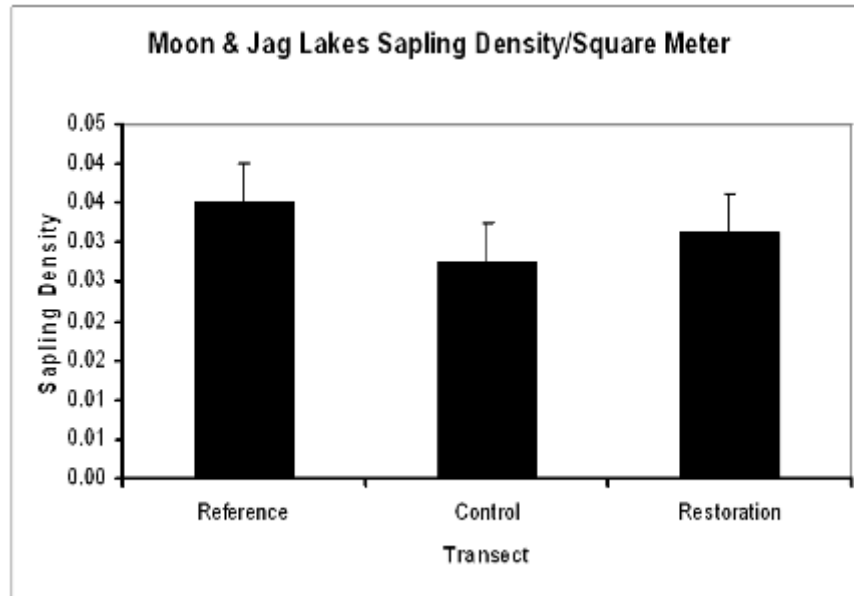
Figure 7. Moon and Jag Lakes sapling density/hectare on each transect, data recorded in 2007.

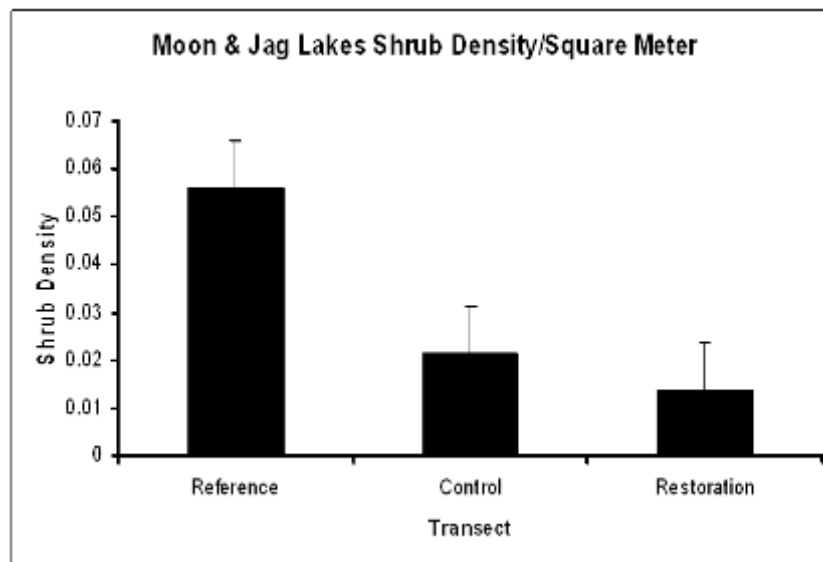
Figure 8. Moon and Jag Lakes shrub density/hectare on each transect, data recorded in 2007.
