Lake Use Report No. FX-39

LULU LAKE Walworth County

An Inventory With Planning Recommendations

Prepared by Wisconsin Department of Natural Resources

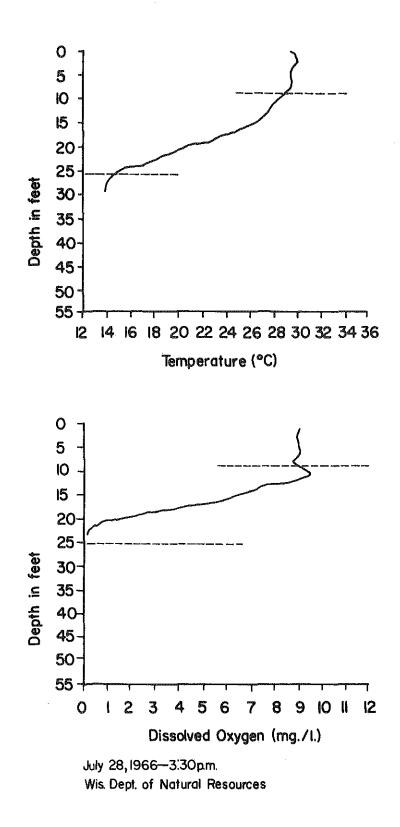
FIGURE I.

Temperature and Oxygen Profiles

With little wind fetch the lake develops a fairly shallow mixed layer in summer. The thermocline develops at about nine feet and temperatures decrease rapidly to about 27 feet. Sufficient oxygen to support even tolerant fishes exists only to a depth of about 20 feet in midsummer. About 62 percent of the total lake volume can support fish in midsummer.
