# Aquatic Plant Management Plan

## McCaslin Lake

Chuck Druckrey  
Marinette County Land Information Department  
Land & Water Conservation Division  
February 2010

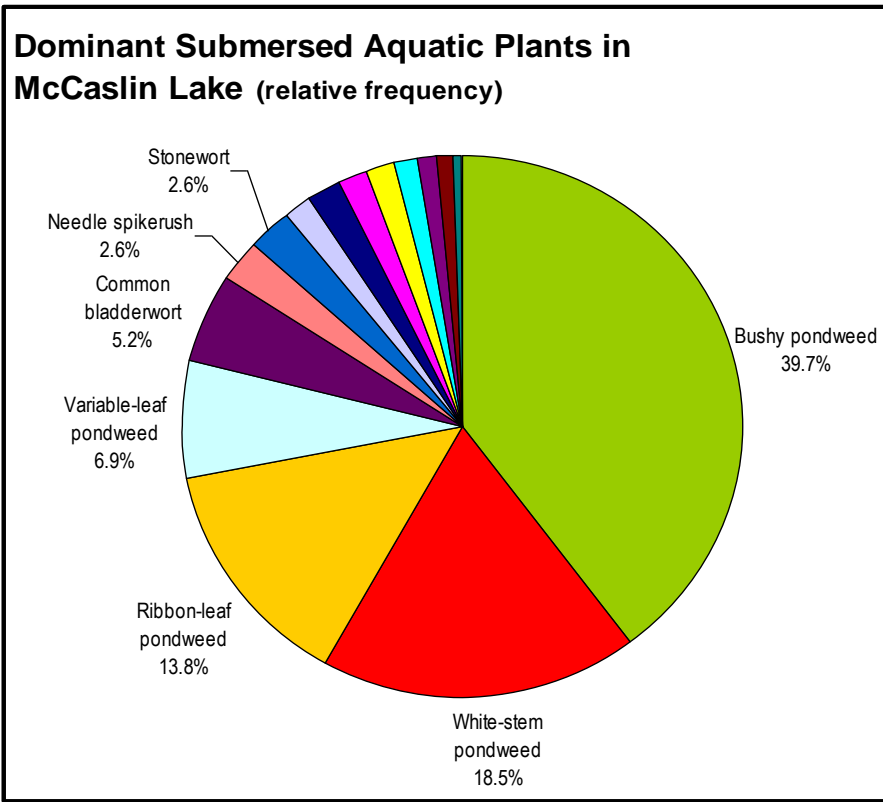
**Figure 3. Dominant submersed plants.**

16 species of submersed plants were identified in McCaslin Lake. Bushy pondweed, white-stem pondweed, and ribbon-leaf pondweed were the dominant species, accounting for nearly three quarters of the plant population (figure 3). Four other species were found in at least 3% of the sample points.

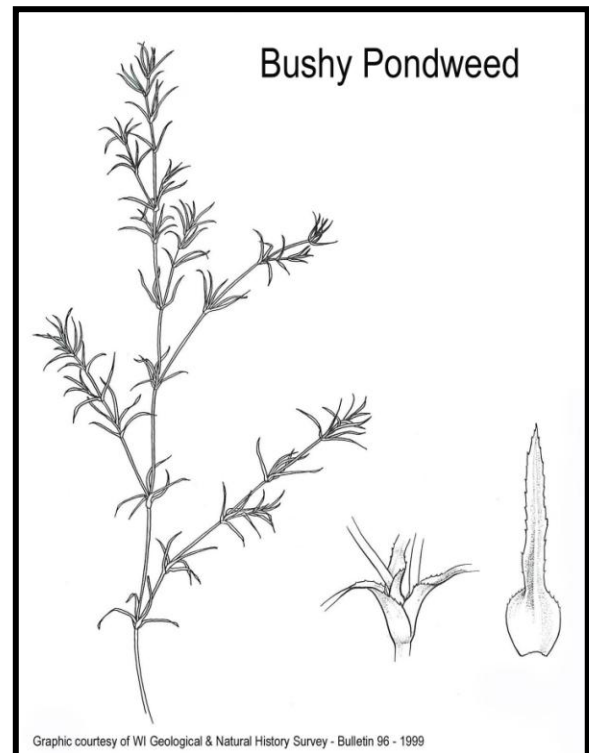
Bushy pondweed (*Najas flexilis*) was the most abundant submersed plant in McCaslin Lake. It was found at 44% of sample sites. This plant varies greatly in growth form, in shallow water it is typically compact and bushy. In deep water it is often wiry with widely scattered leaves. The leaves are very narrow (1/16<sup>th</sup> inch wide) with a broad base where they attach to the stem. Plants generally grow no more than 2 feet tall and prefer a sand or firm muck substrate.

Bushy pondweed is unique in that it's one of the few annual aquatic plants. It dies each winter and depends on seed to grow new plants each year. The plants and seeds, which are produced in great number each year, are important food for waterfowl.

In McCaslin Lake bushy pondweed shows no distinct depth preference and can be found growing in water from one to 7 feet deep. Due to its short stature bushy pondweed is seldom reported as a nuisance plant.
