Lake Belle View Restoration Project  
Two Year Evaluation

Large-scale Lake Planning Grant Report

December 2013

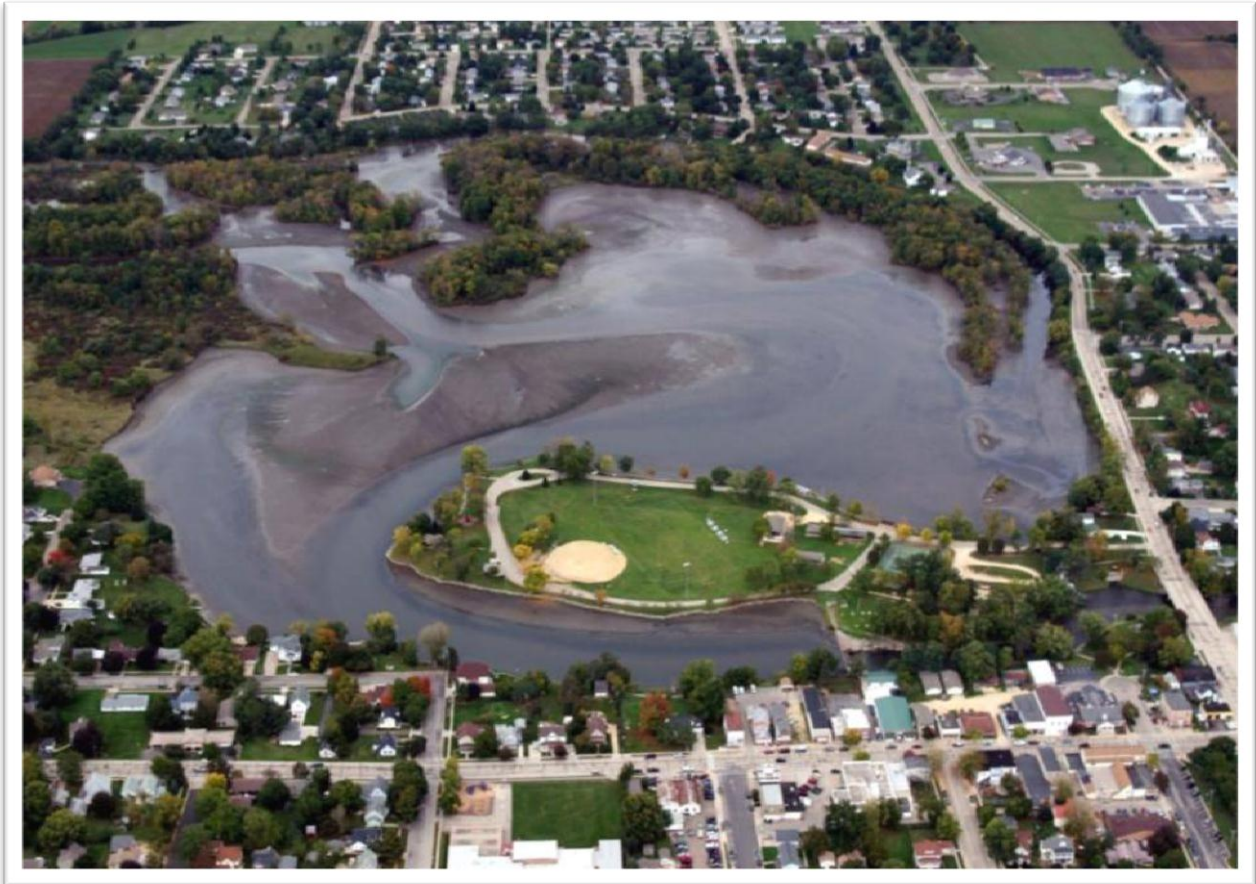
Figure 1: Lake Belle View Temperature Profiles

The vertical profile data for temperature, dissolved oxygen, pH and specific conductance appear in Figures 1 - 4. One issue of concern during the planning phase of the project was the potential for winterkill conditions. The dissolved oxygen profiles in Figure 2 demonstrated adequate dissolved oxygen levels in the lake but anoxia did occur seasonally near the bottom. In Figure 1, modest thermal stratification was limited to June in both years and reflected mixing in the shallow lake. Therefore, the low oxygen levels near the bottom did not reflect stratification but rather light and photosynthesis limitation. Consistent with decreasing dissolved oxygen levels with depth, pH measurements also declined with depth (Figure 3). Specific conductance levels were typically in the range of 500 – 600 uS/cm except in February of 2013 when levels reached 700 uS/cm, suggesting chloride runoff from street salt applications.

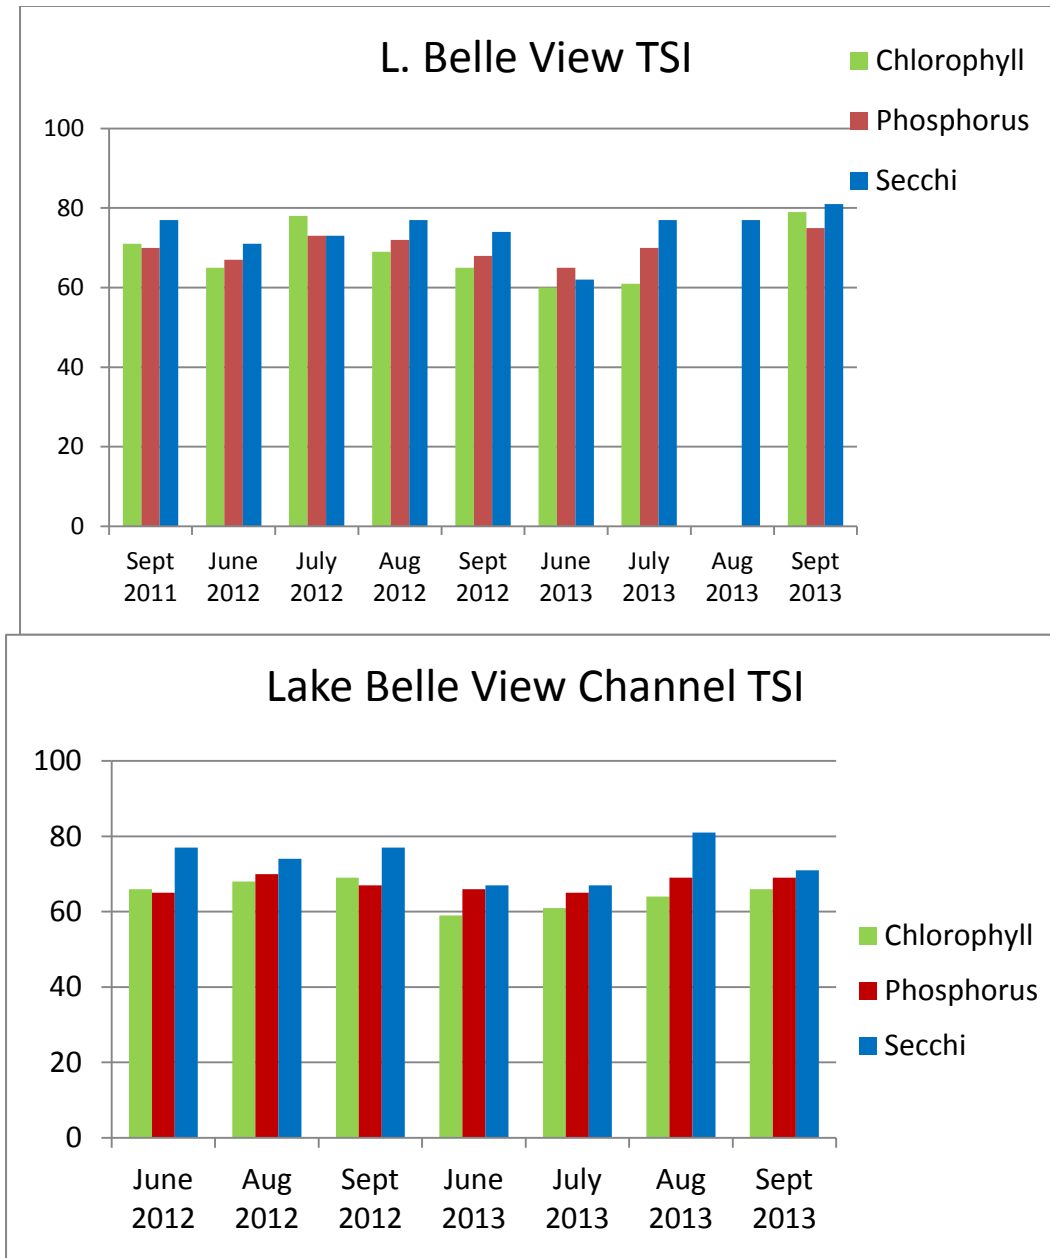
Figures 7: Lake Belle View TSI

Transformed to Trophic State Index (TSI), both secchi and phosphorus TSI values typically exceeded chlorophyll values and indicated turbidity related to carp disturbances (Figure 7). The very poor water clarity reflected a combination of phytoplankton and sediment related turbidity due to carp. In all cases, the trophic states related to the three measures reflected highly eutrophic conditions. Nitrogen data are presented in Figure 8. Phosphorus concentrations were relatively high compared with nitrogen concentrations and nutrient limitation was often indeterminate or nitrogen limited in the lake and phosphorus limited just twice in the channel (Figure 9).

(TSI 50 – 70 – eutrophic and > 70 = hypereutrophic)

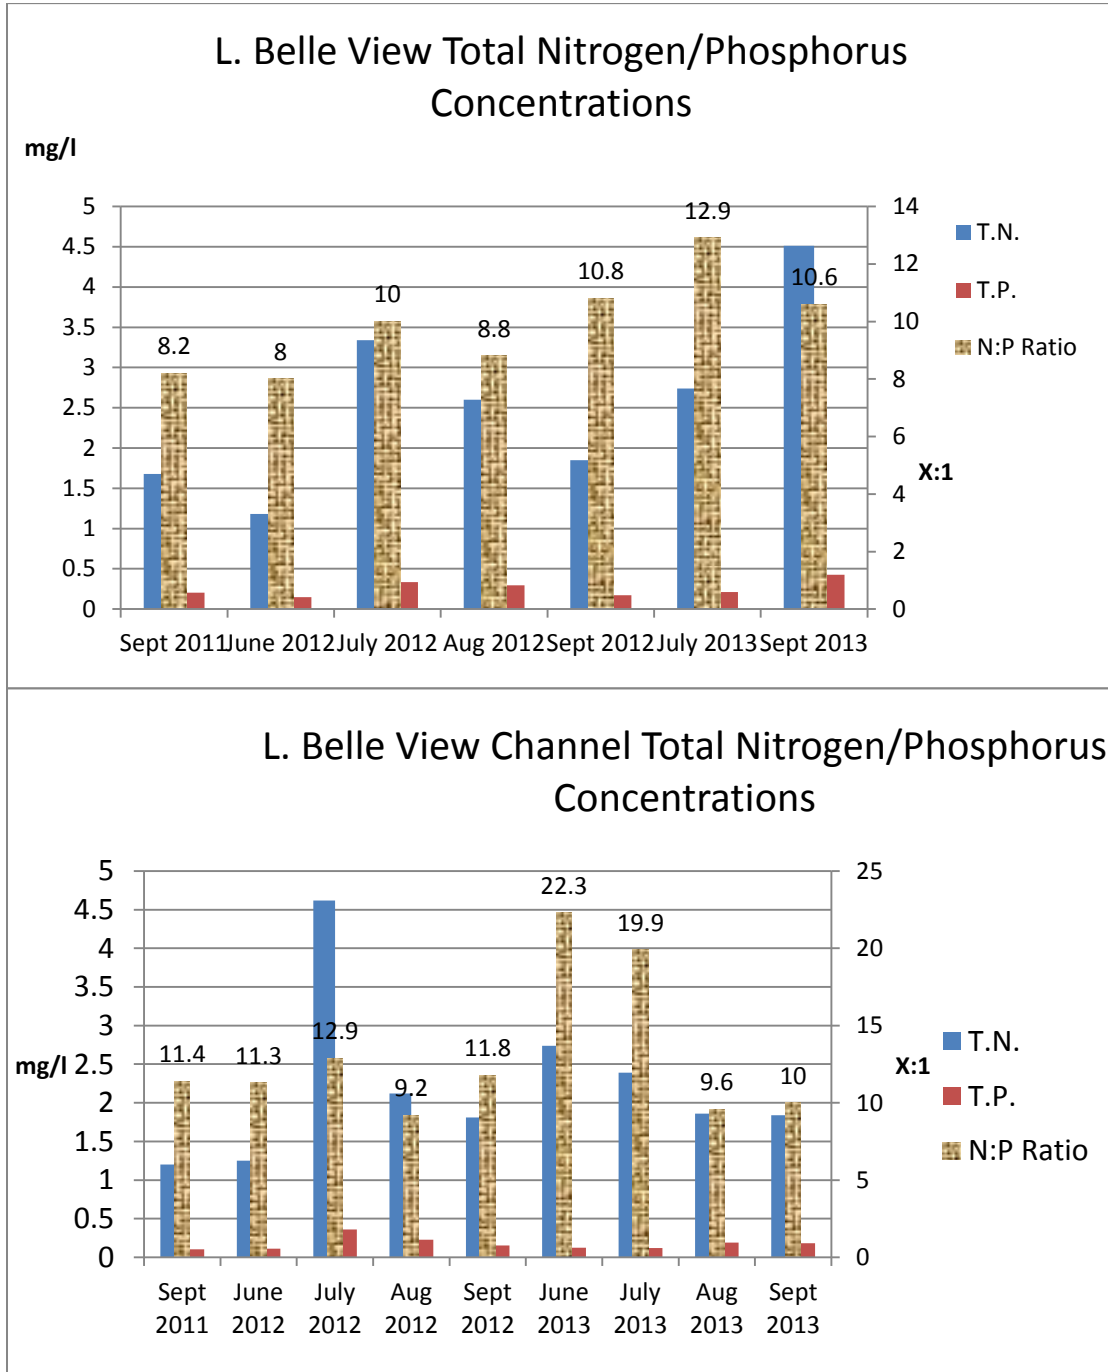
Figure 9: Lake Belle View N:P Ratios

(< 10:1 indicated N limitation, 10:1 – 15:1 indeterminate, >15:1 = P limitation)

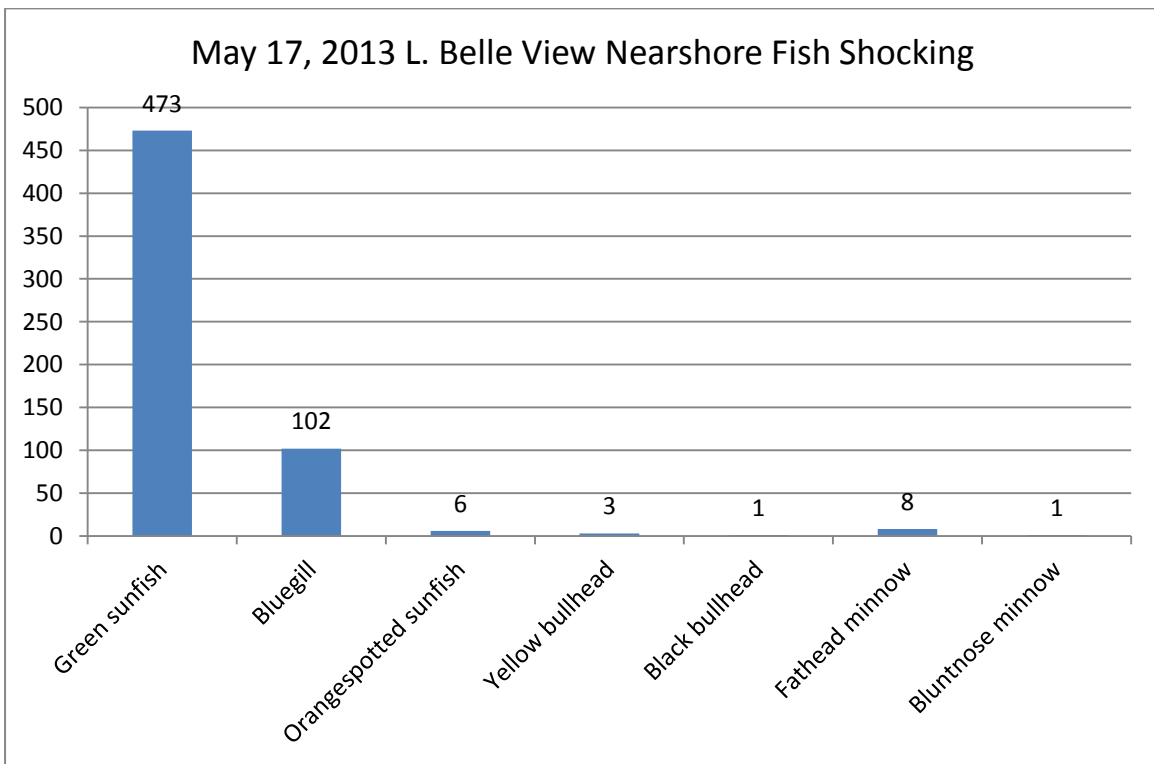
Figure 13: Lake Belle View Nearshore Fish Shocking Results

Based on two nearshore electroshocking surveys conducted in September 2012, eight native fish species were collected along with the first confirmation that common carp had survived the construction drawdown. Another nearshore electroshocking survey was performed in May 2013 with six native species collected (Figures 13 and 14). The nearshore shocking did not reveal information concerning the status of most native fish species that were stocked in the lake, however an abundance of bluegills (*Lepomis macrochirus*) and green sunfish (*L. cyanellus*) indicate potential predation on common carp eggs and fry. While common carp were not collected during the 2013 nearshore electroshocking survey, numerous common carp catches had been reported by anglers and several were seined along the north end of the lake.

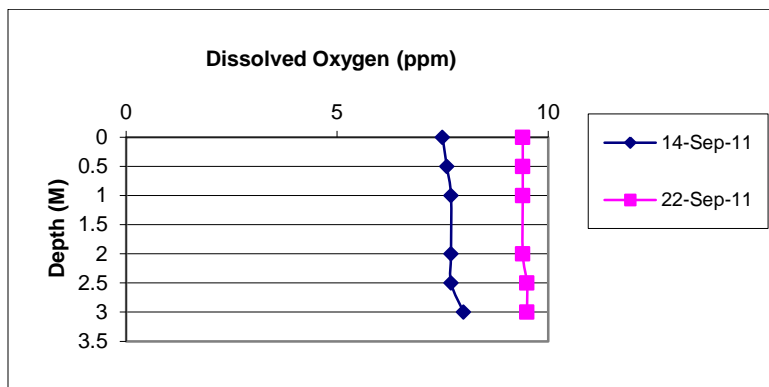
Dissolved oxygen levels remained above the water quality criterion level of 5 mg/l throughout the water column on September 14 and 22.

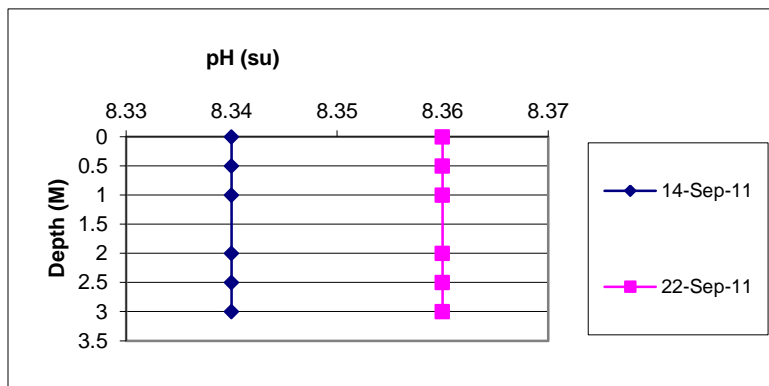
Specific conductance and pH mirrored the mixed water column as well.

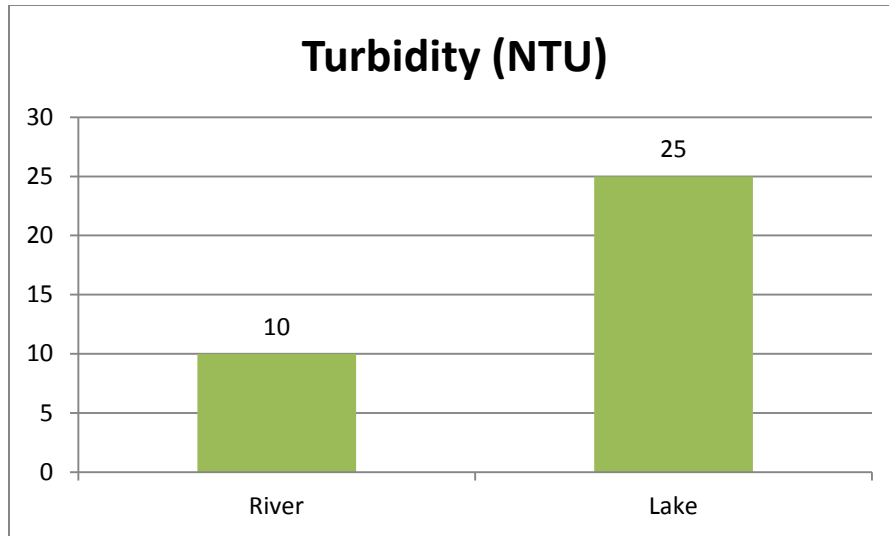
Wind and lack of aquatic vegetative cover over the sediment resulted in turbid conditions based on secchi measurements of 1' (0.31 M) on September 14 and 1.2' (0.37 M) on September 22.

Unlike the summer months, the river water clarity was better in September than in the lake due to the factors mentioned above.

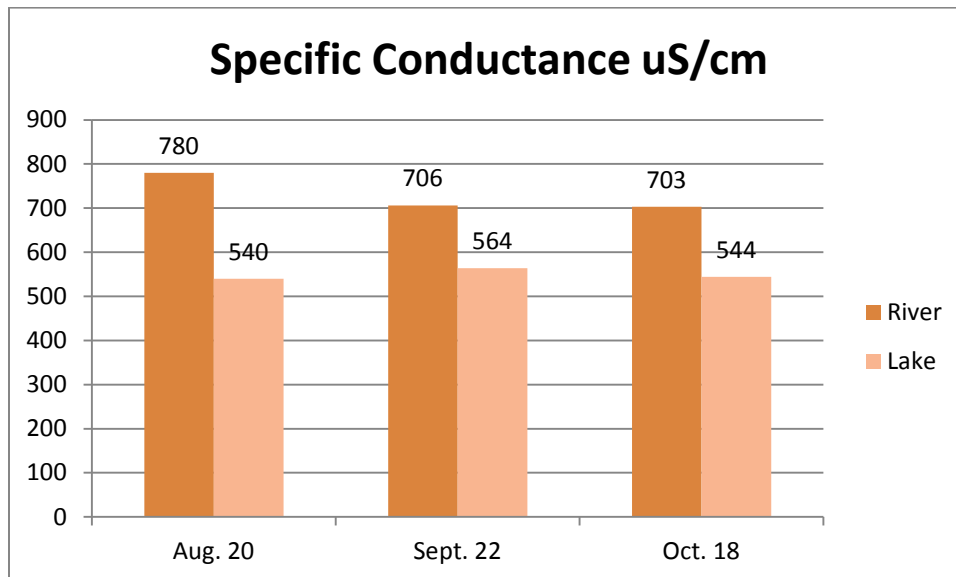
The specific conductance levels in the river were significantly higher than measured in the lake and reflect higher total dissolved solids discharged from the Mt. Horeb wastewater treatment plant to the West Branch Sugar River and Madison Metropolitan Sewerage District discharge to Badger Mill Creek. The levels found in the lake are more typical of groundwater and surface water that drain limestone topographies and therefore reflect better water quality.
