THE MILJALA CHANNEL OF ROCK LAKE

SEDIMENT CONTROL AND WATER QUALITY IMPROVEMENT

Water Resources Management Workshop
Nelson Institute for Environmental Studies
University of Wisconsin-Madison

2012

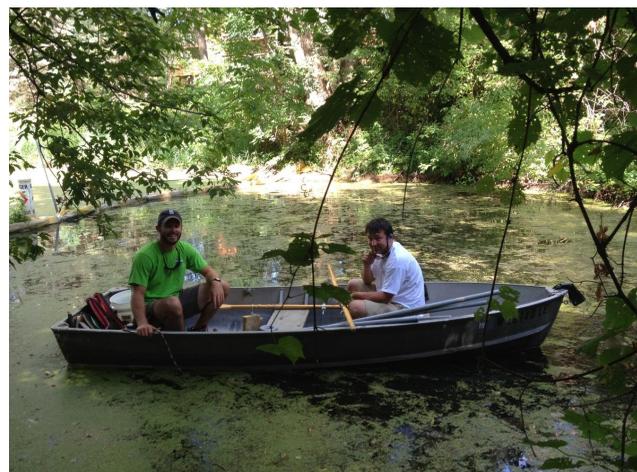
FIGURE 2.4 TAKING THE SECOND ROUND OF SEDIMENT CORES. PICTURED ARE TOM BENEKE AND STEVE NEARY. PHOTO CREDIT: MEGAN PHILLIPS, 7.11.12

We collected samples of the sediment accumulated behind the turbidity curtain and analyzed the grain size distribution to make some inferences about the sources of sediment and sediment transport (Figures 2.3 and 2.4).

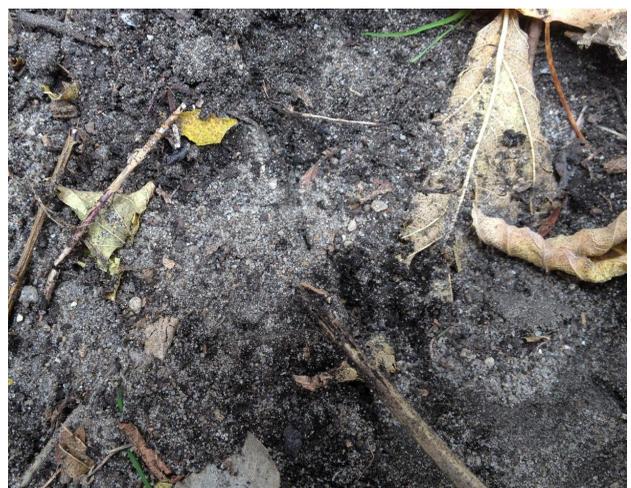
FIGURE 2.5 SANDY SOIL NEAR SS2. PHOTO CREDIT: STEVE NEARY, 10.5.12

Sand is exposed in the bed of the ditch upstream of SS2 and downstream of SS5 (Figure 2.5). The steep, eroding banks upstream of SS2 also have a high sand content. A silty clay layer underlies the Houghton muck and may be exposed in places. We conducted an erosion survey in April 2012 and found extensive areas of exposed banks throughout the east to west section of the ditch. We have also observed signs of erosion and deposition in the crop field south of

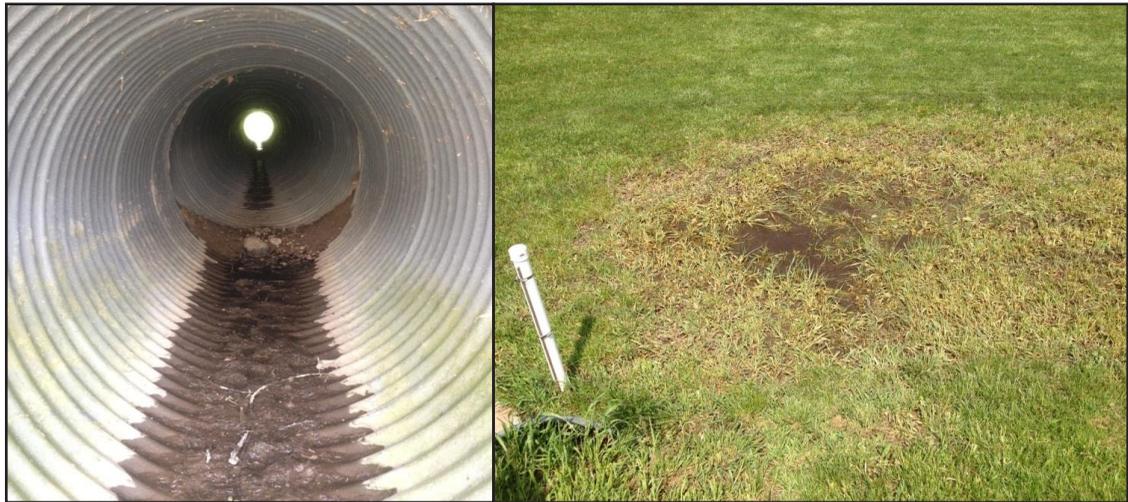
FIGURE 2.7 SS8 AFTER A LARGE SPRING STORM (LEFT). THERE WAS EVIDENCE OF SOME PONDED WATER IN FRONT OF THE CULVERT, BUT THE CREST STAGE GAGE RESULTS WERE INCONCLUSIVE (RIGHT). PHOTO CREDIT: STEVE NEARY, 5.11.12

from the Shorewood Meadows subdivision could lead to erosion of mineral soil. A crest-stage recorder was installed at the culvert to measure the maximum depth of water moving through the culvert during a rainstorm. Surprisingly, the subdivision was not a significant source of runoff during 2012. Flows were never high enough to obtain meaningful results from the crest stage recorder. Only on two dates was there any evidence that water had moved through the culvert at all; on other occasions, when we arrived during or just after a rainfall, the barrel of the culvert was dry or blocked with debris and the soil near the entrance was cracked. While drought was certainly a factor, the use of grass swales for drainage, rather than curb-and-gutter, means that the amount and velocity of runoff from the subdivision is much lower than would be observed from a similar area with traditional curb-and-gutter. Infiltration tests showed that the soil is quite permeable (Table 2.1). The subdivision could still be a source of runoff in wet years when frequent rains cause the soil to become saturated.

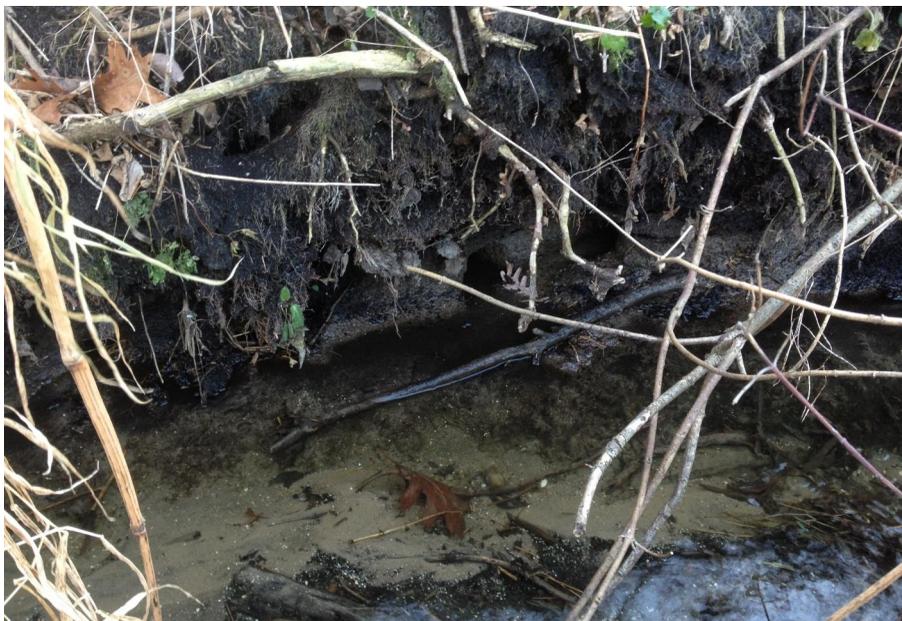
FIGURE 2.10 STEEP, ERODING AND UNDERCUT BANKS FOUND ALONG THE DITCH IN SEVERAL PLACES. SAND IS ALSO PREVALENT IN THE DITCH, PARTICULARLY IN BENDS WHERE VELOCITY SLOWS ENOUGH TO FORCE IT FROM THE WATER COLUMN. PHOTO CREDIT: STEVE NEARY, 12.2.11

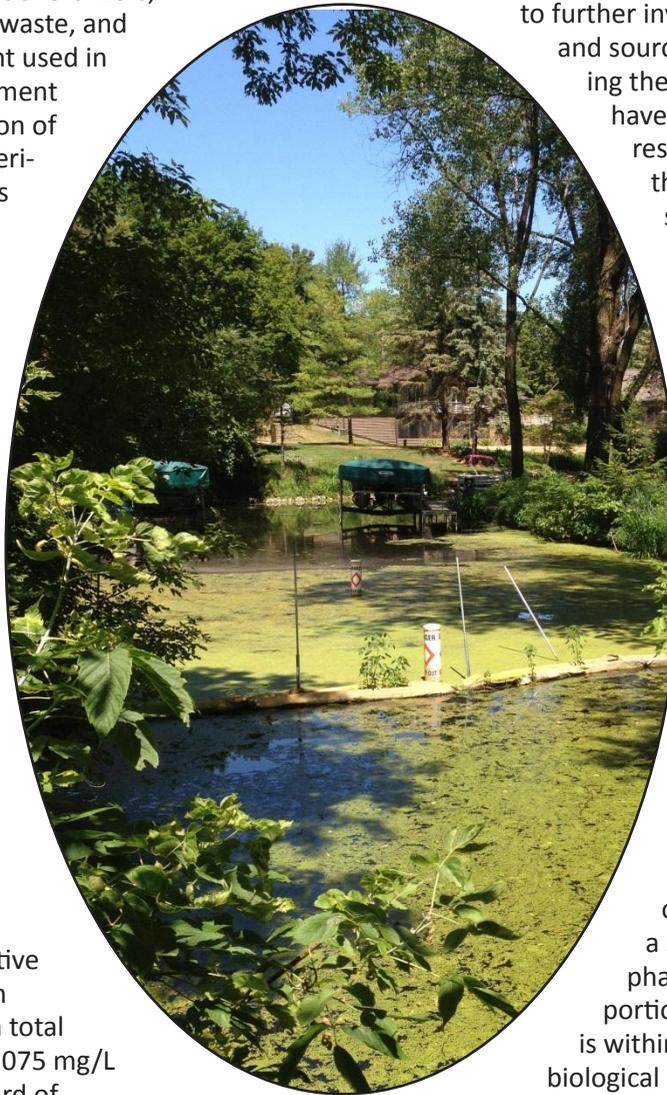
FIGURE 2.11 EUTROPHICATION BEHIND THE SEDIMENT CURTAIN. PHOTO CREDIT: STEVE NEARY, 6.26.12

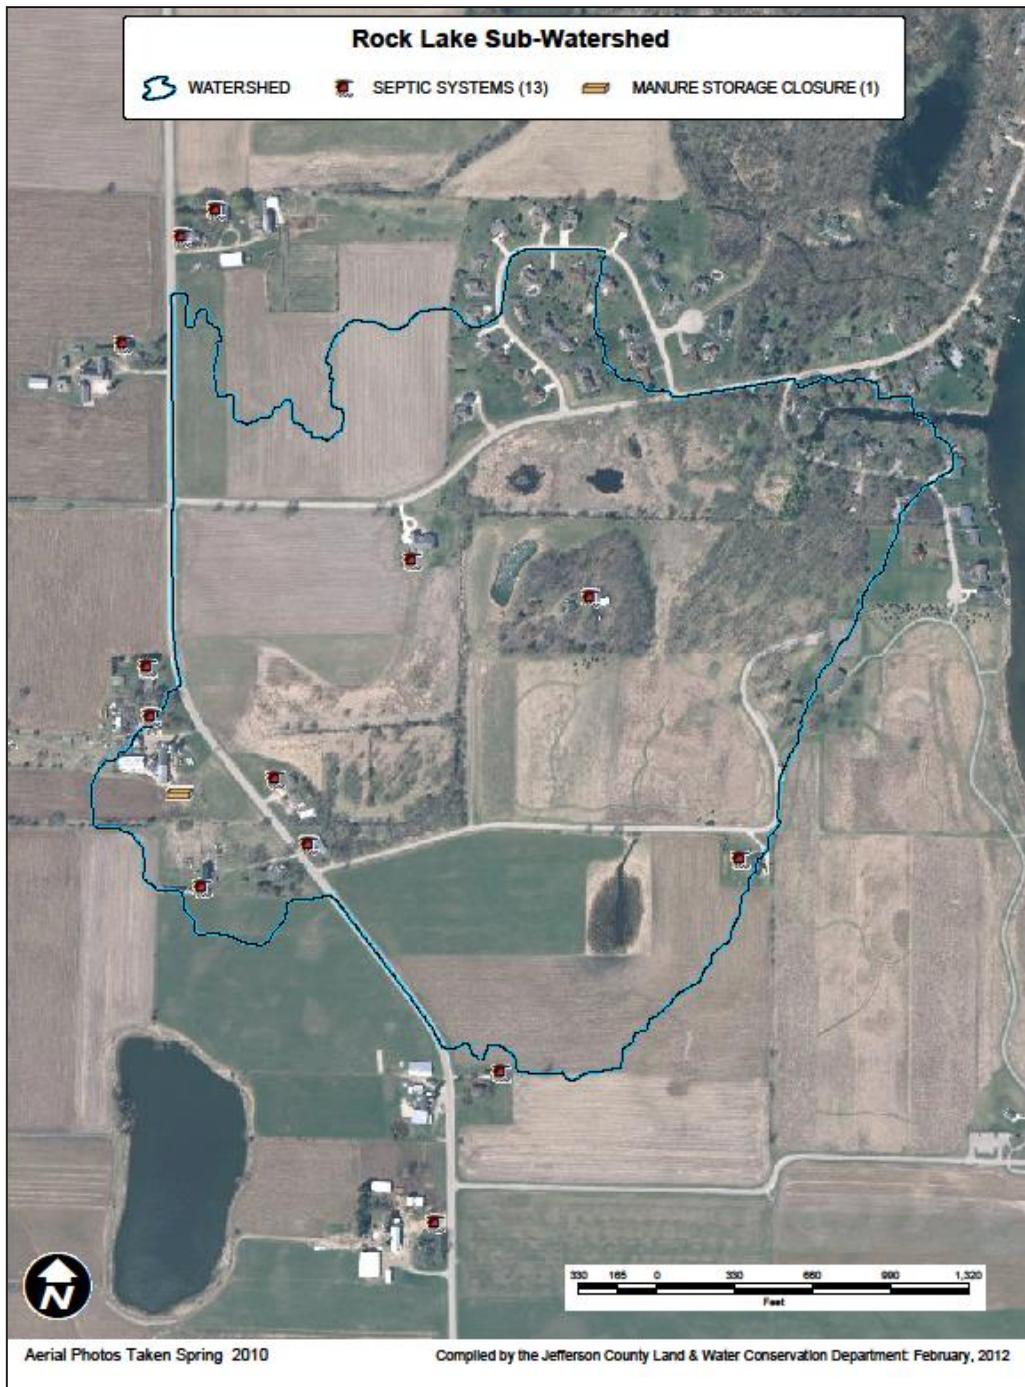
FIGURE 2.14 SEPTIC SURVEY MAP. INCLUDED ARE LOCATIONS OF SEPTIC SYSTEMS AND A PREVIOUSLY REMOVED MANURE PIT WITHIN THE WATERSHED. SOURCE: JEFFERSON COUNTY LAND AND WATER CONSERVATION DEPARTMENT.

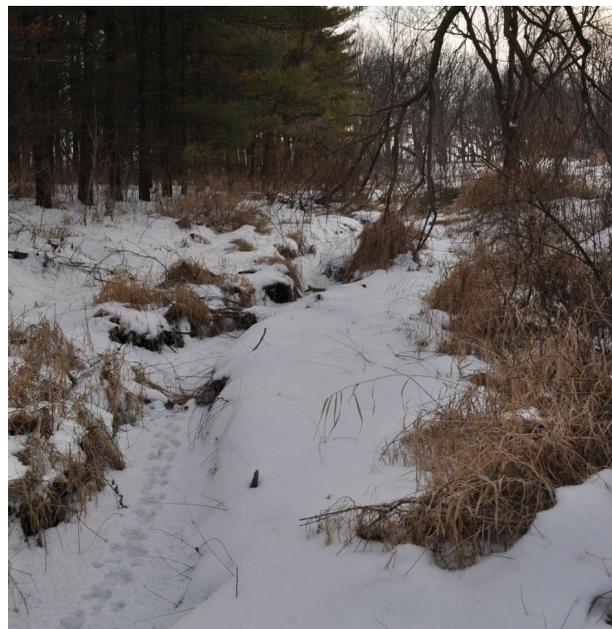
FIGURE 2.17 ANIMAL TRACKS ARE EVIDENT AND UBIQUITOUS THROUGHOUT THE WATERSHED, INDICATING A PERENNIAL BACTERIA SOURCE. PHOTO CREDIT: STEVE NEARY, 1.27.12

Another likely source of bacteria in the watershed is wildlife. It is well known that wildlife feces are a contributor to the presence of *E. coli* and fecal coliform in wetland and other naturally occurring ecosystems (Gordon and Cowling, 2003, Whitman et al., 2006). Numerous mammalian and avian species were observed in the area over the course of the study period, including deer, sandhill cranes, mallards and muskrats (Figure 2.17). In addition, a dead raccoon was discovered near the ditch at SS5 in June 2012.

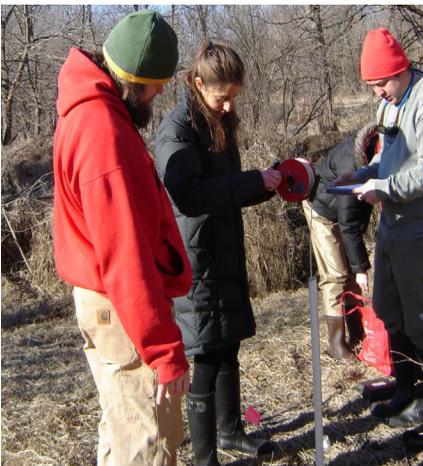
FIGURE 2.18 RECORDING GROUNDWATER ELEVATION AT MW5. PICTURED ARE IAN ANDERSON, MARIA GARCIA DE LA SERRANA, AND STEVE NEARY. PHOTO CREDIT: PATRICIA CICERO, 3.9.12

We installed data loggers in several wells to track groundwater levels, and compared those to flows in the ditch (Figure 2.18). Our hope was to find a strong relationship between groundwater storage in the Houghton Muck, as reflected by the height of the water table, and groundwater discharge to the ditch that could be used to model baseflow, but the correlation was weak (Figure 2.19).

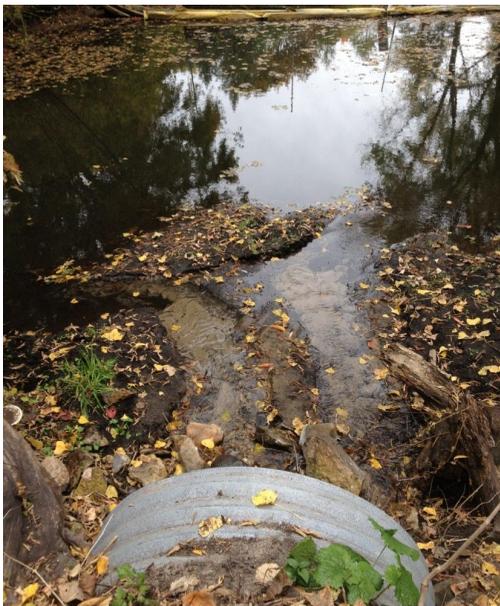
FIGURE 3.2 SAND DEPOSITION AT THE CULVERT OUTLET INTO MILJALA CHANNEL. PHOTO CREDIT: STEVE NEARY, 10.5.12.

Neither of the first two recommendations can address the mobilization of contaminated sediment (Figure 3.2) that has settled in the ditch bottom, or the downstream source of bacteria — possibly from wildlife or from bacteria free-living in the soil. They do little to address the sediment problem, which includes bed and bank erosion in the ditch (Figure

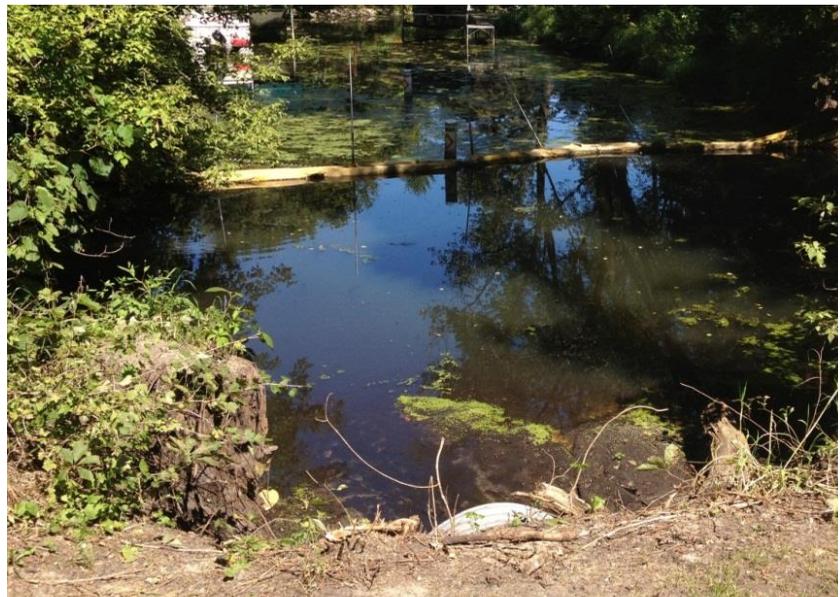
FIGURE 3.3 VEGETATION WAS CUT ON THE STEEP BANKS ABOVE THE CULVERT OUTLET TO THE MILJALA CHANNEL. TO PREVENT FURTHER EROSION, THESE BANKS SHOULD REMAIN VEGETATED THROUGHOUT THE YEAR. PHOTO CREDIT: STEVE NEARY, 8.22.12

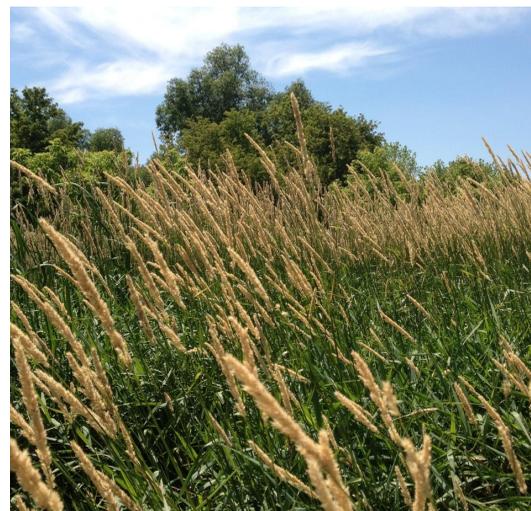
FIGURE 3.4 THE BUFFER STRIP BETWEEN SS5 AND SS7 WAS ESSENTIALLY MONOCULTURE PATCHES OF REED CANARY GRASS AND STINGING NETTLE. PHOTO CREDIT: STEVE NEARY, 6.26.12

Site vegetation is currently dominated by reed canary grass, an invasive species (Figure 3.4). To establish more diverse vegetation and maximize habitat benefits, reed canary grass would have to be controlled, except in locations of permanent standing water. Sod scraping with a bulldozer can be effective and can expose the seed bank, or some combination of well-timed mowing, herbicide application and burning can be used (WRCWG, 2009). Since high phosphorus levels, sediment deposition, and water level fluctuations favor invasive species like reed canary grass and narrow-leaf or hybrid cattails, this could be an uphill battle. Wetland restoration is often

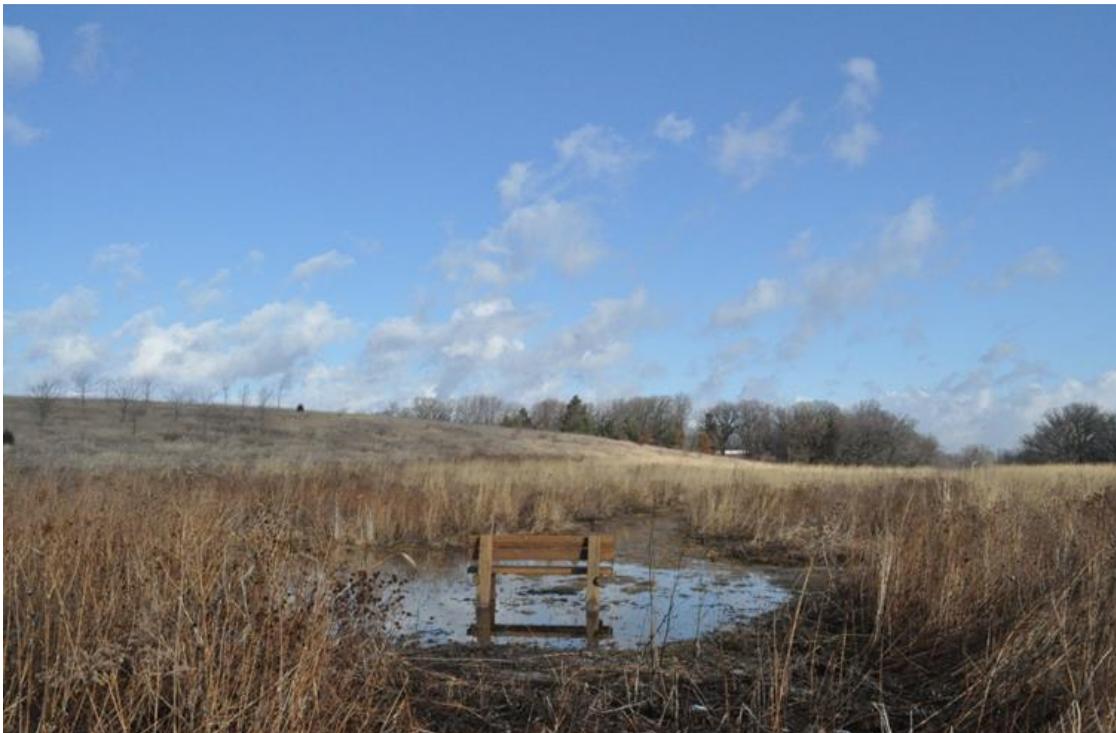
FIGURE B.1 INFILTRATING MELT WATER IN THE FIELD BETWEEN TWO DRUMLINS. A DRAIN TILE CONNECTING SS4 TO THE DITCH RUNS ALONG THIS FIELD (RIGHT HAND SIDE OF THIS PICTURE). PHOTO CREDIT: STEVE NEARY, 2.29.12

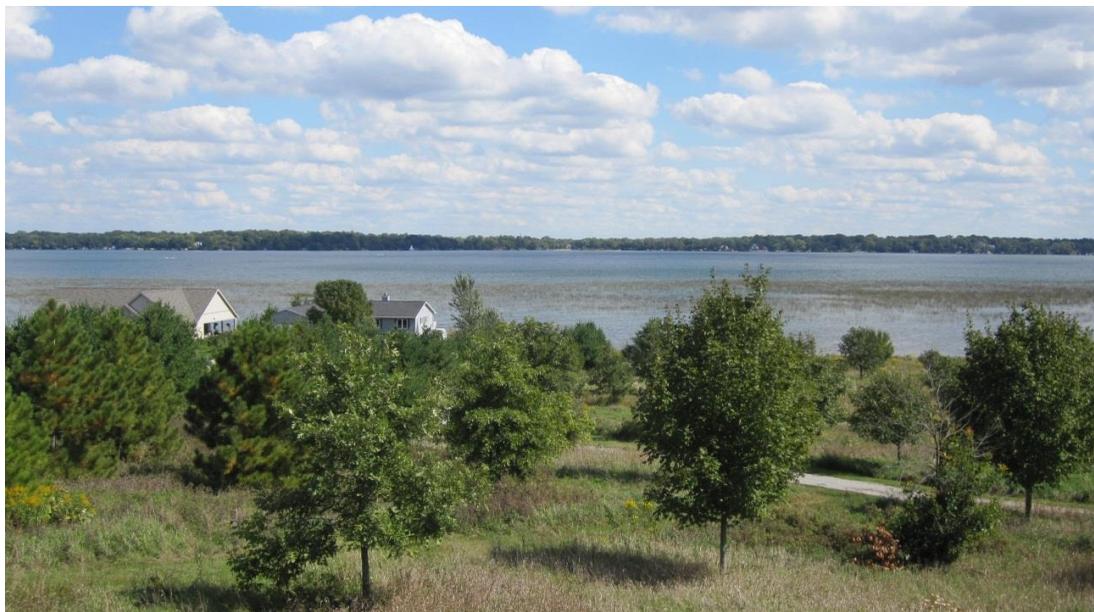
FIGURE B.4 ROCK LAKE AND THE NO-WAKE ZONE LOCATED NEAR THE OUTLET OF THE MILJALA CHANNEL. THIS SENSITIVE AREA SUPPORTS A COMMUNITY OF BULRUSH PLANTS THAT PROVIDES CRITICAL HABITAT FOR FISH, INSECTS, AND MIGRATING WATERFOWL. PHOTO CREDIT: STEVE NEARY, 9.16.11.

It is important to note that Rock Lake has been identified as an outstanding to exceptional lake by the DNR, and the area where this channel drains has been identified as a sensitive lake area and a public rights feature of the state (Figure B.4). Past runoff from the

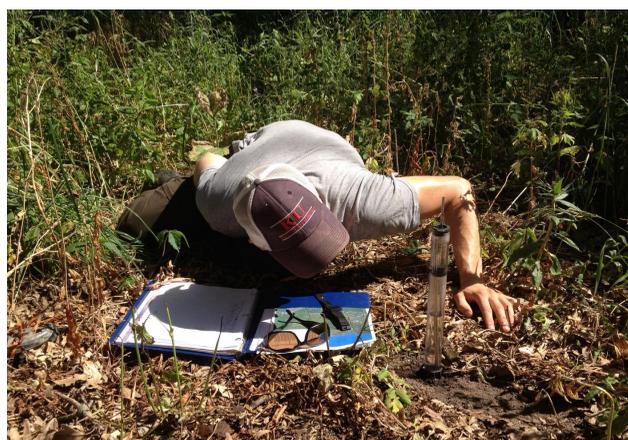
FIGURE C.3 SOIL INFILTRATION TEST. CONDUCTED BY MIKE DRAPER. PHOTO CREDIT: STEVE NEARY, 6.15.12

Infiltration tests were conducted in the soils of the Miljala Channel watershed in order to determine infiltration capacities (Figure C.3). Different soil types with varying cover types were tested to provide

Infiltration tests were conducted using a Decagon Devices Minidisk Infiltrimeter. This device has a Mariotte tube with a sintered steel disk at its base, which allows slow seepage of water into the adjacent tube, upon which the device is placed. An attached bubble chamber with a suction control tube applies the tension needed to control the speed of infiltration.

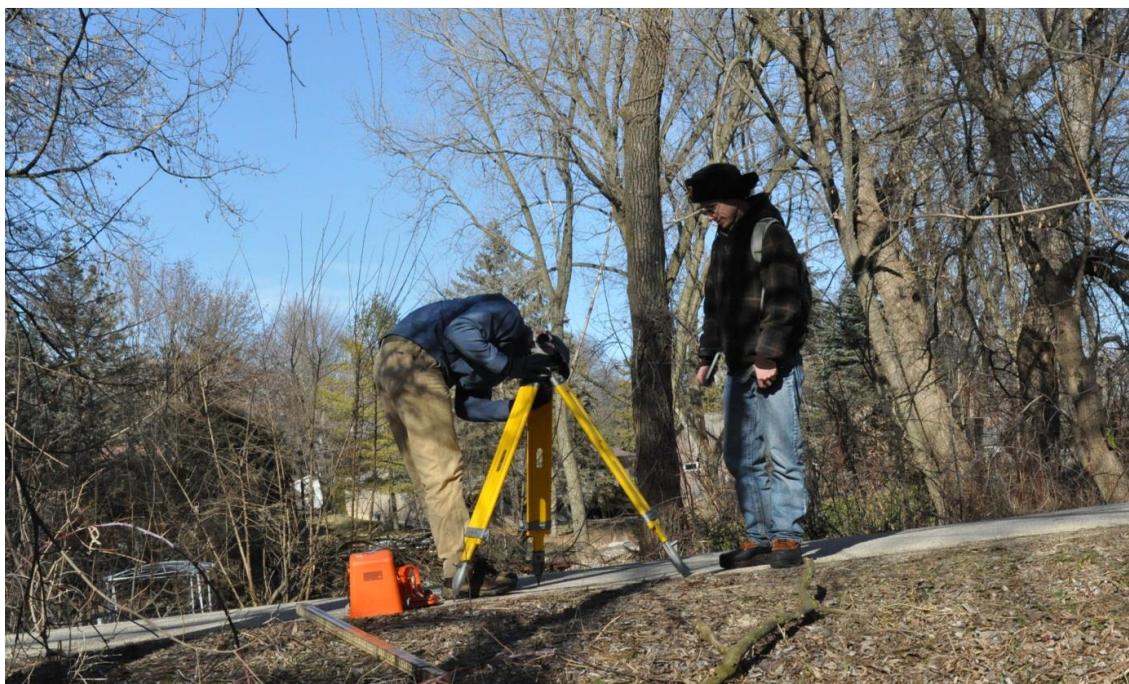
FIGURE C.4 CONDUCTING A LANDSCAPE SURVEY TO GAIN ACCURATE ELEVATION DATA FOR MONITORING WELLS AND THE STAGE RECORDER. PICTURED ARE TOM BENEKE AND JOSH BOHNERT. PHOTO CREDIT: STEVE NEARY, 3.9.12

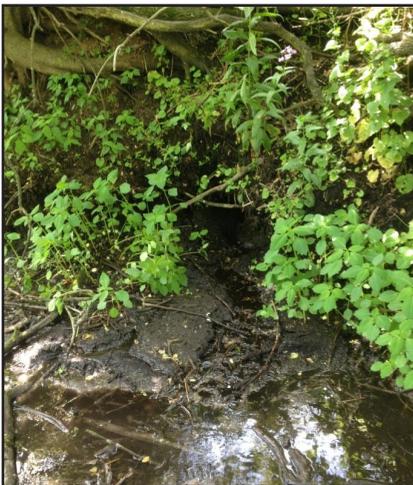
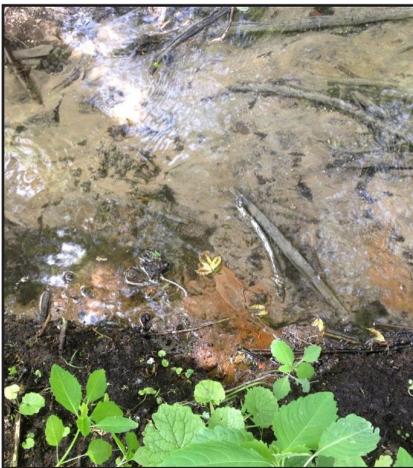
FIGURE F.1 GROUNDWATER DISCHARGE (TOP) AND REDOXOMORPHIC SOILS (BOTTOM) BETWEEN SS3 AND SS5. IDENTIFIED BY UW MADISON WETLANDS ECOLOGY PROFESSOR, QUENTIN CARPENTER, DURING A WETLAND WALK. BOTH OF THESE FEATURES ARE TYPICAL OF WETLANDS. PHOTO CREDIT: STEVE NEARY, 5.17.12

The discovery of multiple groundwater discharge points between SS3 and SS5 was a third point of interest. These points are located on both sides of the ditch, with water being discharged from the Shropshire property as well as from the property to the north containing three wetland scrapes. Reddish brown water and soil at these discharge points indicates the presence of redoxomorphic activity, which is a defining characteristic of wetland soils (Mitsch and Gosselink, 2007). The WRM cohort also made an interesting discovery at SS5. A soil probe into the bed of the ditch produced a thick layer of relatively non-decomposed woody material. Professor Carpenter suggested that this was a remnant of a former Tamarack swamp.

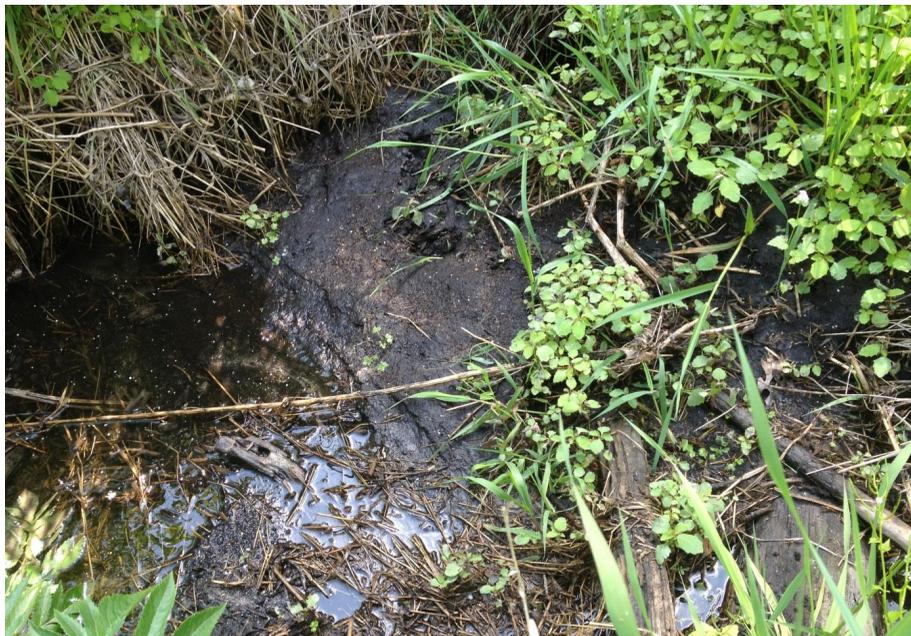
FIGURE G.1 EARLY COLONIZING PLANTS ARE ABLE TO QUICKLY GAIN A FOOTHOLD IN DEPOSITED SEDIMENT AFTER A STORM EVENT.

The spatial distribution of a given emergent species is generally random, although there are likely to be some patterns evident. Species capable of tolerating fluctuating water levels, such as sedges, are more likely to be found on fringe areas, while species that require constant inundation will be found in deeper spots within a marsh (Curtis, 1959). During intense precipitation events, sedimentation can occur that may create open pockets of exposed soil. These sites create a favorable environment for early colonizers like reed canary grass and smartweed (Figure G.1).

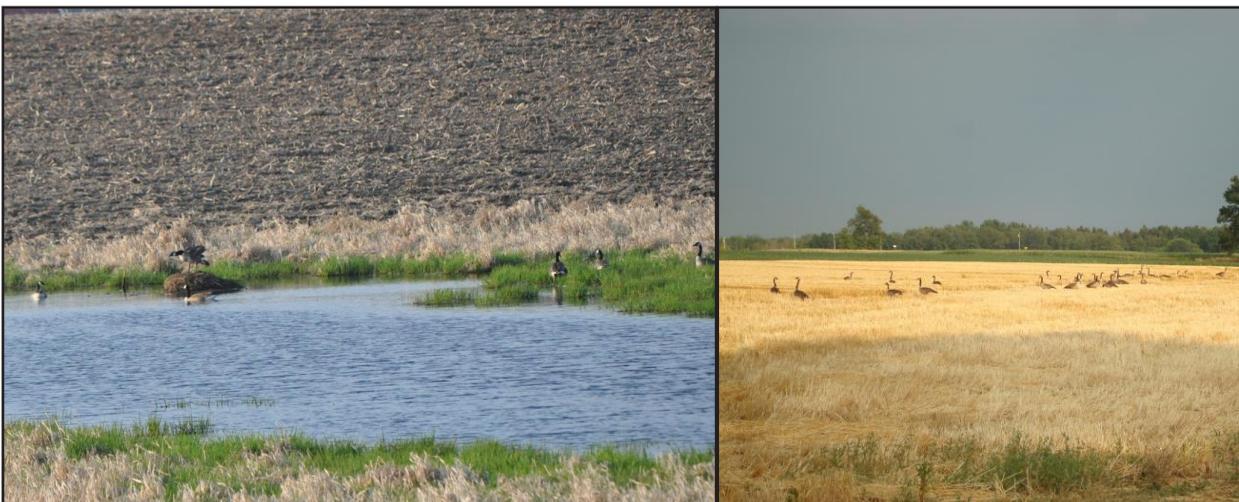
FIGURE G.3 CANADIAN GEESSE FORGE A TEMPORARY HOME AT THE SOUTH EDGE OF THE POND AT SS4 (LEFT) AND REED CANARY GRASS BEGINS TO FORM AROUND THE POND (RIGHT).

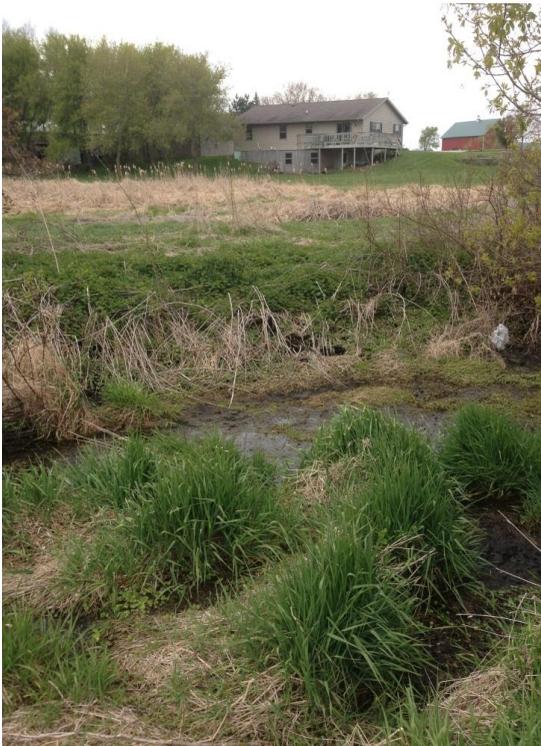
FIGURE G.4 REED CANARY GRASS EMERGES FROM MATS FORMED BY TUSSOCK SEDGE, A NATIVE WETLAND PLANT, AT SS4. PHOTO CREDIT: STEVE NEARY, 3.18.12
