Combined Preliminary Assessment/ Site Inspection Report

Tarco, Incorporated Chlorinated Investigation
Town of Onalaska, La Crosse County, Wisconsin

October 7, 2002

USEPA # WIN 000508272

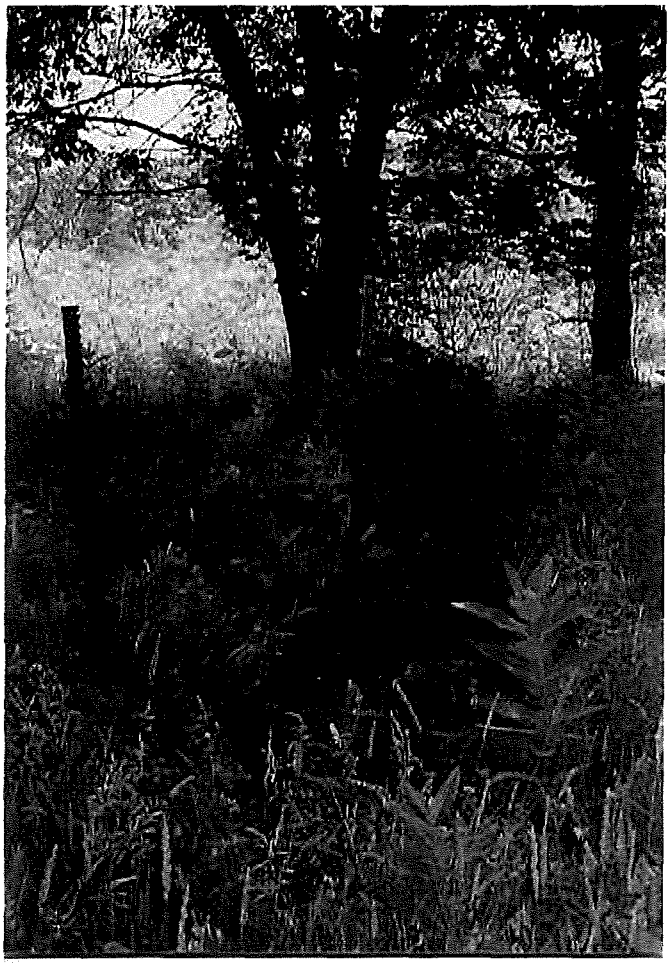
Photo 1

Sample location for SS-1 looking southeast (Photo taken by Mae Willkom, July 2002).

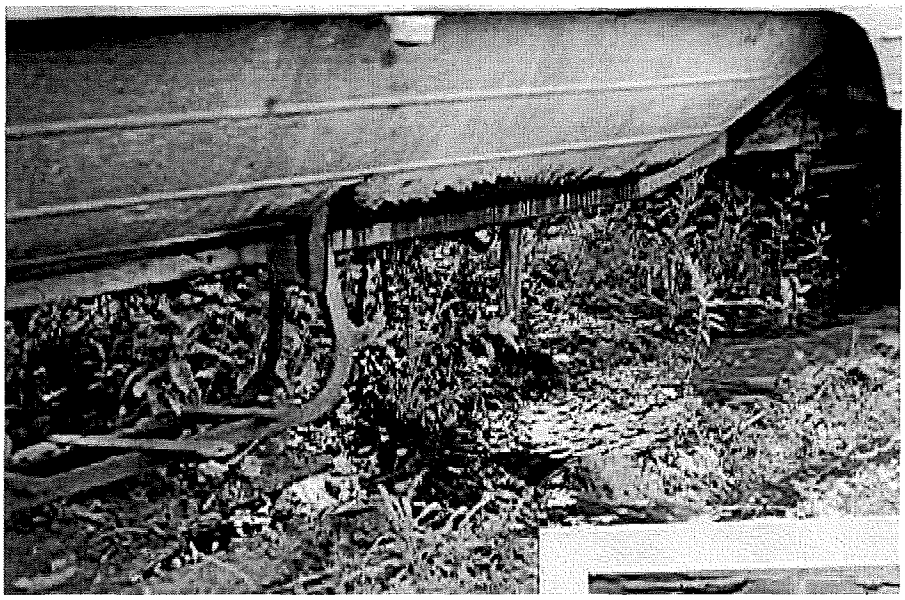
Photo 8

Photo of tanker releasing waste solvent to soil on Tarco, Inc. property (Photo taken by Clancy Stoffel, August 1972)

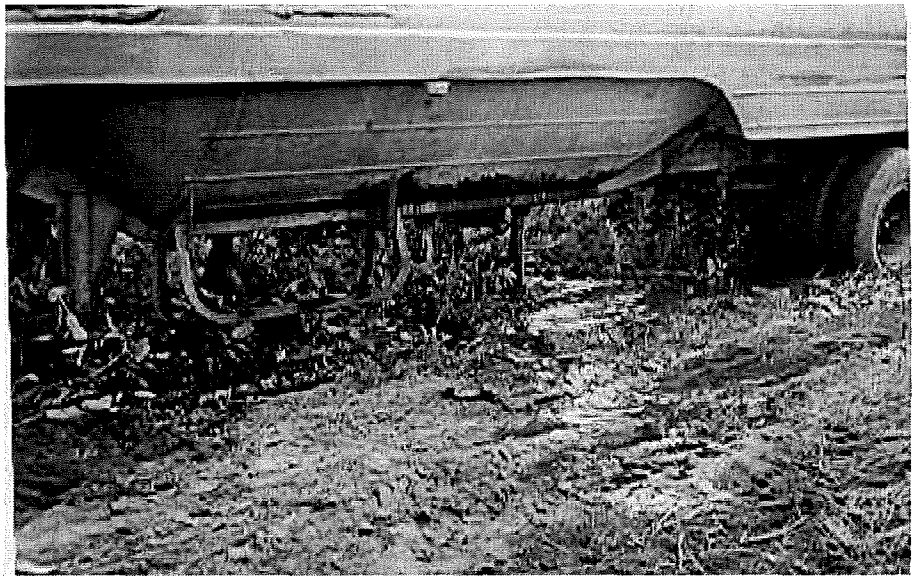
Photo 9

Photo of tanker releasing waste solvent to soil on Tarco, Inc. property (Photo taken by Clancy Stoffel, August 1972)
