FIVE YEAR REVIEW REPORT

REFUSE HIDEAWAY LANDFILL SUPERFUND SITE
MIDDLETON, WISCONSIN

Town of Middleton,
Dane County, Wisconsin

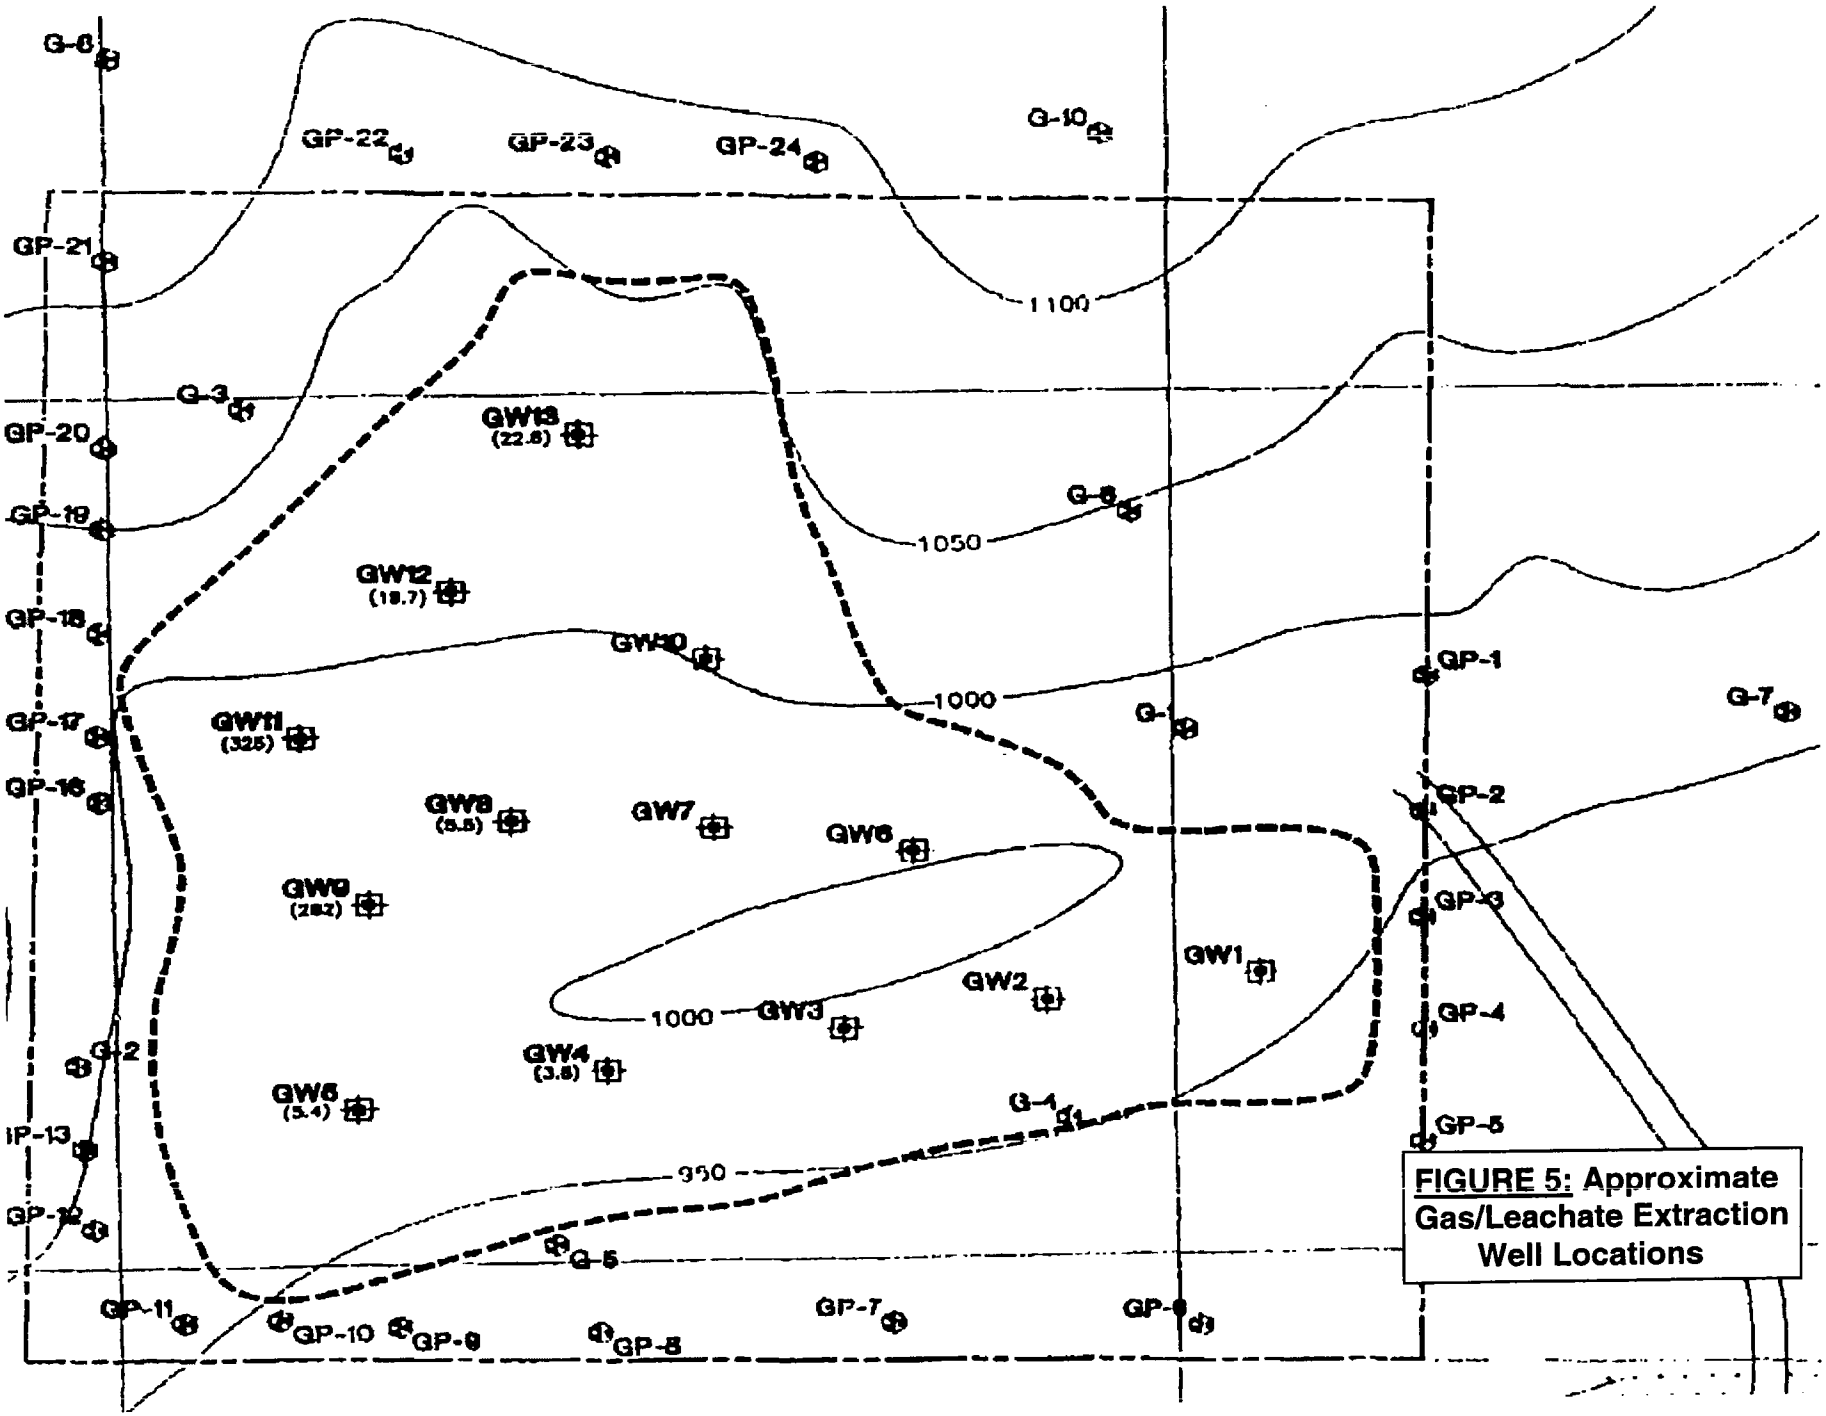
FIGURE 5: Approximate Gas/Leachate Extraction Well Locations

b. Visual inspections of the landfill surface did not reveal significant erosion concerns or stressed vegetation, but low vegetative growth was observed in the southern portion of the landfill in the vicinity of GW-1, GW-2, and GW-3.

Issue	Currently Affects Protectiveness (Y/N) Y=Yes; N=No	Affects Future Protectiveness (Y/N) Y=Yes; N=No
1. Low flows at south branch gas/leachate extraction wells GW-1, GW-2, and GW-3, possibly due to low spots caused by differential landfill settling.	N	Y
2. Low vegetative growth in the southern portion of the landfill near GW-1, GW-2, and GW-3.	N	Y
3. Little to no methane detected in G-1, G-2, and G-11 well nests, especially during the winter months.	N	Y
4. Institutional Controls for the RHL Site as required by the 1995 ROD are not in place.	N	Y

a. It is necessary to excavate and re-grade gas header piping from GW-4 to GW-1 and repair the line from GW-1 to DL-1.

- Re-install piping with proper slope to the pipe, and restore that section of landfill cap.	WDNR	U.S. EPA	Dec. 2008	N	Y
2. Low vegetative growth was observed in the southern portion of the landfill in the vicinity of GW-1, GW-2, and GW-3.	- Re-grade and seed, water, and fertilize the area.	WDNR	U.S. EPA	Nov. 2008	N	Y
