SECOND
FIVE YEAR REVIEW REPORT FOR

REFUSE HIDEAWAY LANDFILL SUPERFUND SITE
MIDDLETON, WISCONSIN

Town of Middleton,
Dane County, Wisconsin

AUGUST 2012

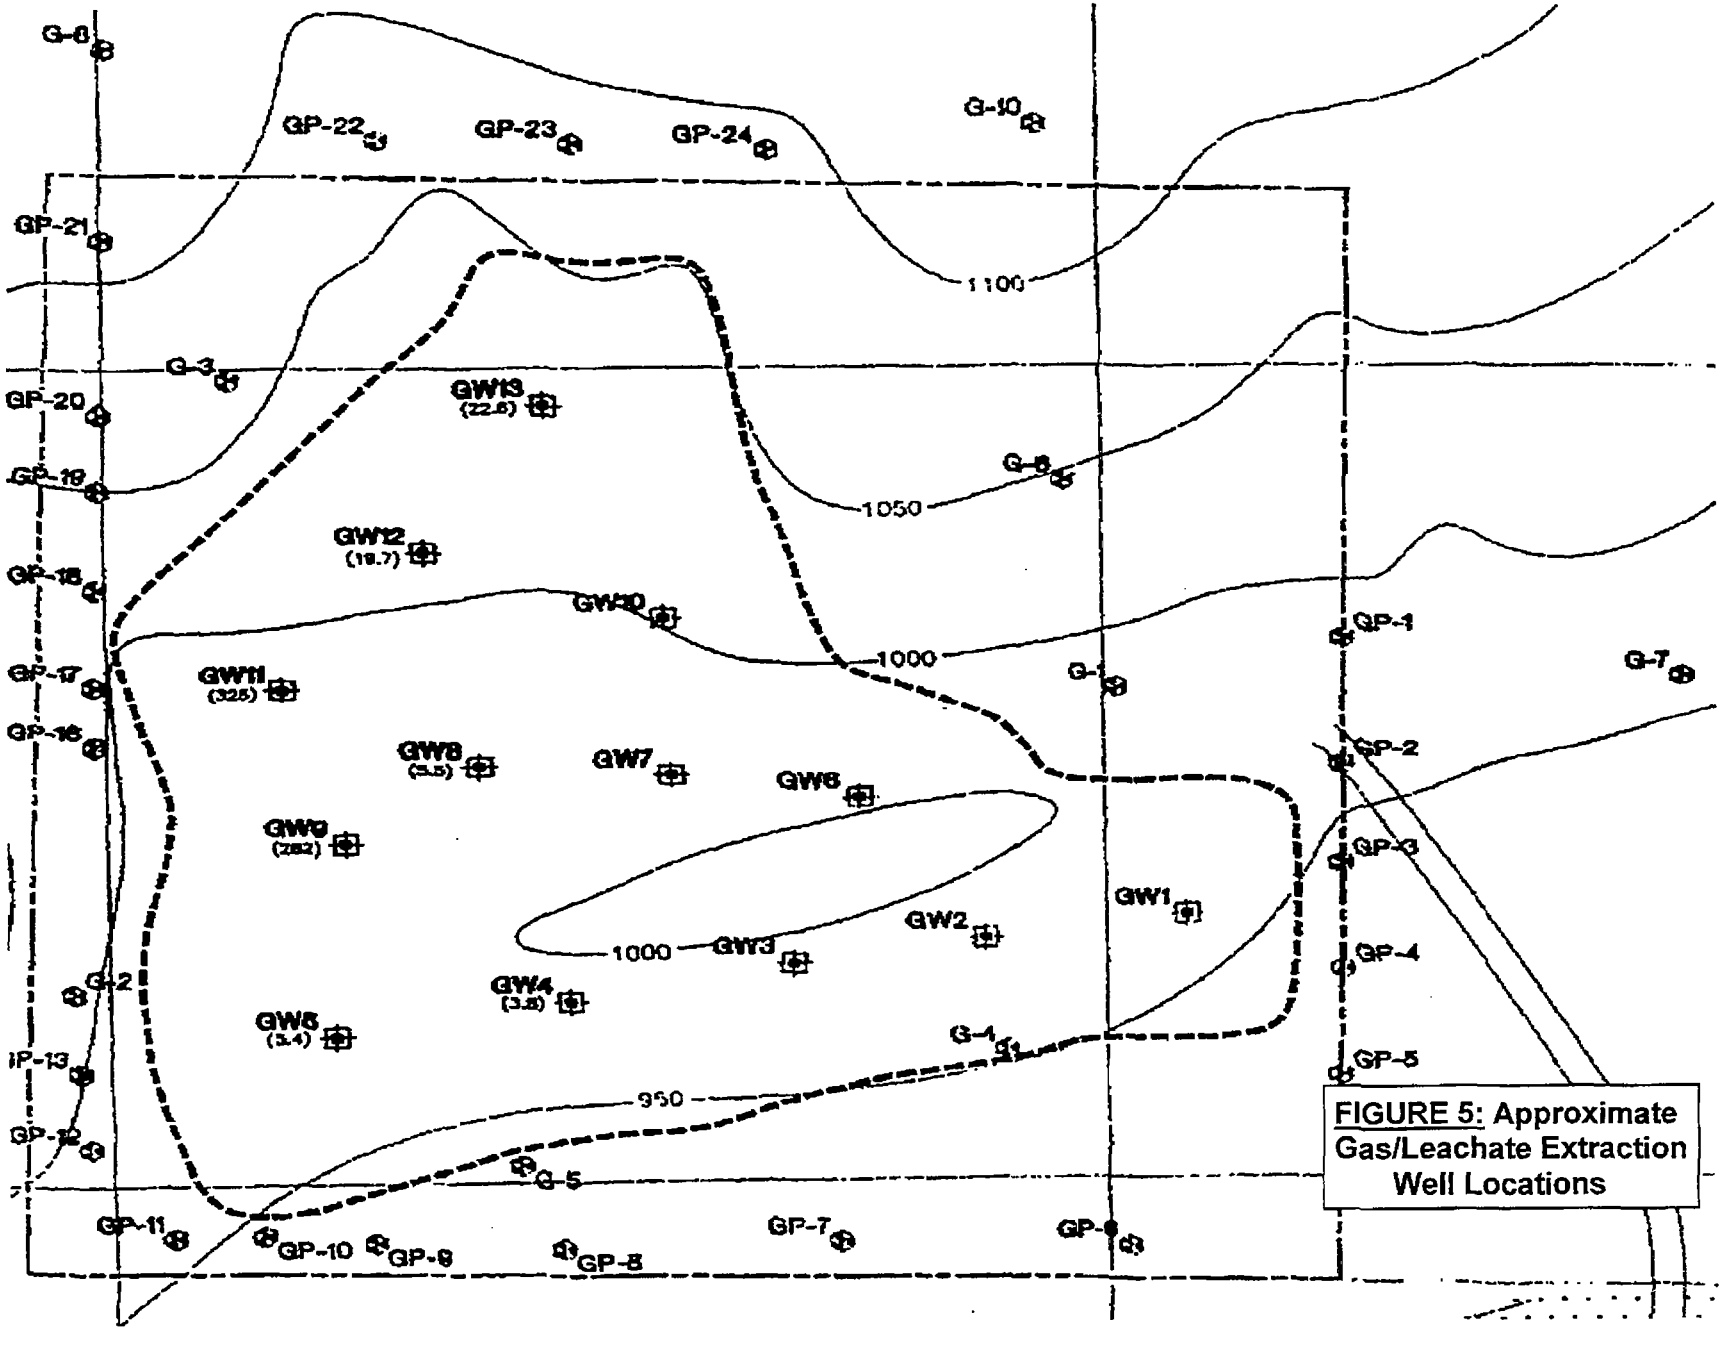
FIGURE 5: Approximate Gas/Leachate Extraction Well Locations

b. Visual inspections of the landfill surface did not reveal significant erosion concerns or stressed vegetation, but low vegetative growth was observed in the southern portion of the landfill in the vicinity of GW-1, GW-2, and GW-3.

Issue	Currently Affects Protectiveness (Y/N) Y=Yes; N=No	Affects Future Protectiveness (Y/N) Y=Yes; N=No
1. Low flows at south branch gas/leachate extraction wells GW-1, GW-2, and GW-3, possibly due to low spots caused by differential landfill settling.	N	Y

a. It is necessary to excavate and re-grade gas header piping from GW-1 through GW-3 and repair or replace the line. This could be addressed as part of a Site-wide replacement of remedy components.

b. Low vegetative growth in the southern portion of the landfill in the vicinity of GW-1, GW-2, and GW-3 should be investigated. It may be necessary to re-seed, water, and fertilize small portions of the area. These cap improvements could occur as part of pipeline replacement work.

1. Low flows and varying pressure at south branch gas/leachate extraction wells GW-1, GW-2, and GW-3.	Short-term: Pump liquid out of piping at GW-1, GW-2, GW-3 locations.	WDNR	EPA	Dec. 2012	N	Y
	Long-term: Investigate and implement replacement of leachate/ landfill gas piping throughout the Site to restore proper vacuum and leachate flow. This will reduce elevated methane concentrations in perimeter gas probes and improve capture and staging of leachate.	WDNR	EPA	Mar. 2014	N	Y

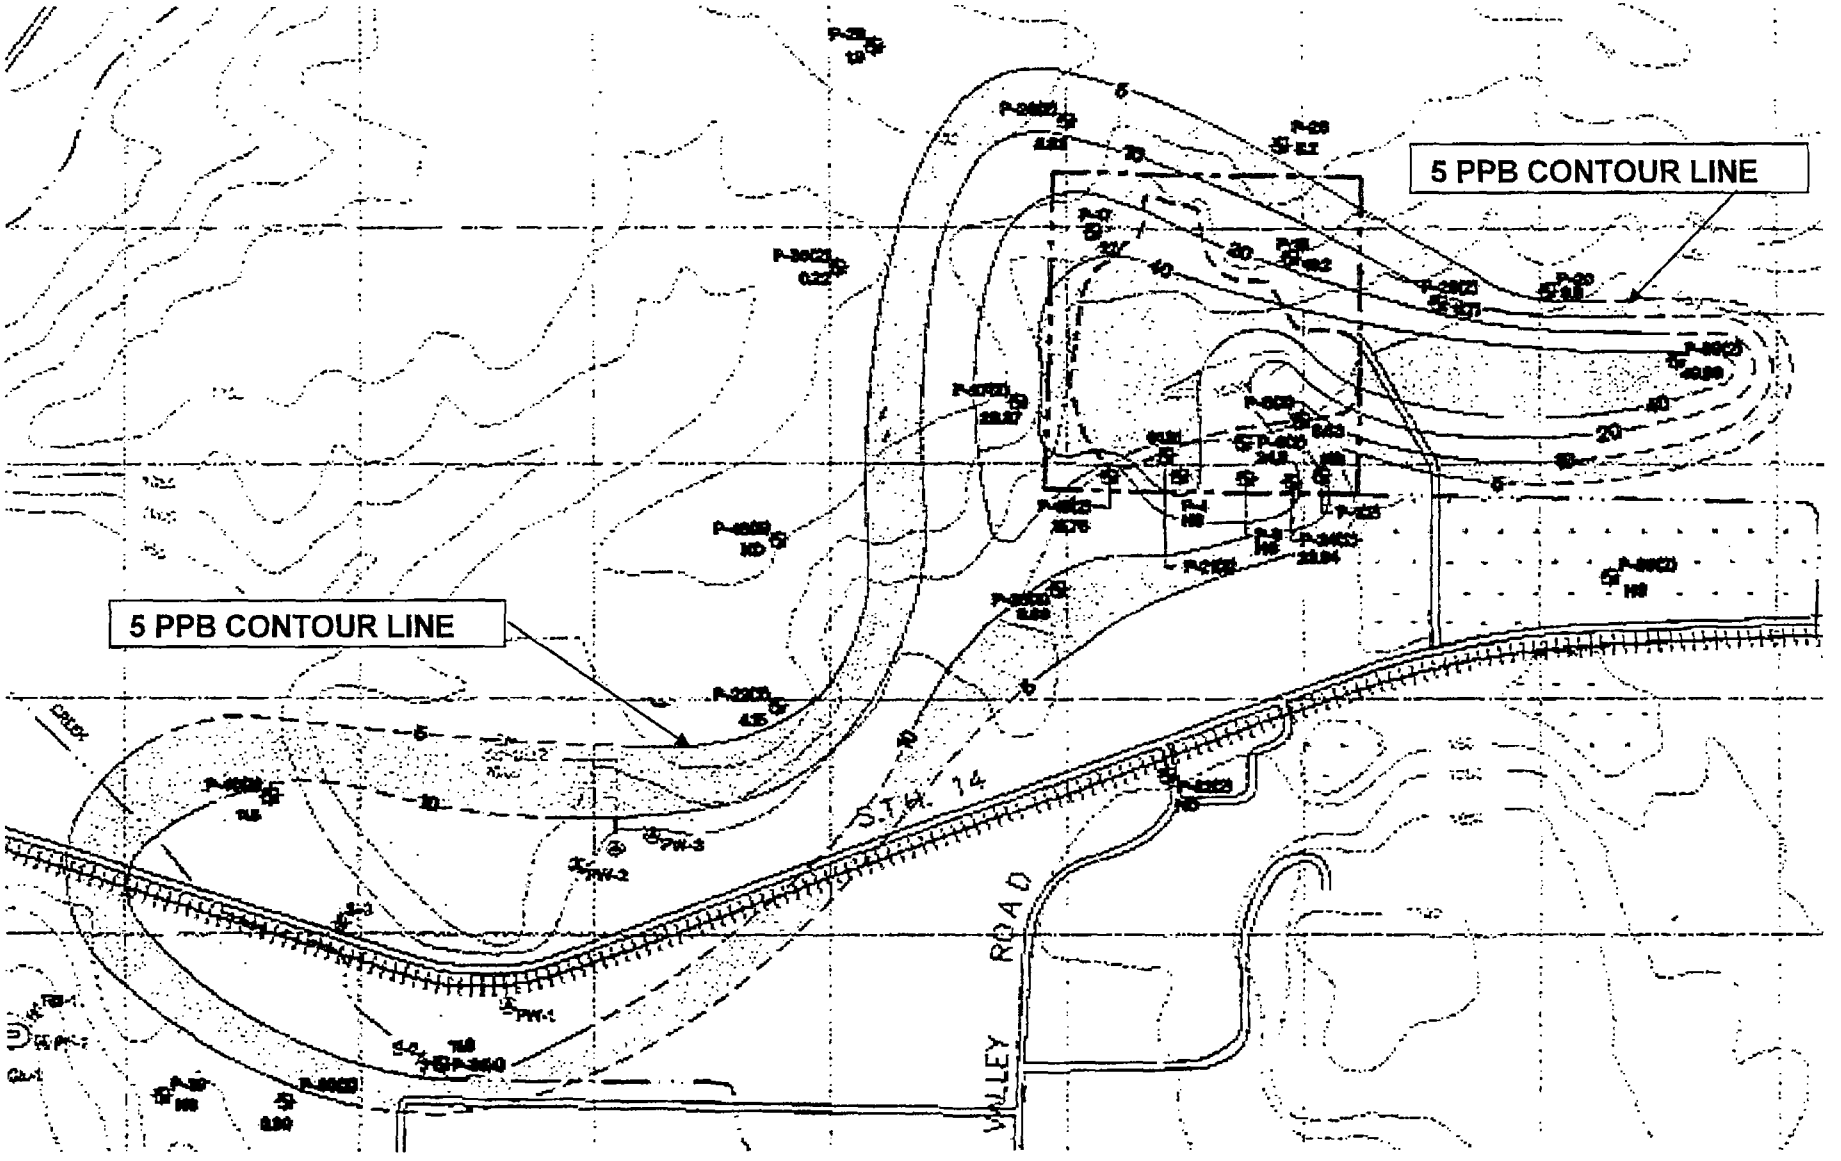
FIGURE 7: Approximate Institutional Control Area.
NOTE: Figure is not to scale.

Figure 7 shows the Site area for which Institutional Controls apply, as well as an approximate depiction of the 1200 foot radius.
