Site Investigation Sample Results Notification

Site Name			DNR ID # (BRRTS #)
Former Navistar/RMG Foundry			02-68-098404
Address	**City**	**State**	**ZIP Code**
1401 Perkins Avenue	Waukesha	WI	53186

SUBJECT: Data Transmittal (1344 White Rock Ave.) for Indoor Air and Sub-slab Vapor Sampling

AT HOME CARING ANGELS SAMPLE LOCATION MAP

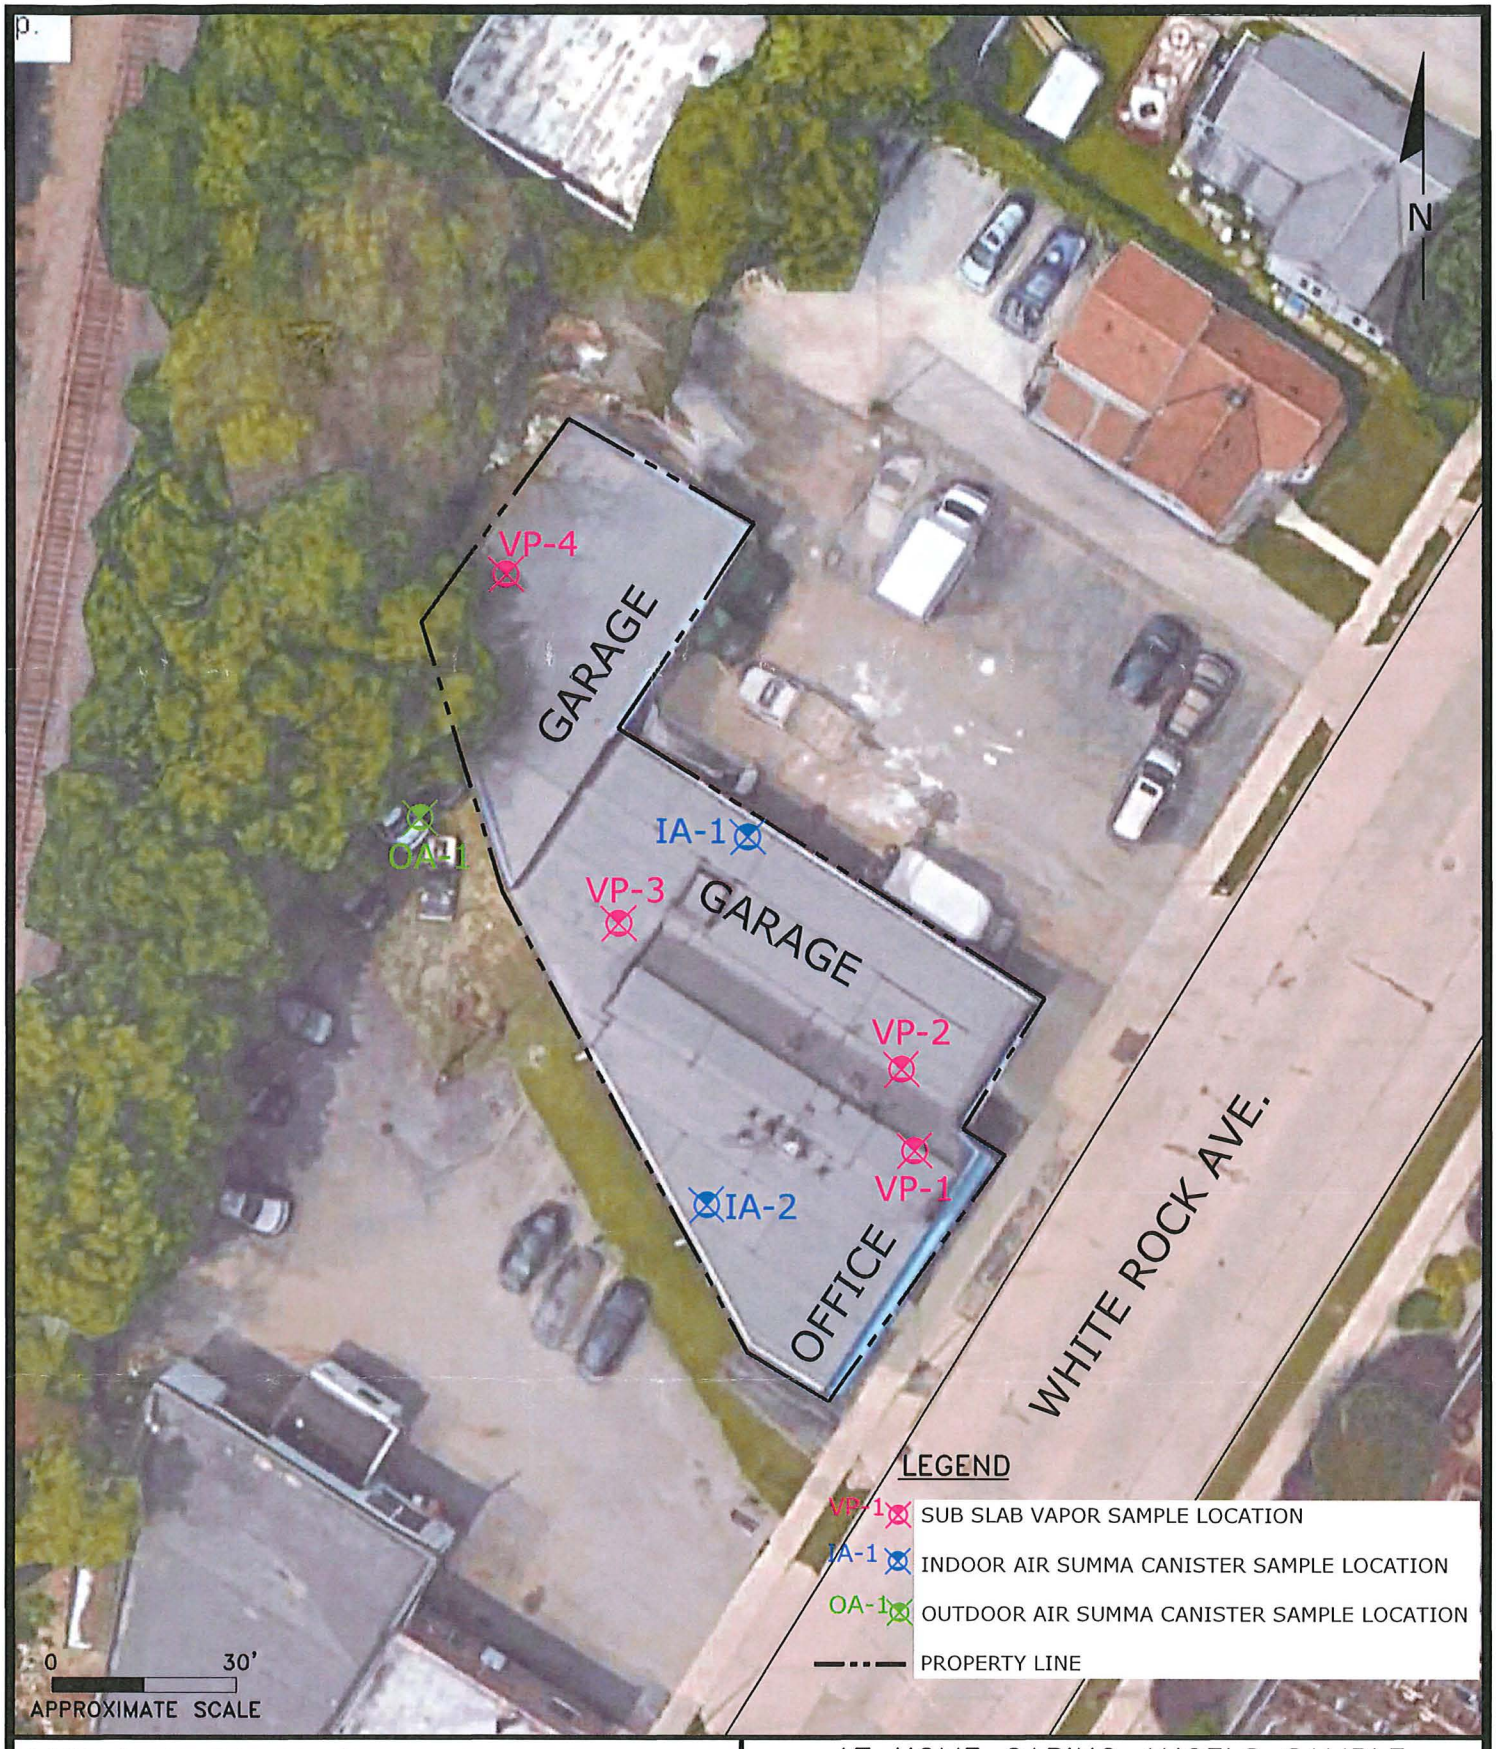
Scale: 1" = 30'	Date: June 22, 2020
KPRG Project No. 11717	FIGURE 1

1344 WHITE ROCK AVE
WAUKESHA, WI
