Domtar
301 Point Basse Ave.
Nekoosa, WI 54457-1422
T 715-886-7111
www.domtar.com

Subject: Domtar A. W. LLC – Nekoosa Mill
Spill Report – March 3, 2019 Spill of Weak Wash
Spill # 13645, ID20190303WC72-1

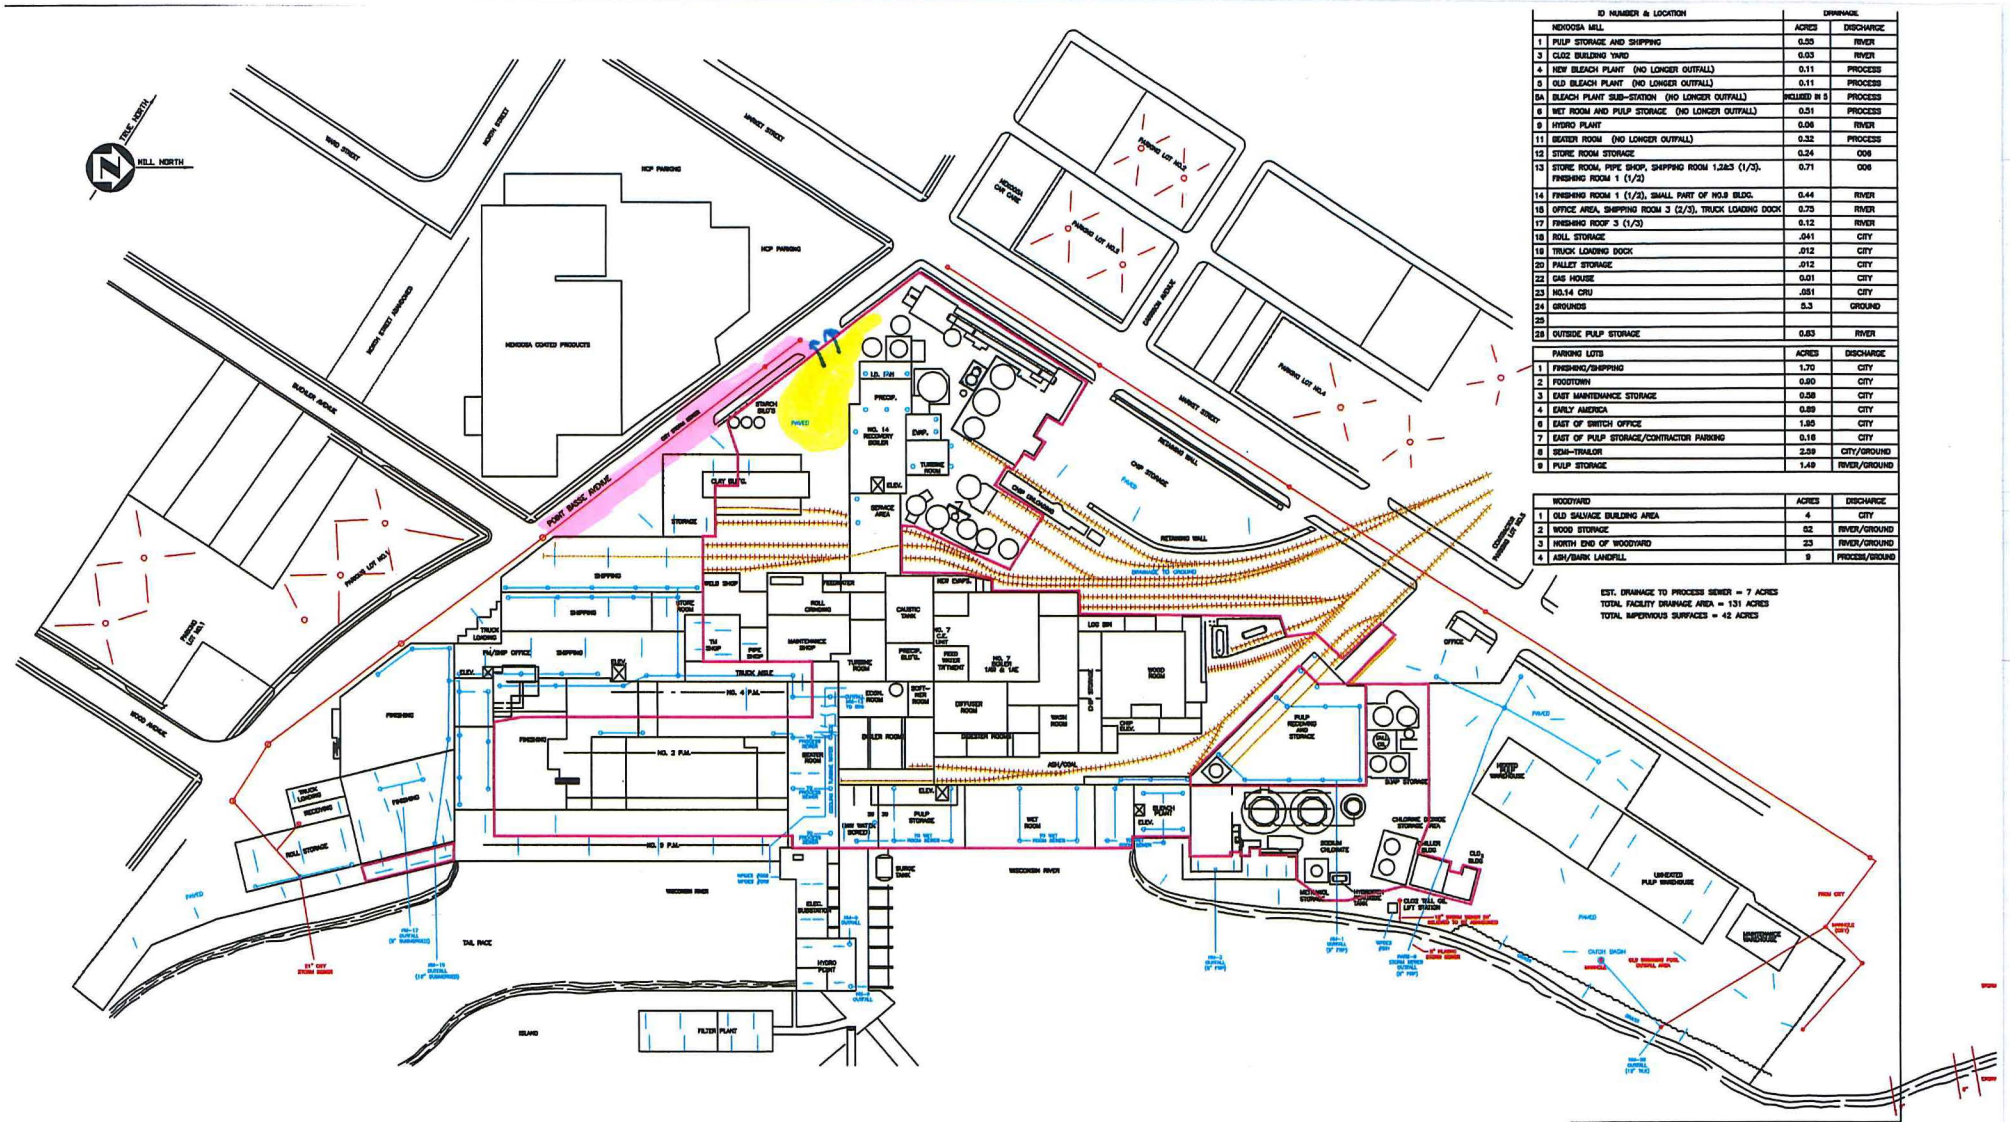
This letter is a follow-up to our previous phone conversation and contact with State Spill Hotline staff on March 3, 2019. On that date, we reported a spill of process wastewater from our facility, located at 301 Point Basse Avenue, Nekoosa, WI. We estimate that no more than 2000 gallons of the process wastewater reached our containment curbing in our production area courtyard, and up to 200 gallons of this wastewater breached the city of Nekoosa storm sewer system. This storm sewer system directly drains to the Wisconsin River.

The incident occurred as a result of excessive draining of a process water tank which contained weak wash. Weak wash is a high-pH wastewater which is a byproduct of the kraft recovery process. Contributing to the root cause of this event was the apparent scaling up of the wastewater collection piping in the production courtyard area. This resulted in the lack of adequate drainage capacity to contain the rapid rate of tank draining of the weak wash.

When we discovered that the wastewater was backing up in the courtyard and overflowing the curbing, we immediately brought in wet lap pulp and placed it on the curbed areas to contain the discharge. We also placed wet lap pulp over the storm drains along Point Basse Avenue, and created containment barricades to pond the wastewater. Vacuum trucks were brought in to remove all of the remaining ponded water.

In response to this incident, we are establishing better practices for controlling tank draining activities for this area of the mill, and reviewing options to improve the capability of the sewer drainage in the courtyard.
