UNDERGROUND STORAGE TANK CLOSURE AND SITE ASSESSMENT

HEATING OIL TANK
2708 WEST WISCONSIN AVENUE
MILWAUKEE, WISCONSIN

JN: 4773.10

September 24, 1993

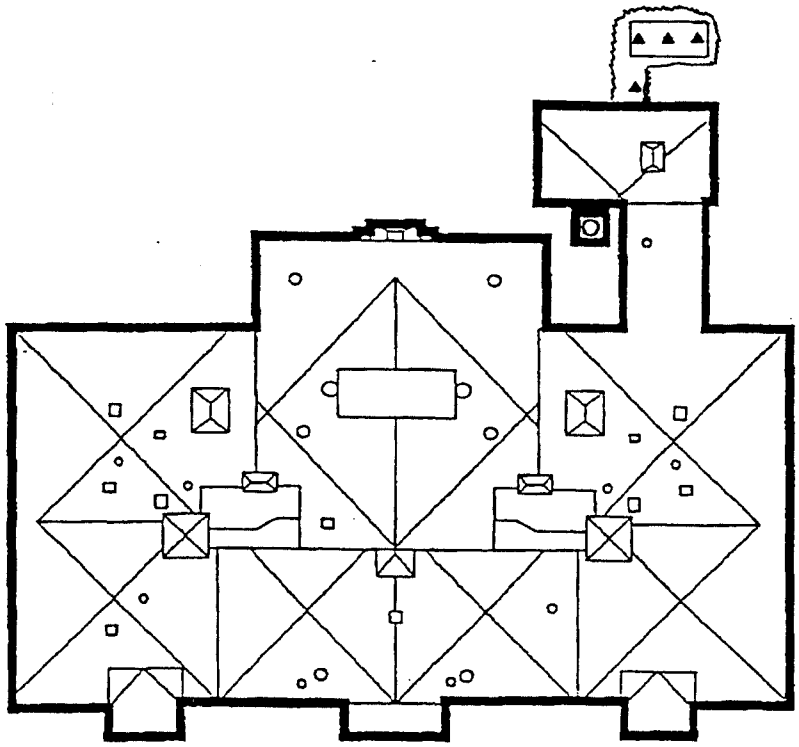
FIGURE 2

The 7,500-gallon heating oil underground storage tank (UST) removed from 2708 West Wisconsin Avenue, Milwaukee, Wisconsin was installed in 1975. The property consists of a school building and a fenced asphalt playground. The UST was located on the north side of the building (Figure 2).

EXCAVATION LIMITS

SAMPLE LOCATIONS ▲
