8/28/2019

401 W. North Ave
Little Chute, WI 54140
(shipping yard)

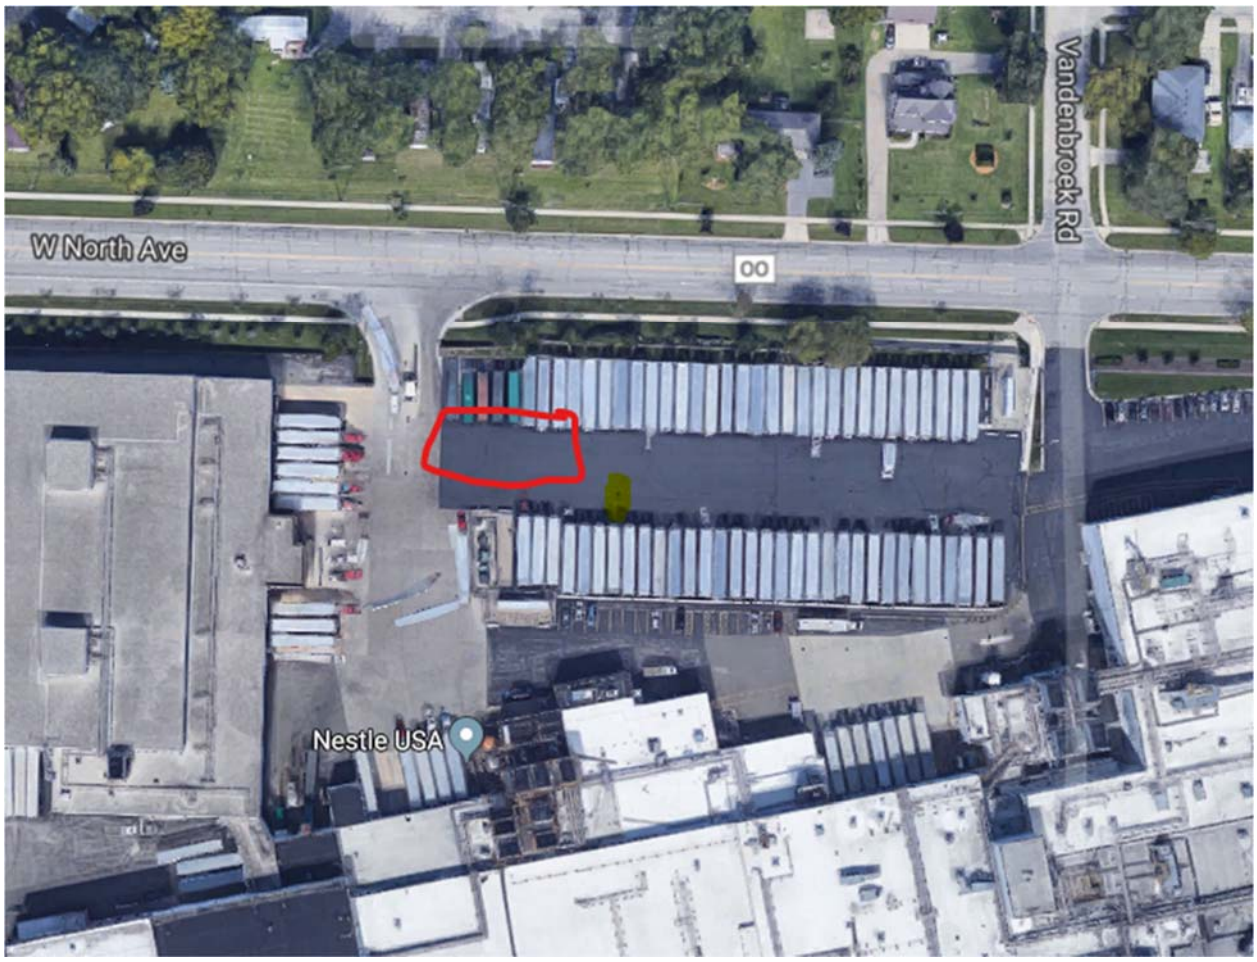
Animal feed on ground. Primarily uncooked pizza dough, but can include other food products.

Initial diking and damming. Runoff started clear (believed to be rainwater buildup), later dough and flour mixture can be seen.

Absorbent material placement

Absorbent pads used to remove contamination from vehicle tires

Testing cleanup with floor scrubbers. They are successful.

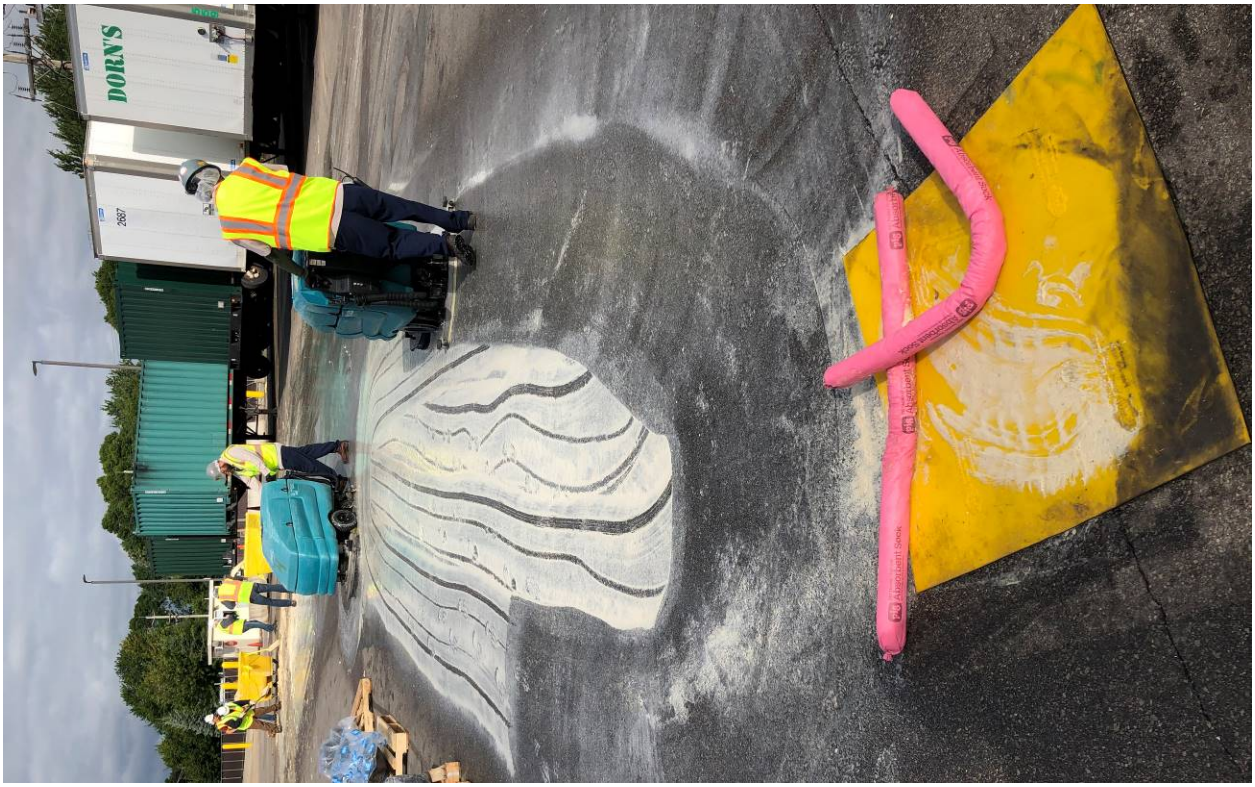
After absorbents were removed, we were left with more of a paste

Continued floor scrubber cleanup. Waste water from the scrubbers was dumped into the SANITARY sewer system inside the building.

Some final passes showing clean asphault

View down storm sewer drain after surface cleanup. No rain or other moving water during this time.
