September 3, 2019

Re: WI - 45-Day Documentation and No Further Action Letter - Ch. NR. 708
Wisconsin Public Service Corporation
Hydraulic Oil
2850 S. Ashland Ave., Green Bay, WI 54304 (Brown County)
Reported 7/17/2019, SERTS ID: 20190724NE05-1

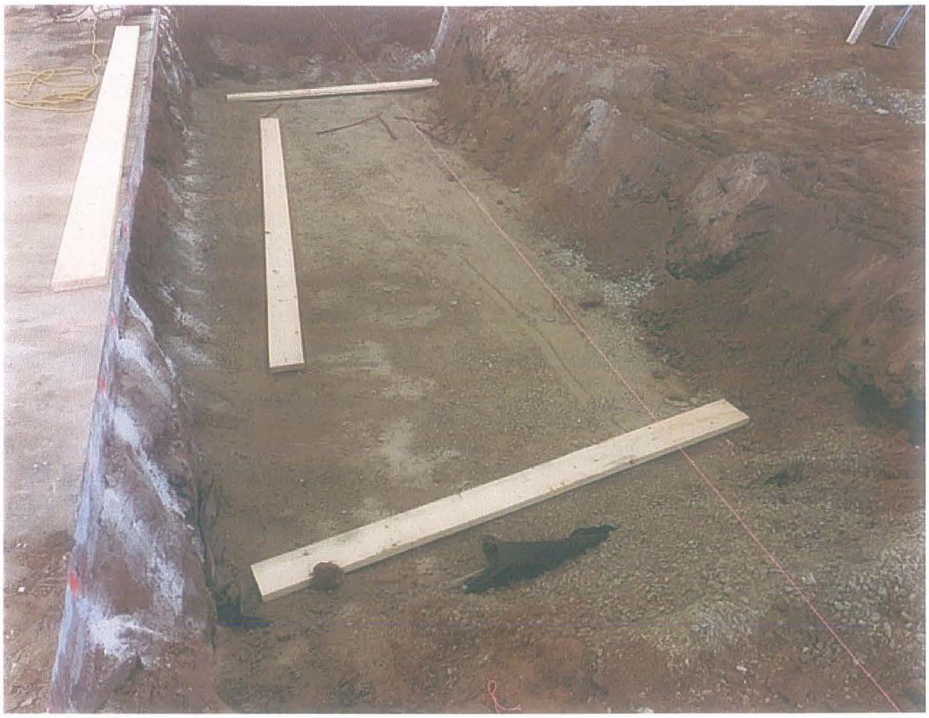
- Time of Spill: 10:00 hours on Wednesday, July 17, 2019
- Incident Description: On the morning of Wednesday, July 17, 2019 during removal of a hydraulic hoist in the fleet area of the Green Bay Service Center, WPS contractors discovered the hydraulic cylinder on the unit had released approximately 5-10 gallons of hydraulic. The oil was released onto the soil around the unit over an area approximately 4 ft. by 4 ft. and down to a depth of approximately 3 ft. below the concrete slab in the service bay. The impacted soil was removed using an excavator and containerized into a lined roll off box for disposal.

Figure 2: Cylinder Tubes where Leak Occurred
