State of Wisconsin - Department of Natural Resources
Substance Release Notification Report (SERTS)
Report created on 06/03/2014

SPILL ID# 20140324NE59-1+ BRRTS# 04-59-562081

Facility/Property Name and Street Address:	Description:
AARROWCAST, INC 2900 E RICHMOND ST	DRUM STORAGE AND REFUSE SAND AREAS OF LOT

SPILL RESPONSE REPORT TO WISCONSIN DNR

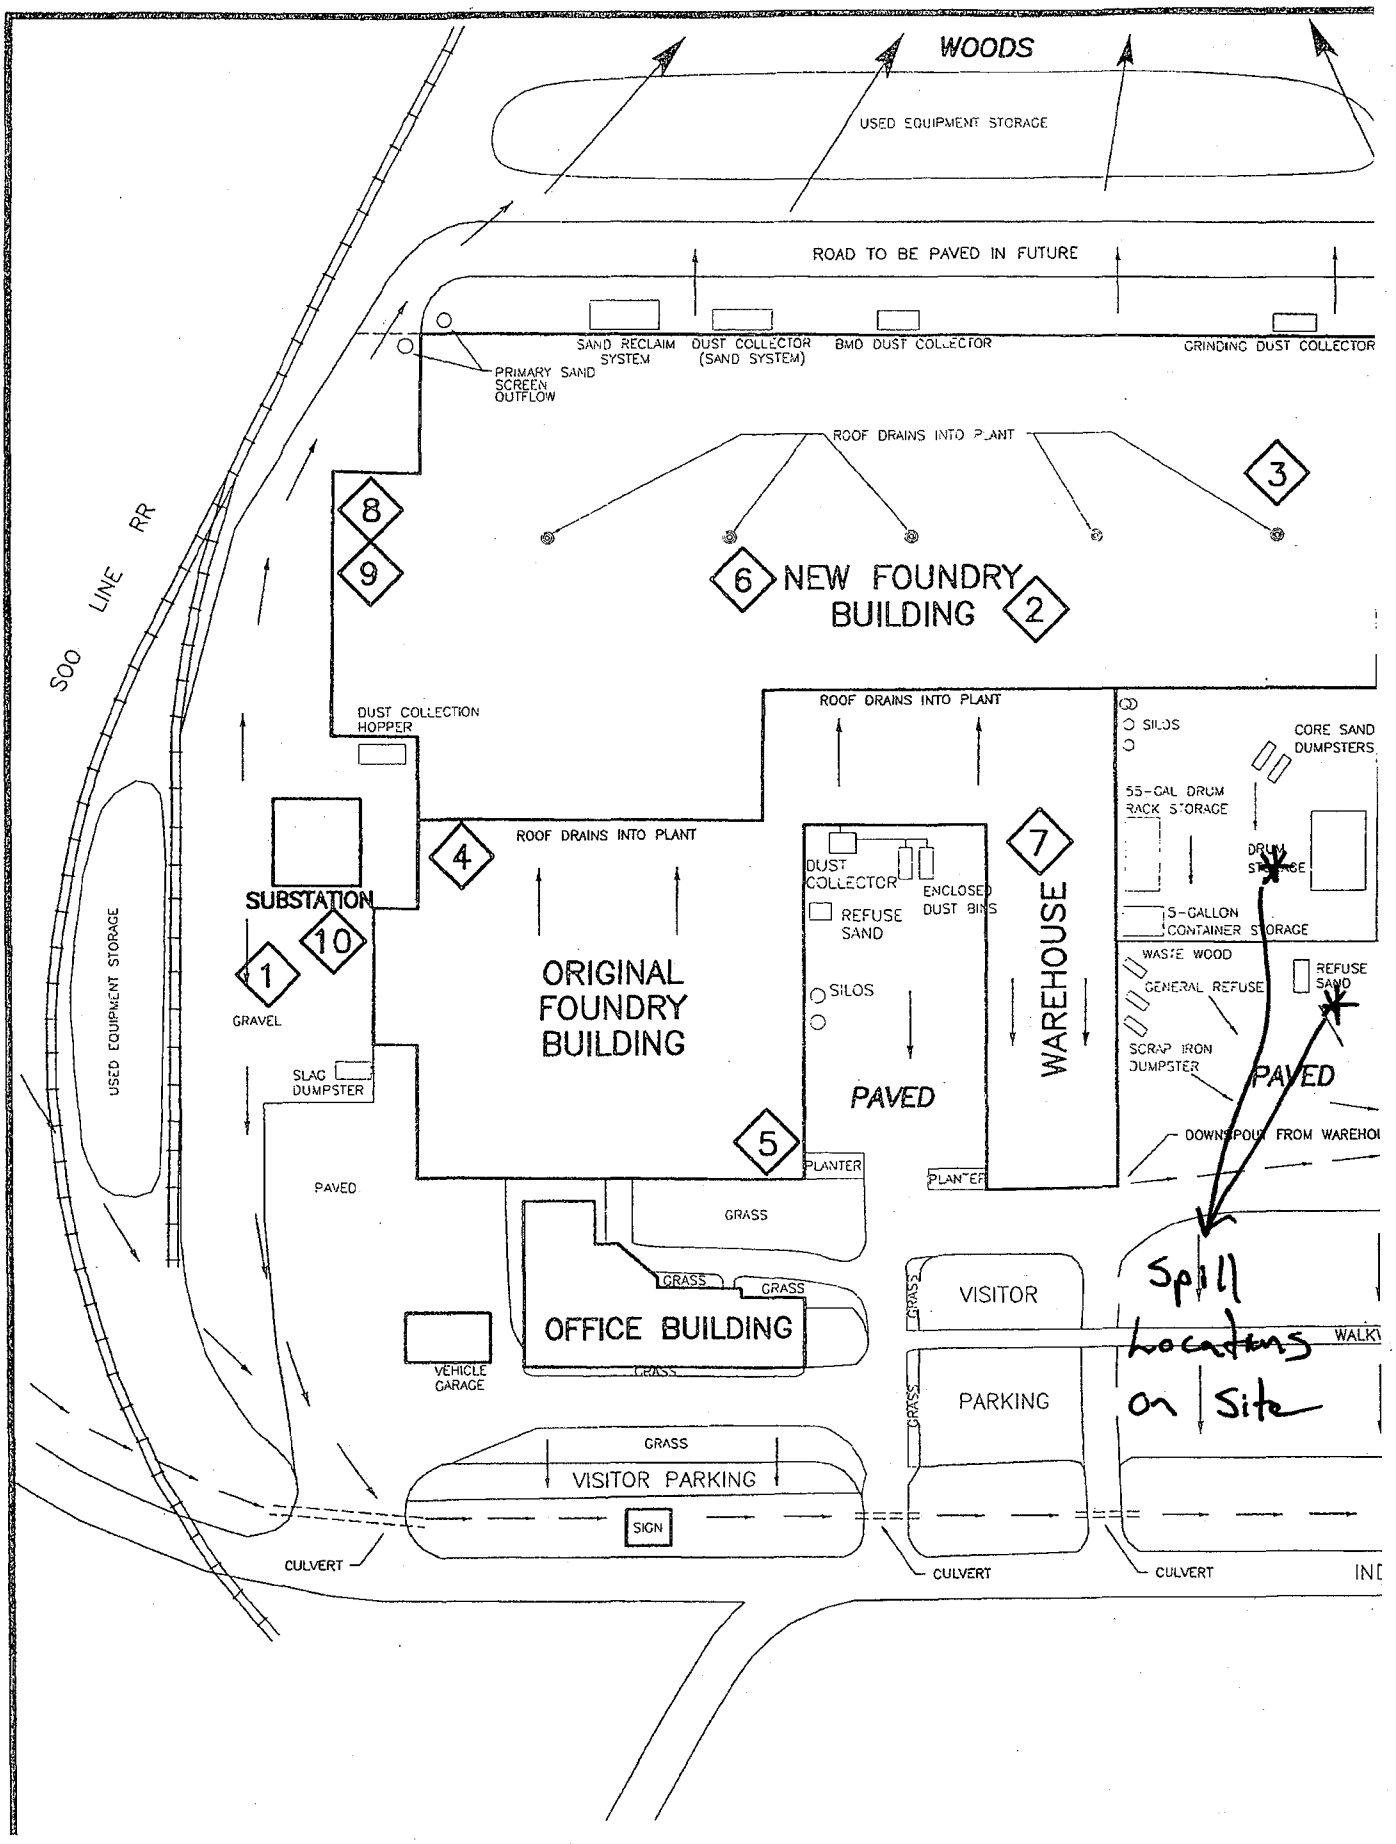
The spill occurred at the above listed location (see attached site drawing with spill location noted). An Aarrowcast employee dumped approximately 200 gallons of mixed Pepset II 2690 Binder and Isocure Focus II 206 Binder into a 20 yard roll-off box that was about 2/3 full of silica sand. About 95% of the material was Pepset II and 5% was Isocure Focus II 206 (See attached MSDS). A few hours later our driver from Harter's Trucking picked up the roll-off box and brought it to our Beneficial Reuse Facility. This is where our waste sand goes to be used in Beneficial Reuse projects. Before dumping, the driver noted that there was liquid dripping out of the back. Instead of dumping he brought the load back to Aarrowcast. There was some leakage at Aarrowcast which was cleaned up. There was a small puddle at our storage facility which was cleaned up. As reported, there was also some visible leakage on the road between Aarrowcast and the storage facility. On 3/24/14, we observed this was dried onto the road. Per our discussion, this was not cleaned up. All material that was cleaned up was put in a 20 yard roll-off box to be evaluated by Veolia Environmental Services for proper disposal.

WOODS
USED EQUIPMENT STORAGE
ROAD TO BE PAVED IN FUTURE
SAND RECLAIM SYSTEM
DUST COLLECTOR (SAND SYSTEM)
BMD DUST COLLECTOR
GRINDING DUST COLLECTOR
PRIMARY SAND SCREEN OUTFLOW
ROOF DRAINS INTO PLANT
NEW FOUNDRY BUILDING
SOO LINE RR
DUST COLLECTION HOPPER
SUBSTATION
GRAVEL
USED EQUIPMENT STORAGE
SLAG DUMPSTER
PAVED
ORIGINAL FOUNDRY BUILDING
DUST COLLECTOR
ENCLOSED DUST BINS
REFUSE SAND
SILOS
PAVED
WAREHOUSE
SILOS
CORE SAND DUMPSTERS
55-GAL DRUM RACK STORAGE
5-GALLON CONTAINER STORAGE
WASTE WOOD
GENERAL REFUSE
REFUSE SAND
SCRAP IRON DUMPSTER
PAVED
DOWNSPOUT FROM WAREHOUSE
PLANTER
GRASS
OFFICE BUILDING
VEHICLE GARAGE
VISITOR
PARKING
VISITOR PARKING
SIGN
CULVERT
Spill Locations on Site

Upon receiving report of the spill we soaked up the resin from the areas with virgin silica sand. We then placed the sand in a 20 yard roll-off box for evaluation by Veolia for disposal. When cleanup was finished the box was tarped to keep the elements out.

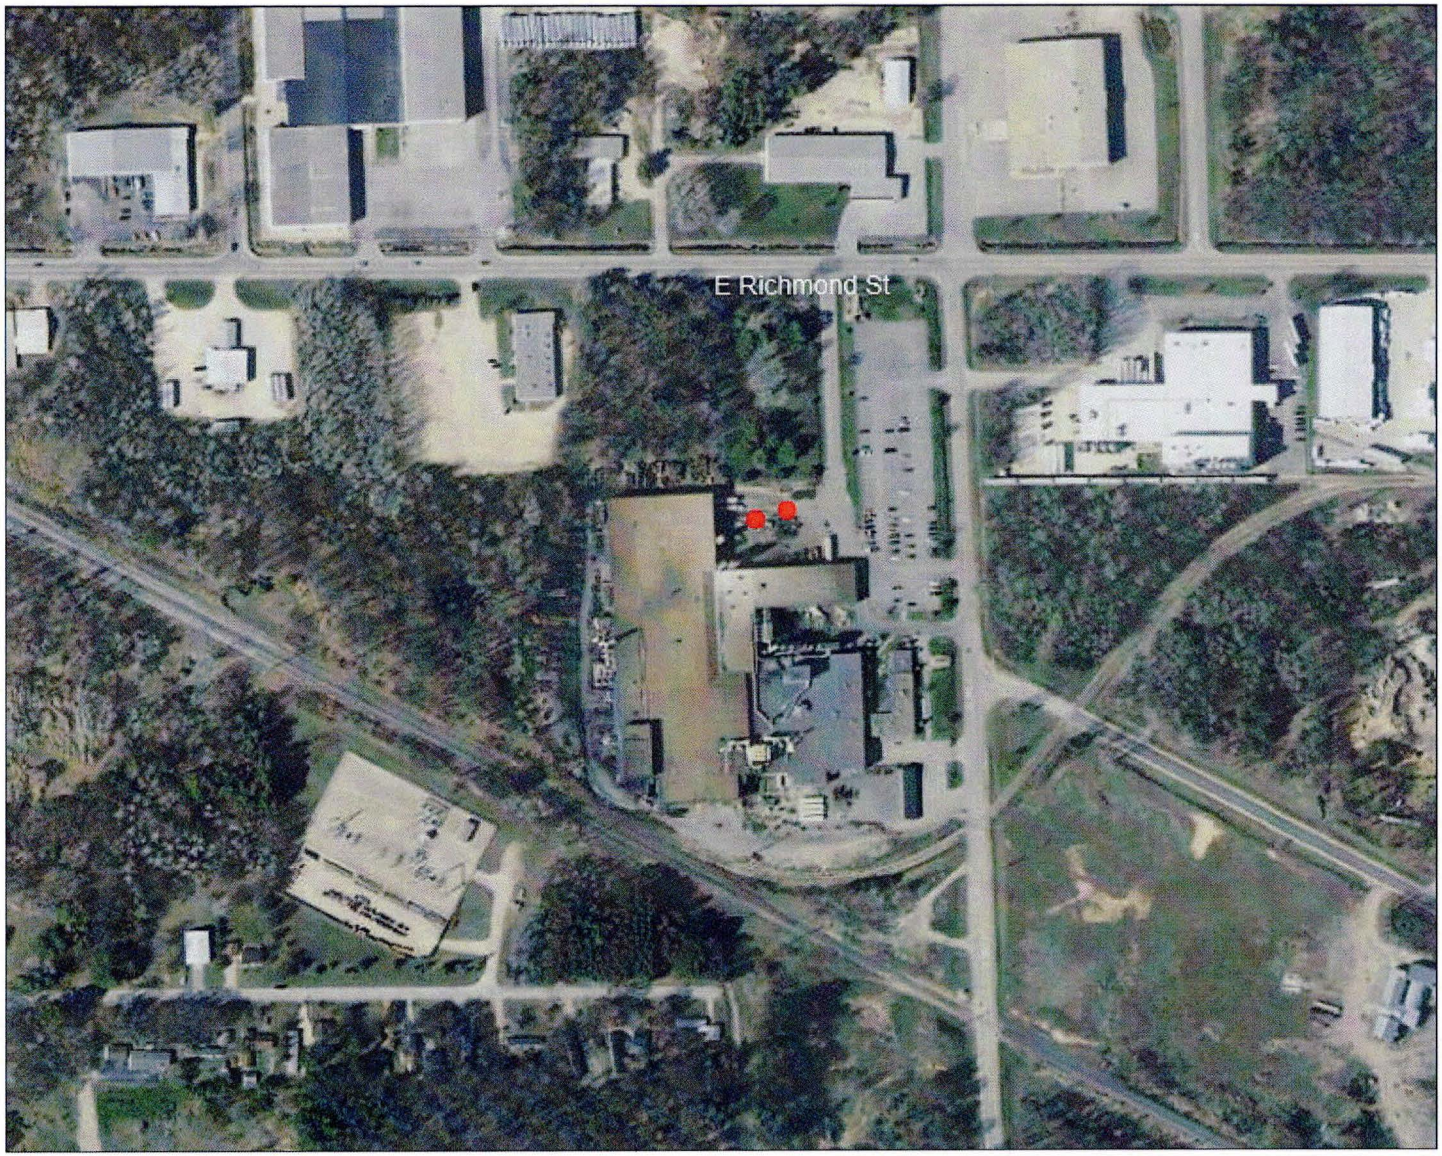
AARROWCAST, INC

SPILL LOCATIONS: RED DOTS

WTM: 632370, 478757

WTM: 632388, 478761
