March 15, 2022

Ref. 1690025584-001

LIMITED PHASE II ENVIRONMENTAL SITE ASSESSMENT RESULTS FOR THE XETEX MANUFACTURING FACILITY AT 1309 NORPLEX DRIVE, LA CROSSE, WISCONSIN

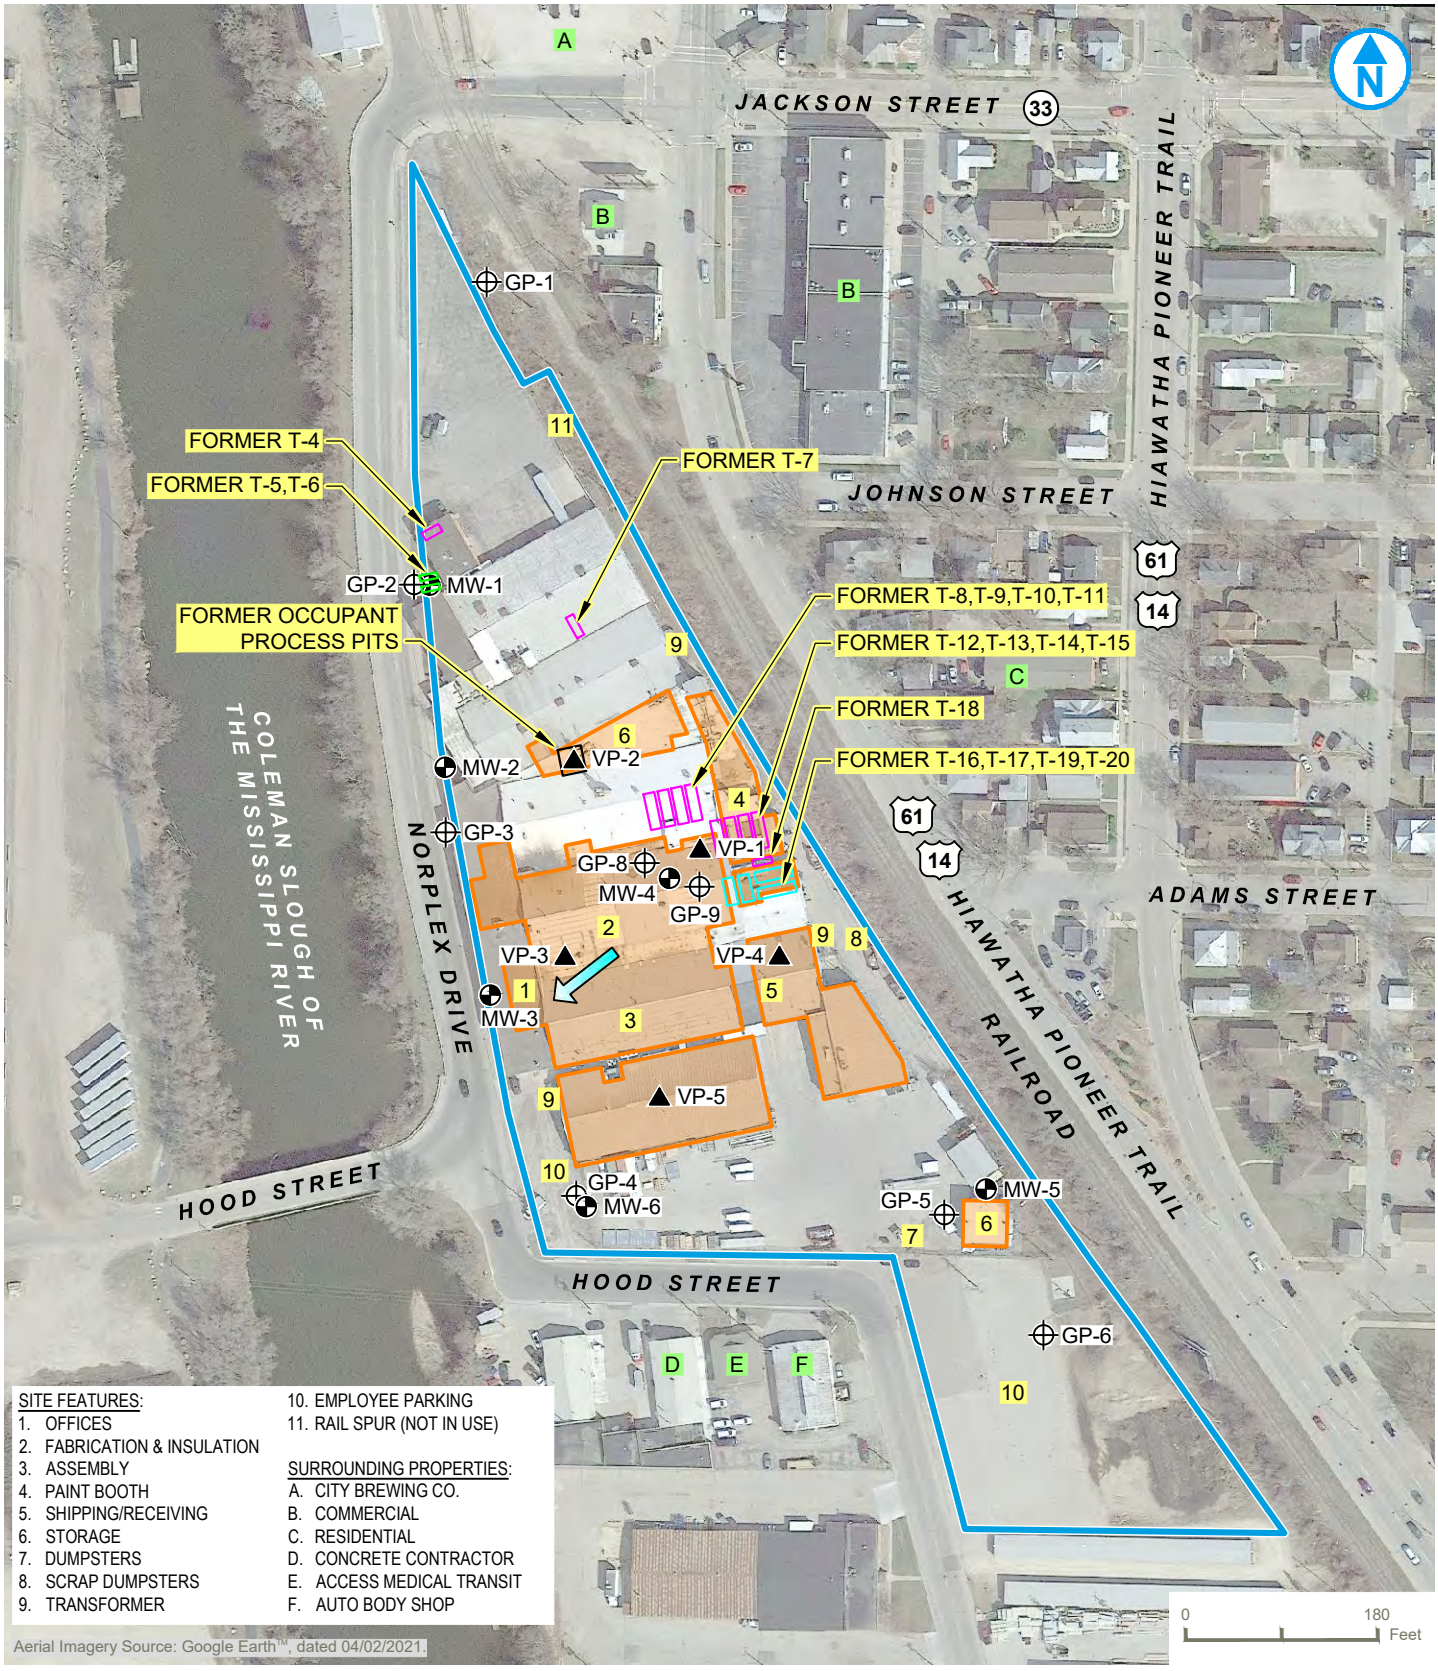
FIGURE 02

Sample Location	Data Objective
VP-1	Within leasehold adjacent to USTs abandoned in place
VP-2	Within leasehold in/adjacent to former press pits
VP-3	On presumed downgradient side of leasehold; dowgradient from USTs abandoned in place
VP-4	Upgradient side of leasehold; adjacent to former failed sump
VP-5	Within southern portion of leasehold; on presumed downgradient side of leasehold

Low levels of multiple VOCs were detected in all five sub-slab soil gas samples collected from vapor pin locations VP-1, VP-2, VP-3, VP-4 and VP-5. None of the VOCs were identified at concentrations above the most stringent Wisconsin VRSLs for residential properties or above the applicable Wisconsin VRSLs for Industrial properties. As such, VOCs in sib-slab soil vapor do not represent a VI concern for the site.

SAMPLE LOCATION LAYOUT
