PHASE I TANK CLOSURE ASSESSMENT
GOVERNMENT CENTER
BURNETT COUNTY HIGHWAY DEPARTMENT
8150 WEST HIGHWAY 70
SIREN, WISCONSIN 54872
OCTOBER 11, 1993

Cooper Engineering Company, Inc.
310 West South Street
Rice Lake, WI 54868

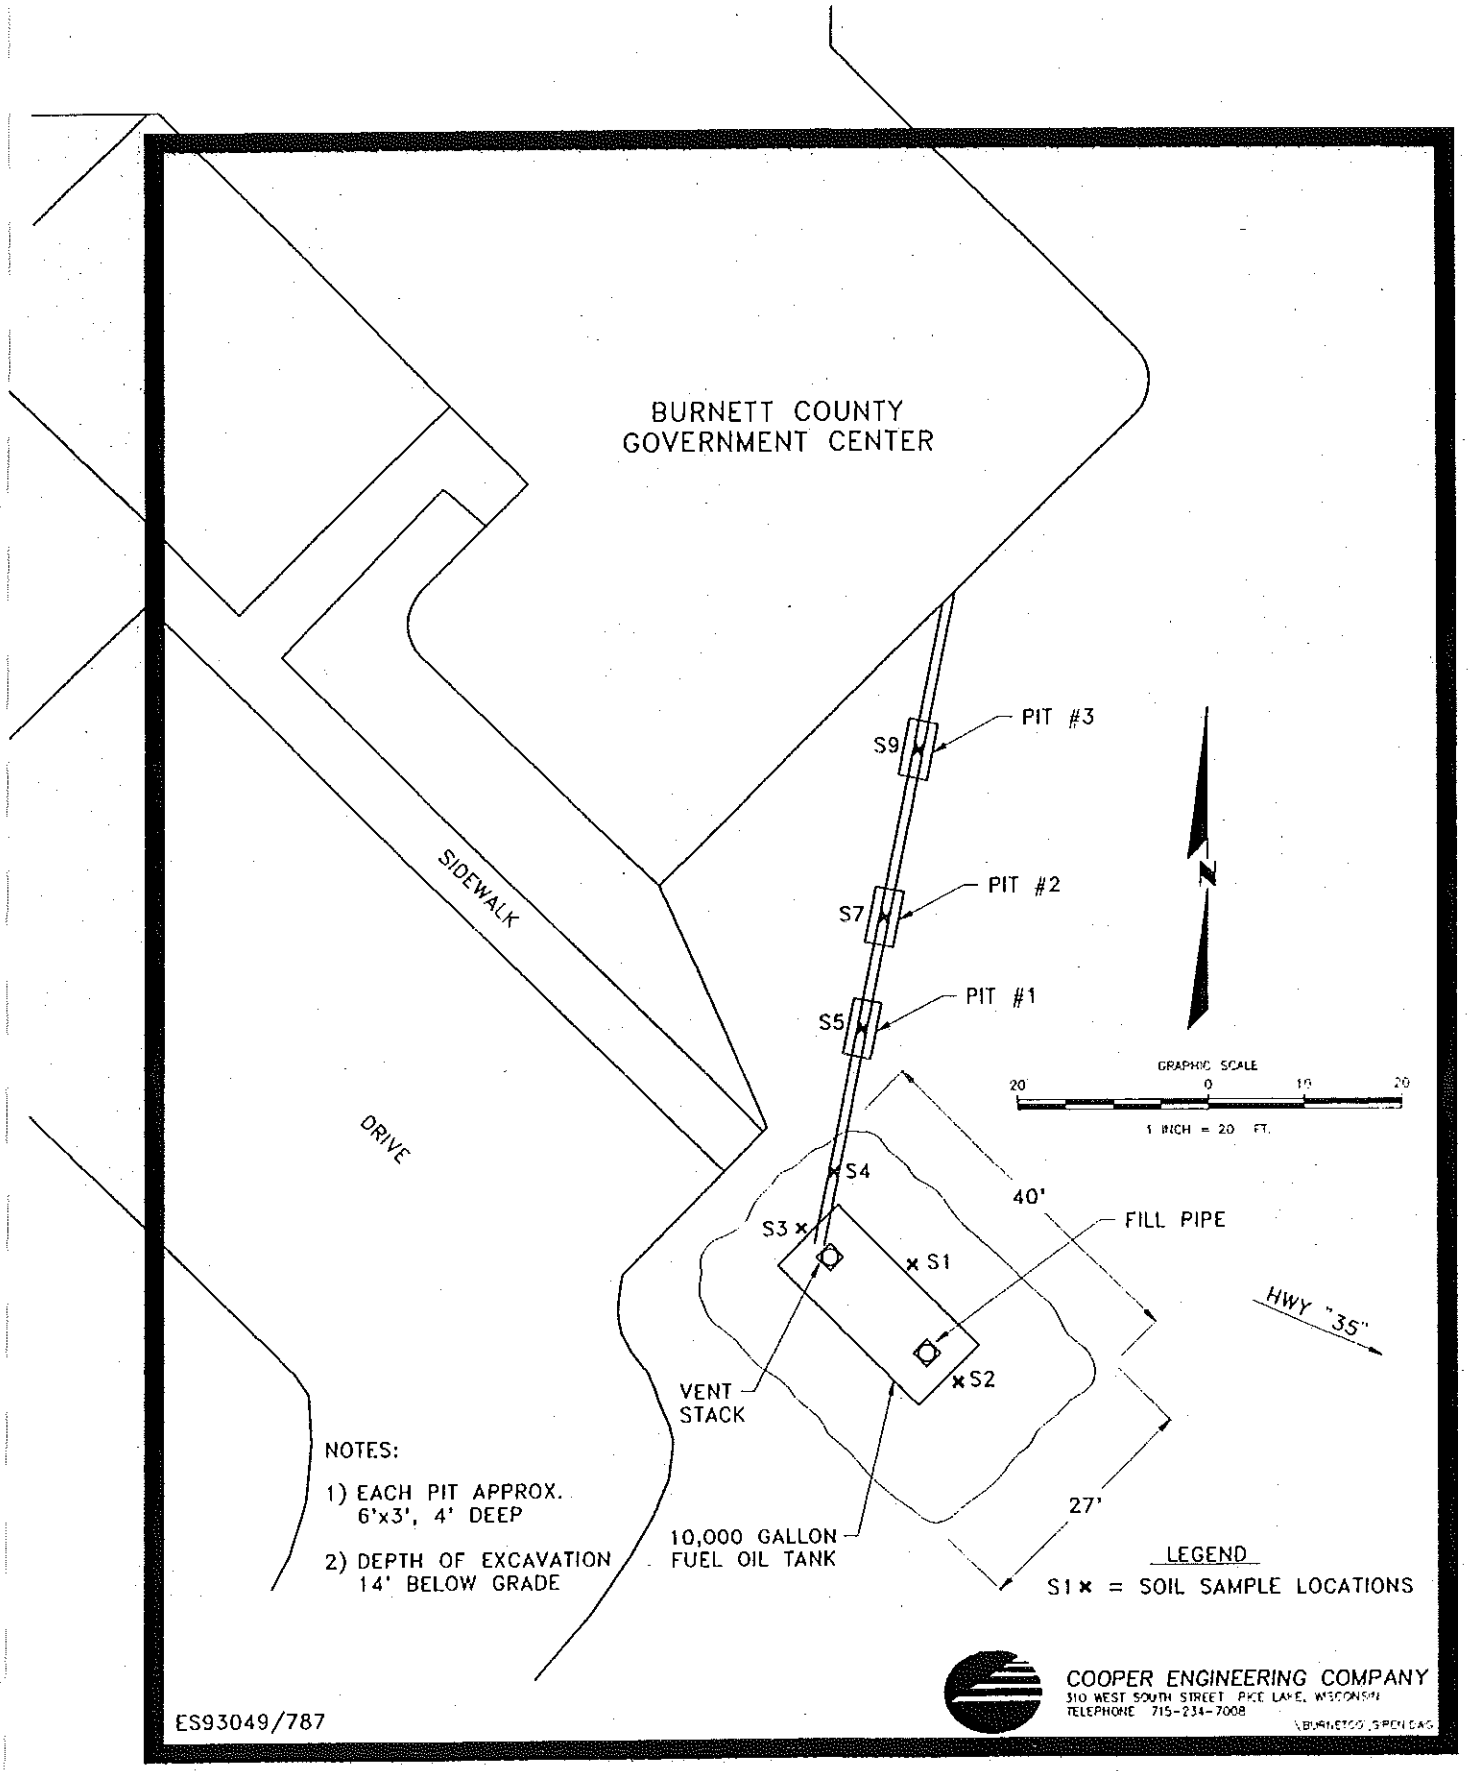
Figure 2 Site Sketch

The excavation site is located at the southeast corner of the building (see Figure 2).

Soil samples at the Burnett County Government Center site were collected from beneath each end of the tank, from beneath the center of the north side of the tank, and from three test pits that were dug below the product supply pipe (see Figure 2). Each sample was collected using a disposable syringe with the end cut off, which had been weighed prior to the sampling and also while containing a representative sample.

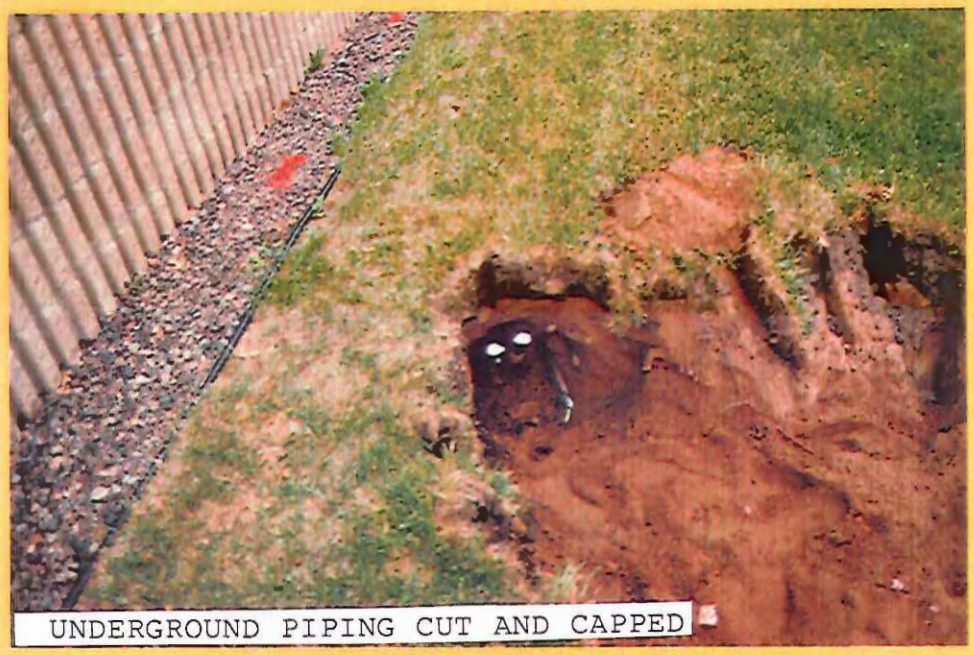
TANK BEING BLOWN AND CLEANED

TANK SET ON SITE

REMOVAL OF TANK FROM EXCAVATION

LEVELING EXCAVATION

UNDERGROUND PIPING CUT AND CAPPED

TANK LABELED FOR TRANSPORT
