Remediation & Redevelopment Continuing Obligation Review

BRRTS ID No. 02-68-443361

Review Date: 08/14/2024

Site Name: Safer Dry Cleaners - Former

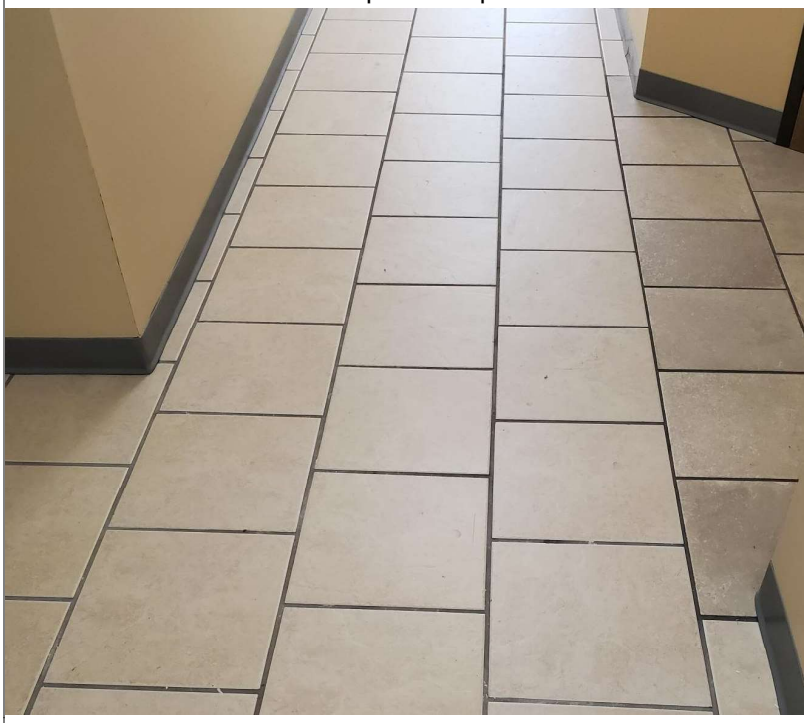
Title: Interior floor - rear building hallway
