October 31, 2013

Subject: **Additional Limited Subsurface Investigation**
Broadway Automotive
1010 & 1109 South Military Avenue
Green Bay, Wisconsin
Cardno ATC Project No. 11.44452.0001 (11003)

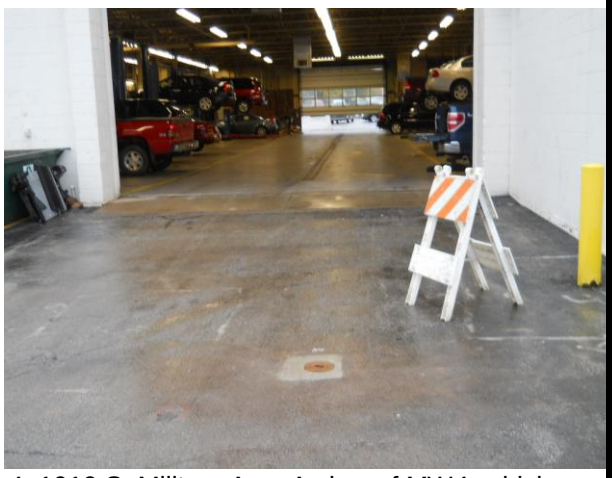
4: 1010 S. Military Ave: A view of MW4, which was installed along the west overhead doors of Building 5 and anomalies 2 and 3.

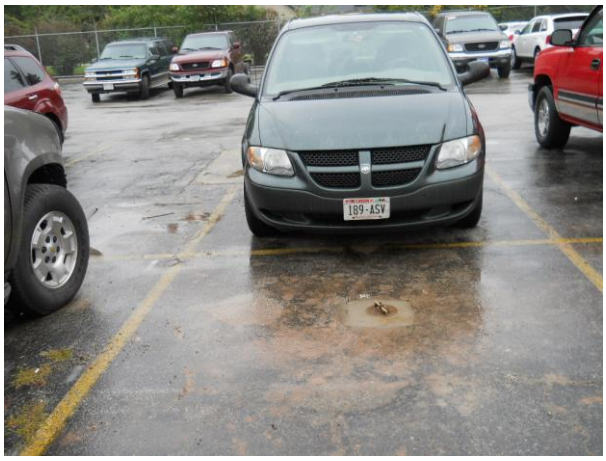
9: 1109 S. Military Ave: A view of MW10, which was installed along the exterior east wall of Building 7 and anomaly 8 (under the vehicle).
