FIVE-YEAR REVIEW REPORT

Five-Year Review Report
for
Lemberger Landfill Site
and
Lemberger Transport and Recycling Site
Whitelaw, Franklin Township Wisconsin

September 2000

PREPARED BY:
Region 5
United States Environmental Protection Agency
Chicago, IL

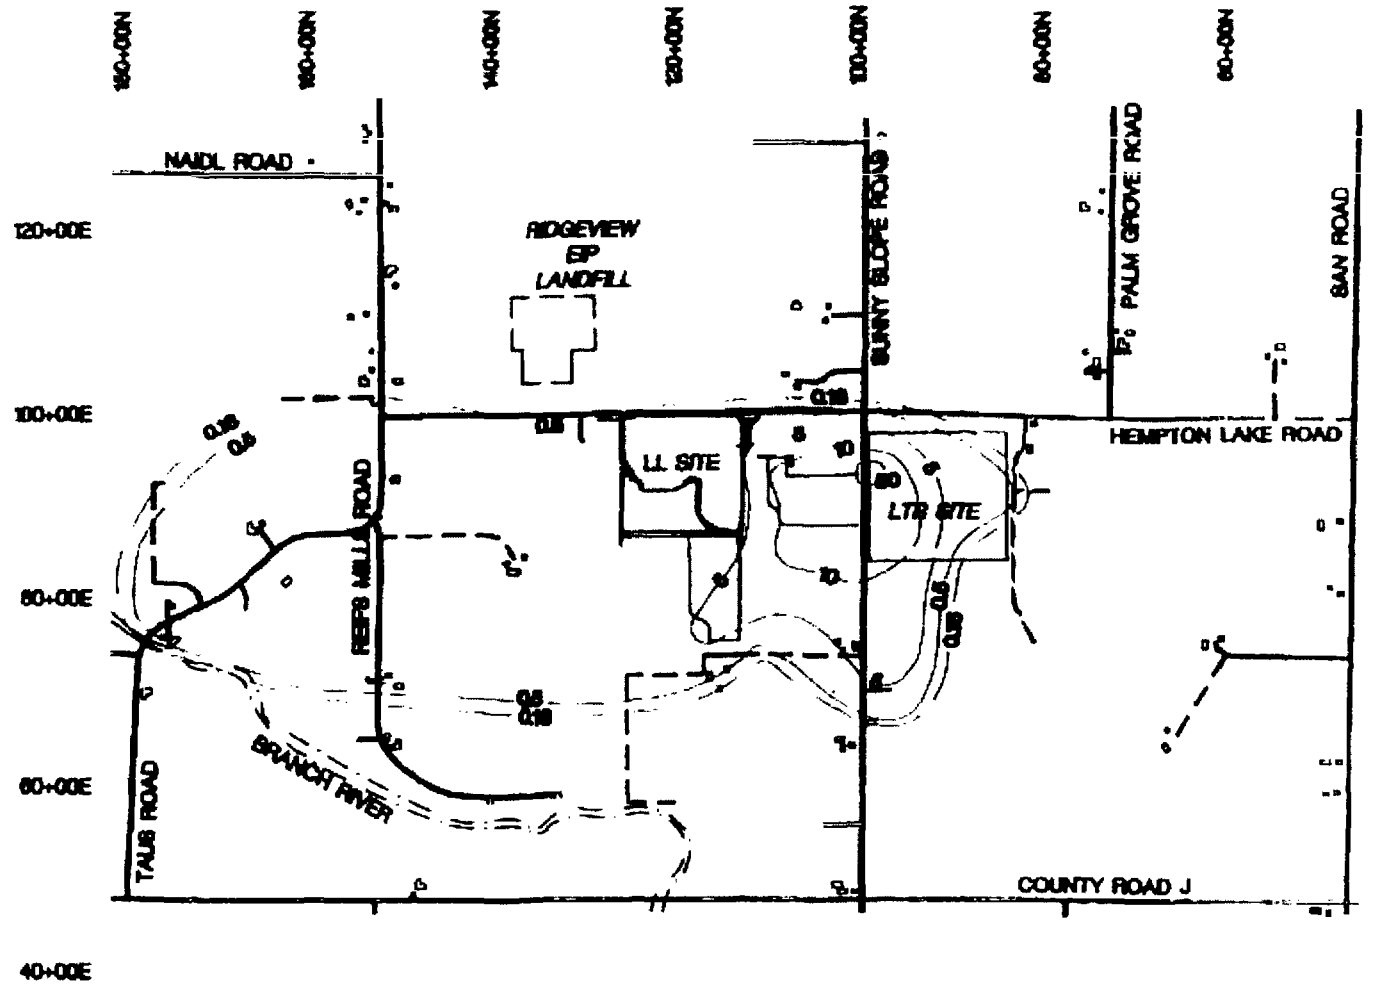
Trichloroethene (TCE), 1,1,1,trichloroethane (TCA) and 1,1 dichloroethene (DCE) are the volatile organic compounds (VOCs) found most commonly and at the highest concentrations. See attached Figure 2 delineating the current extent of the plume under pumping conditions as defined by TCE concentrations. In individual extraction wells, none of the compounds show a discernible long term trend in VOC concentrations. It should by noted that samples collected to date were obtained from a sample tap in the treatment plant and not at the extraction well head.

GROUNDWATER TCE PLUME LOCATION
MARCH 2000 (MICROGRAMS/LITER)
LEMBERGER LANDFILL SITE

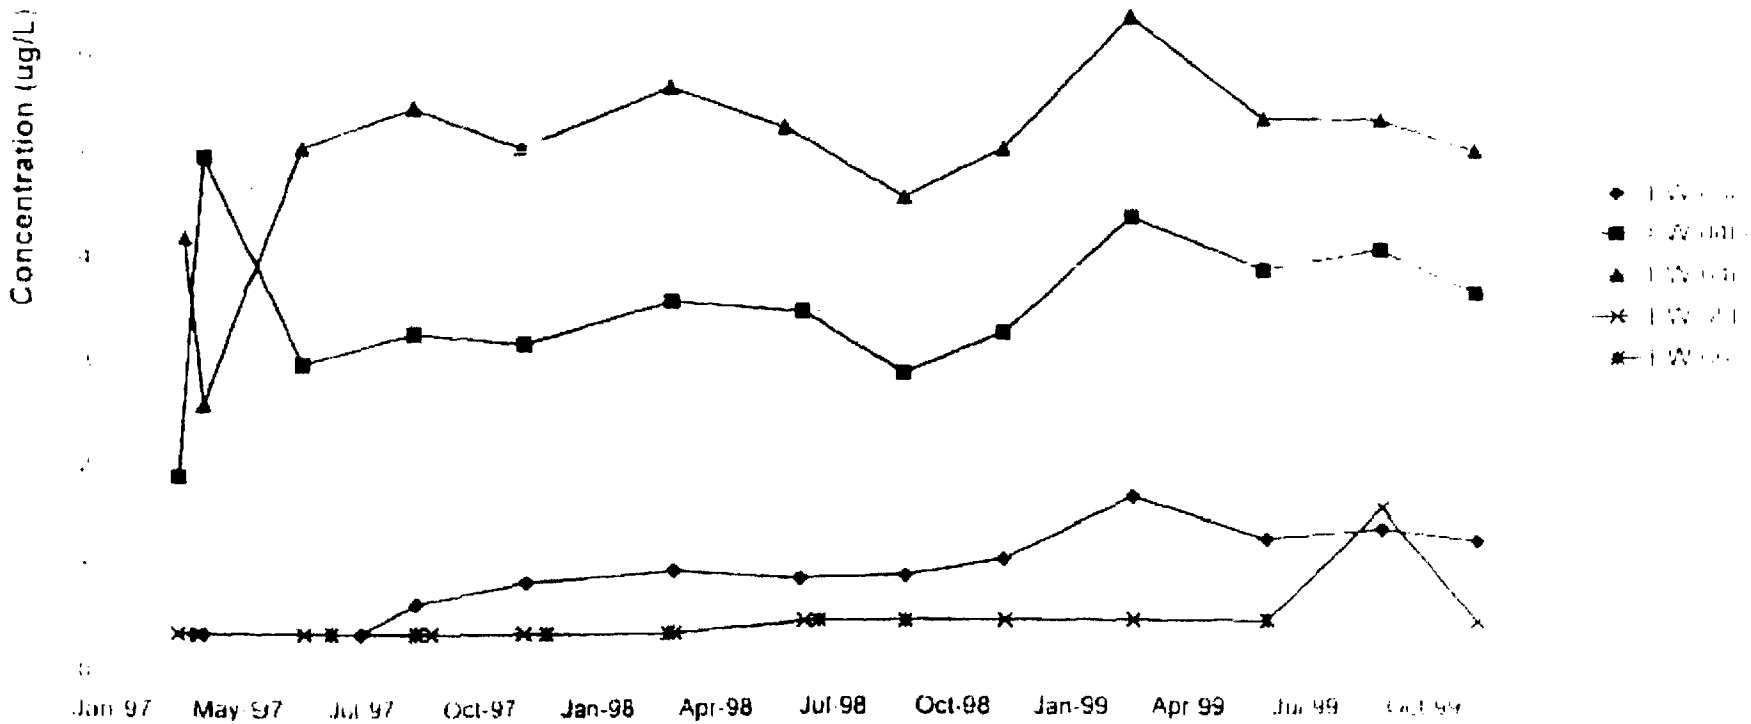
Trichloroethene vs. Time

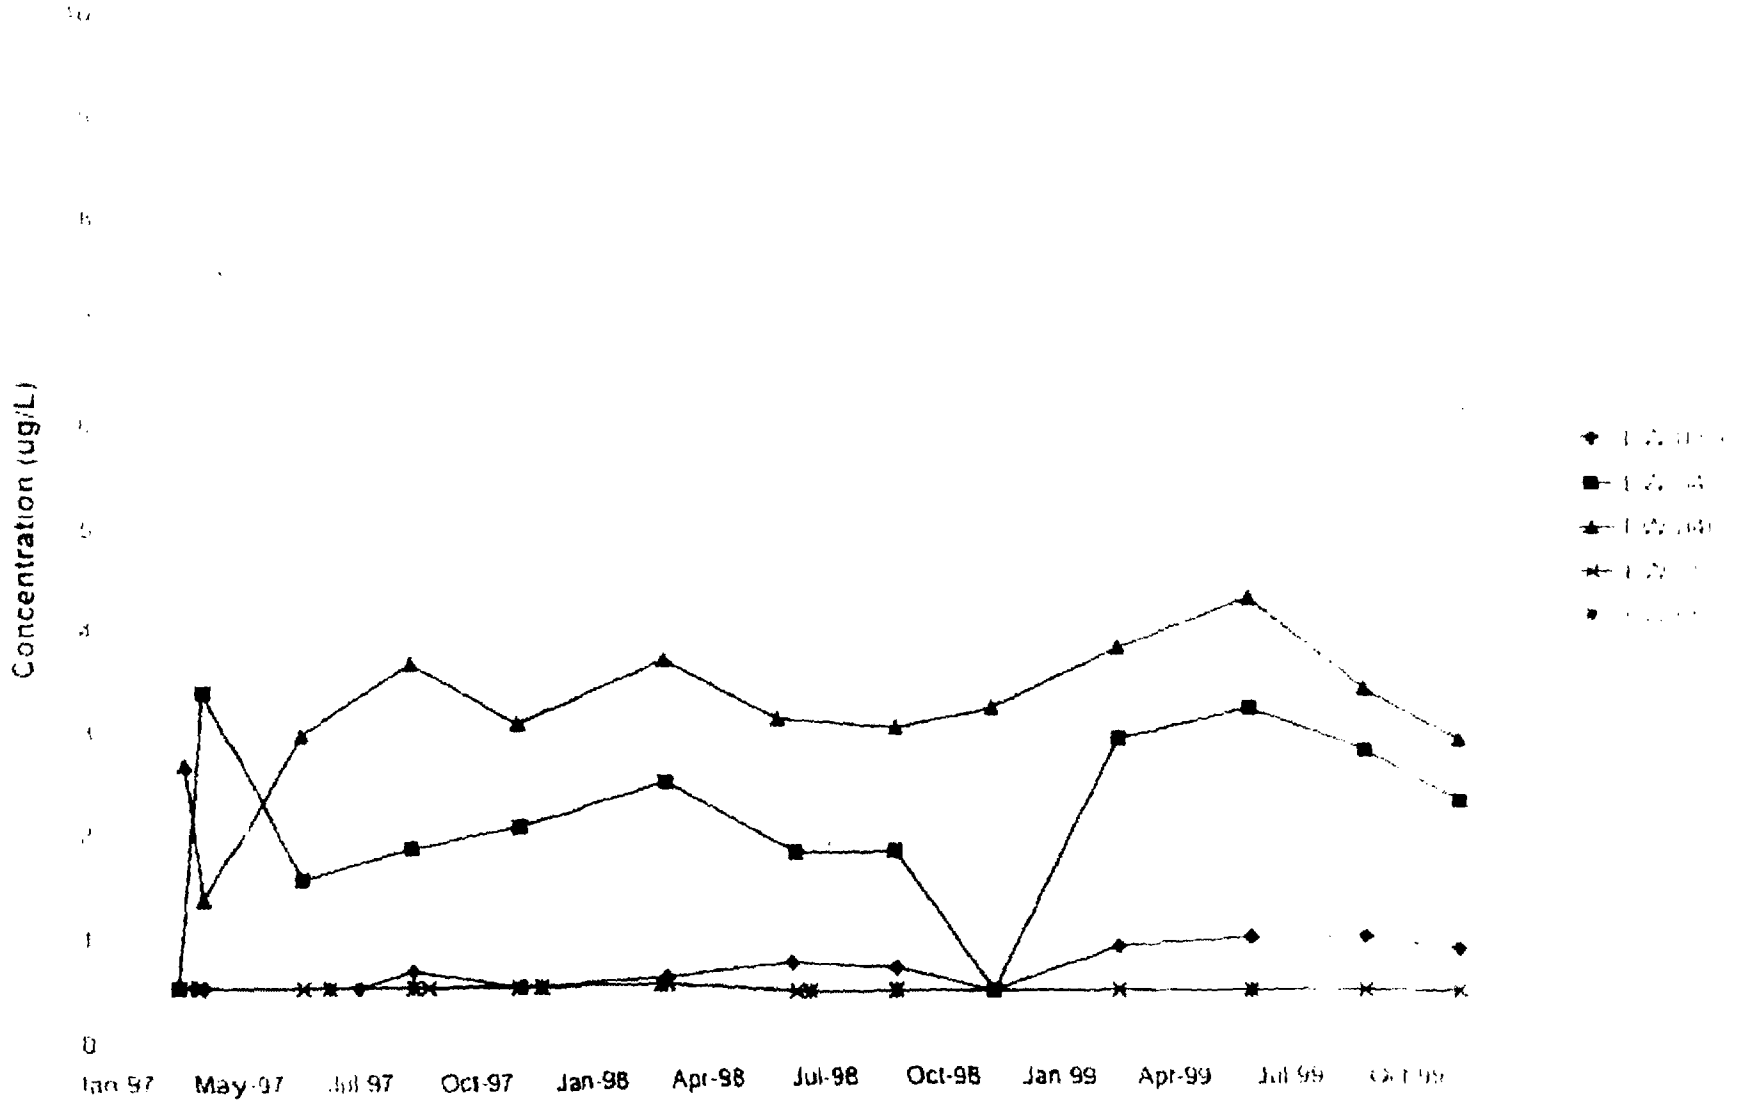
Figure 15

1,1-Dichloroethene vs. Time

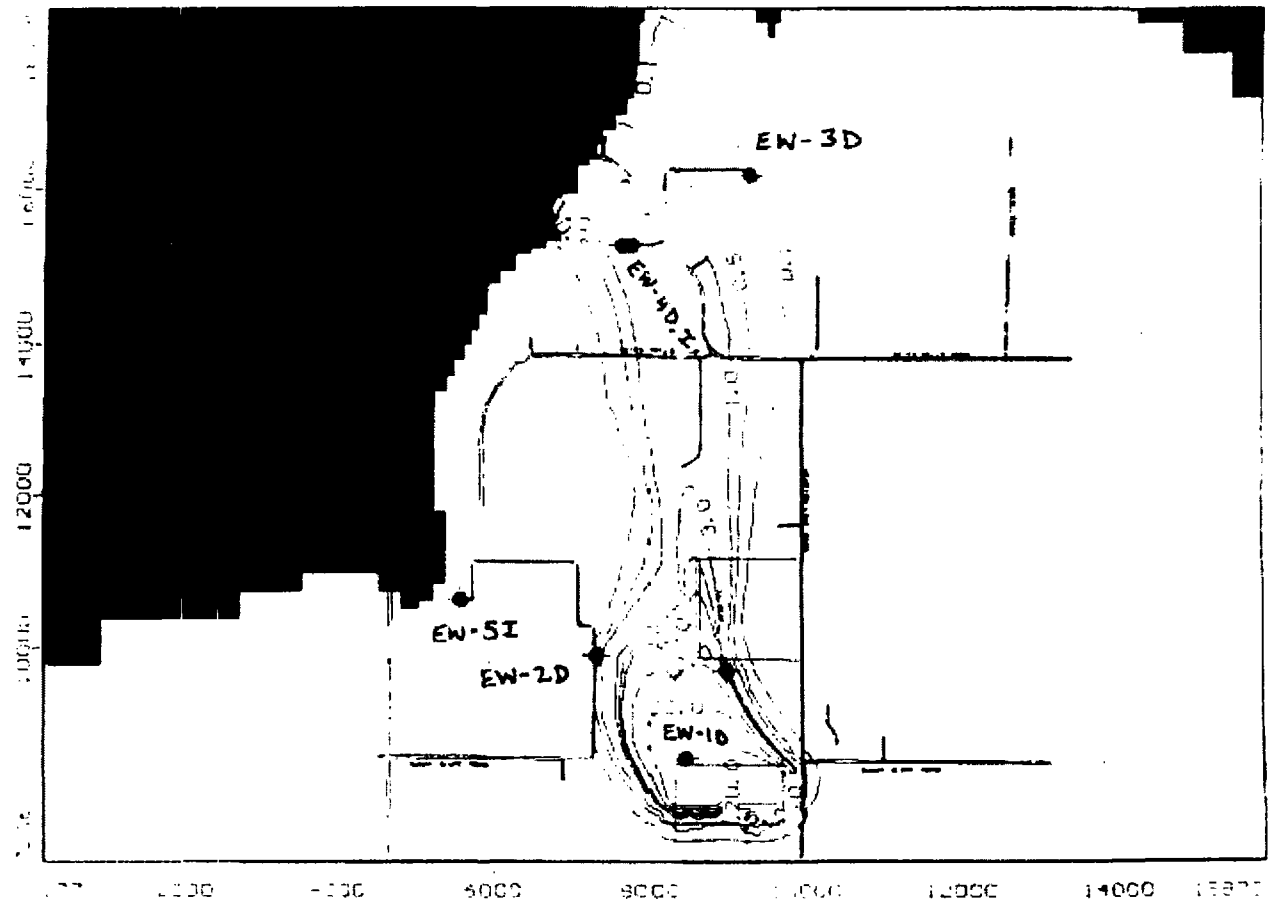
FIGURE 3

TCE contours in µg/L

BASE CASE

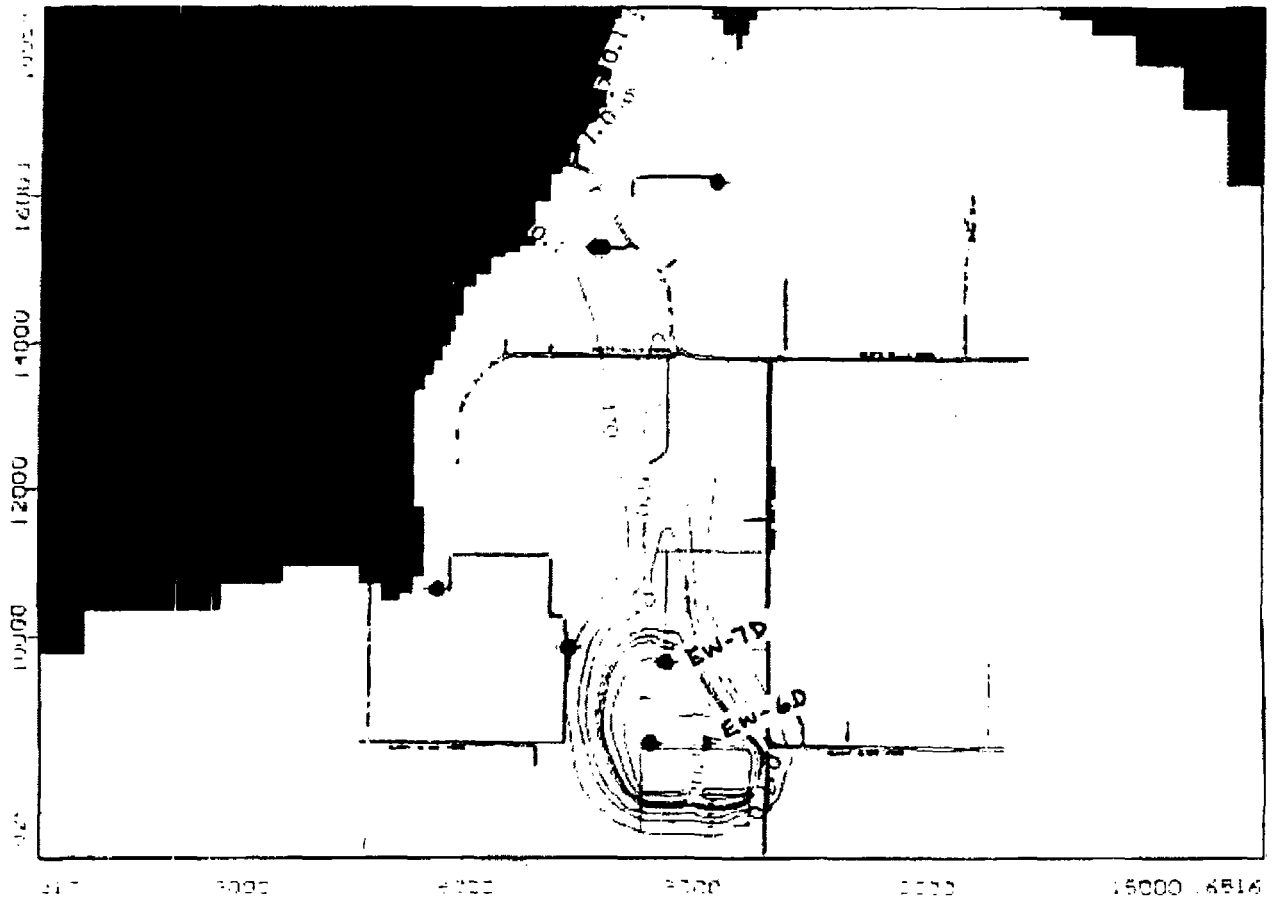
See the attached figure 4 from the June 1999 report for the location and pumping effects of the new wells in Scenario 1. This can be compared against the attached Figure 3 from that report which is called the base case and represents the current pumping system. The addition of these 2 new extraction wells would increase the pumping rate of the entire system from the current 200 gallons per minute (gpm) to 300 gpm. The Agencies have asked LSRG to perform some refinement of the computer modeling in the June 1999 report in order to assure that the proposed modifications will be as appropriate as possible. These refinements are near completion and are not expected to change the recommended modifications. The final version of the June 1999 report will be placed in the local information repository for public review.
