Auto Safety Center
444 N. Main Street
West Bend, Wisconsin 53095

UST REMOVAL AND SITE CLOSURE ASSESSMENT
Auto Safety Center
April 1, 1992

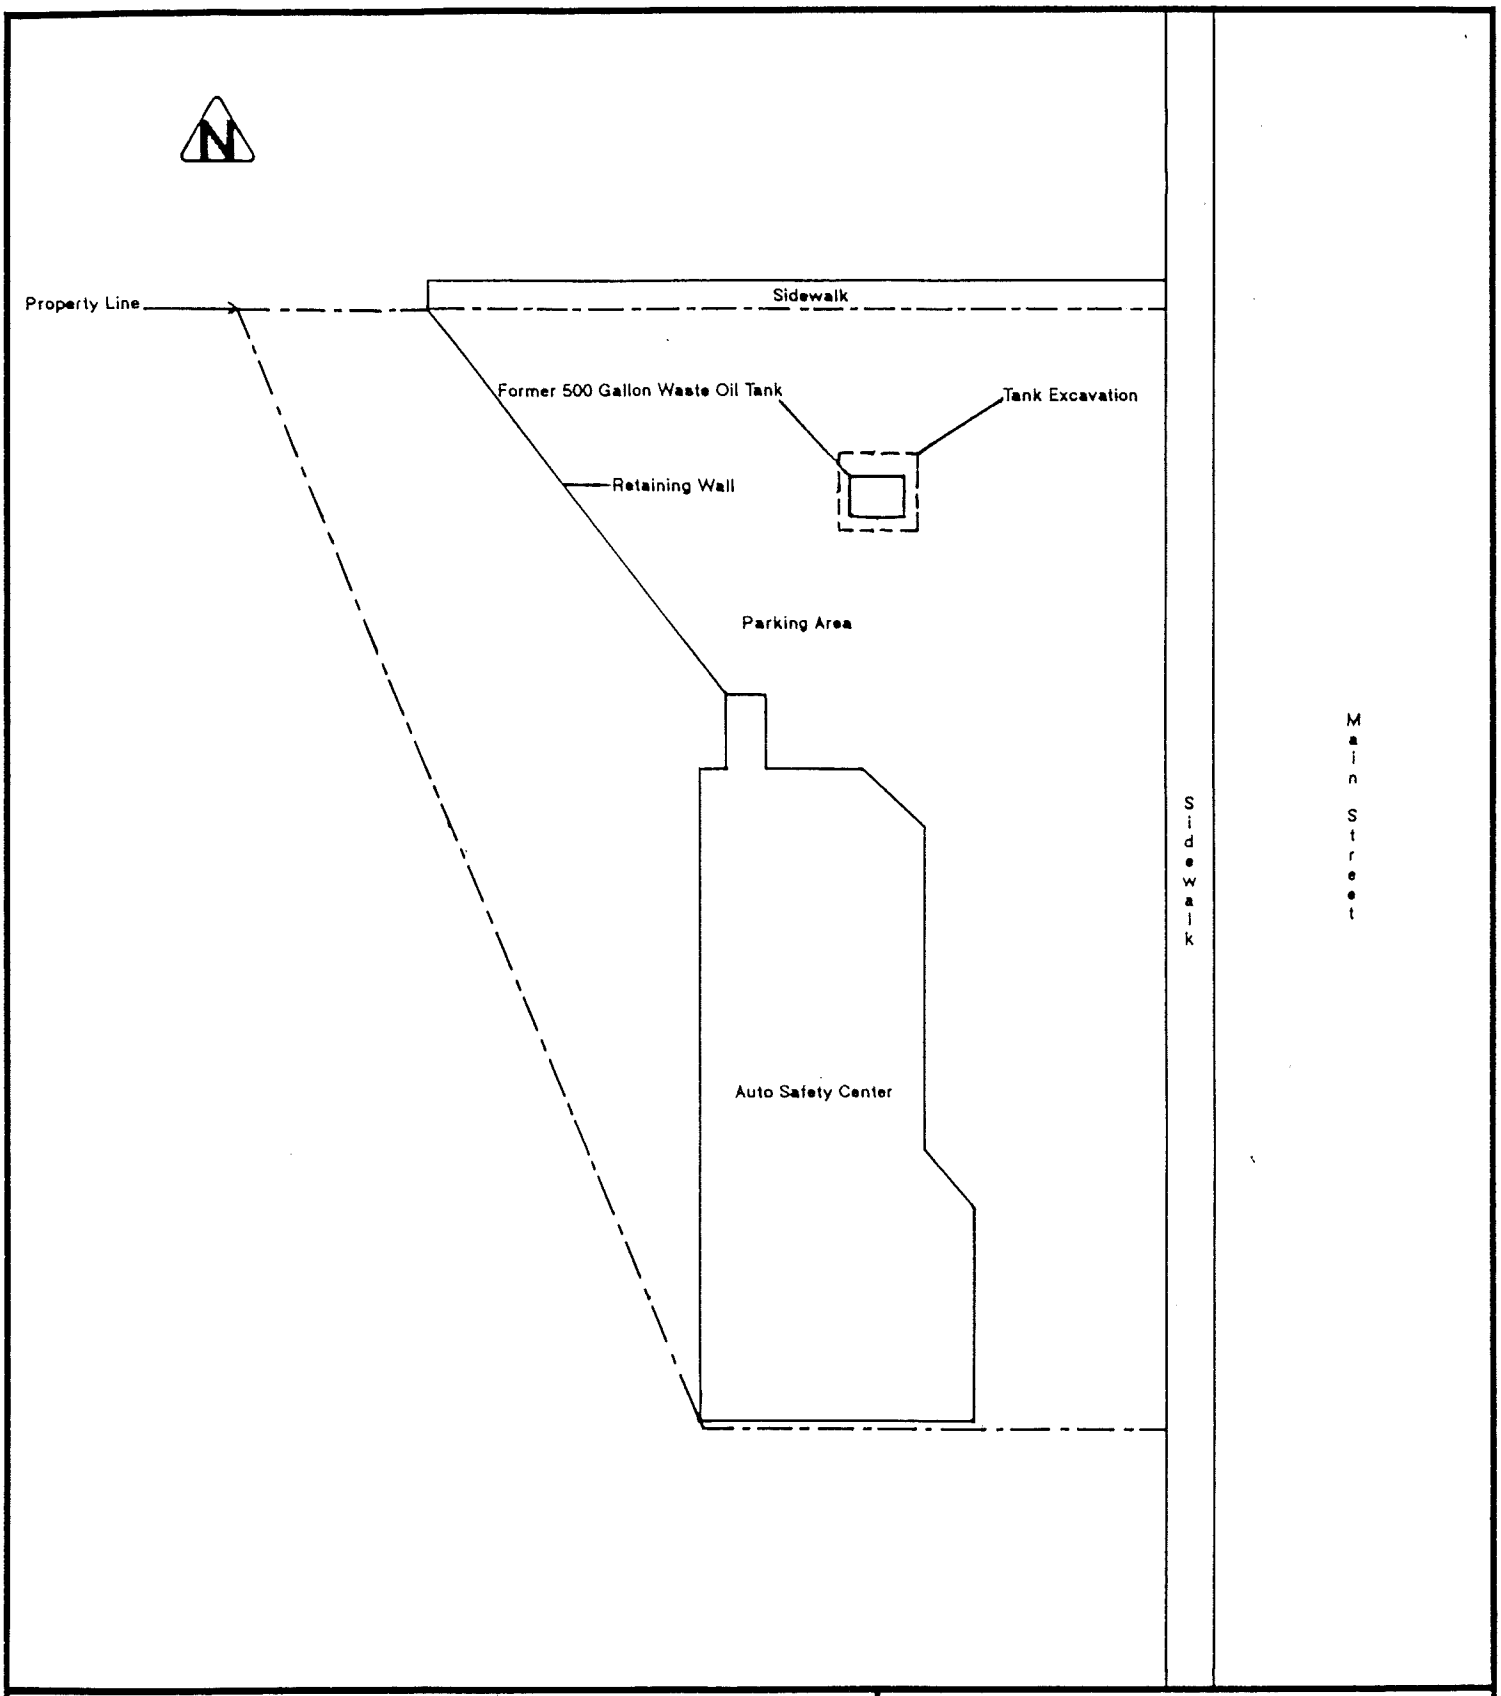
Figure 3-1
TANK EXCAVATION LOCATION

Guelig Brothers Construction Company of Hartford, Wisconsin excavated one asphalt coated steel 500 gallon UST containing waste oil. The excavation pit and the former location of the tank is shown on Figure 3-1. The tank measured four feet by six feet and had no evidence of holes. There was evidence of moderate rust and pitting. Excavated soils consisted primarily of fine-to-coarse grained sand with some cobbles and boulders. The excavation pit measured eight feet by eight feet. Total depth of the excavation was 9.5 feet. Groundwater conditions were not observed within the excavation.

One 500 gallon asphalt coated steel waste oil tank was removed from the site on January 28, 1992. Upon removal the tank exhibited moderate rust and pitting. No holes were visible. Subsurface soils did not exhibit visual petroleum staining. Groundwater was not encountered within the UST excavation.

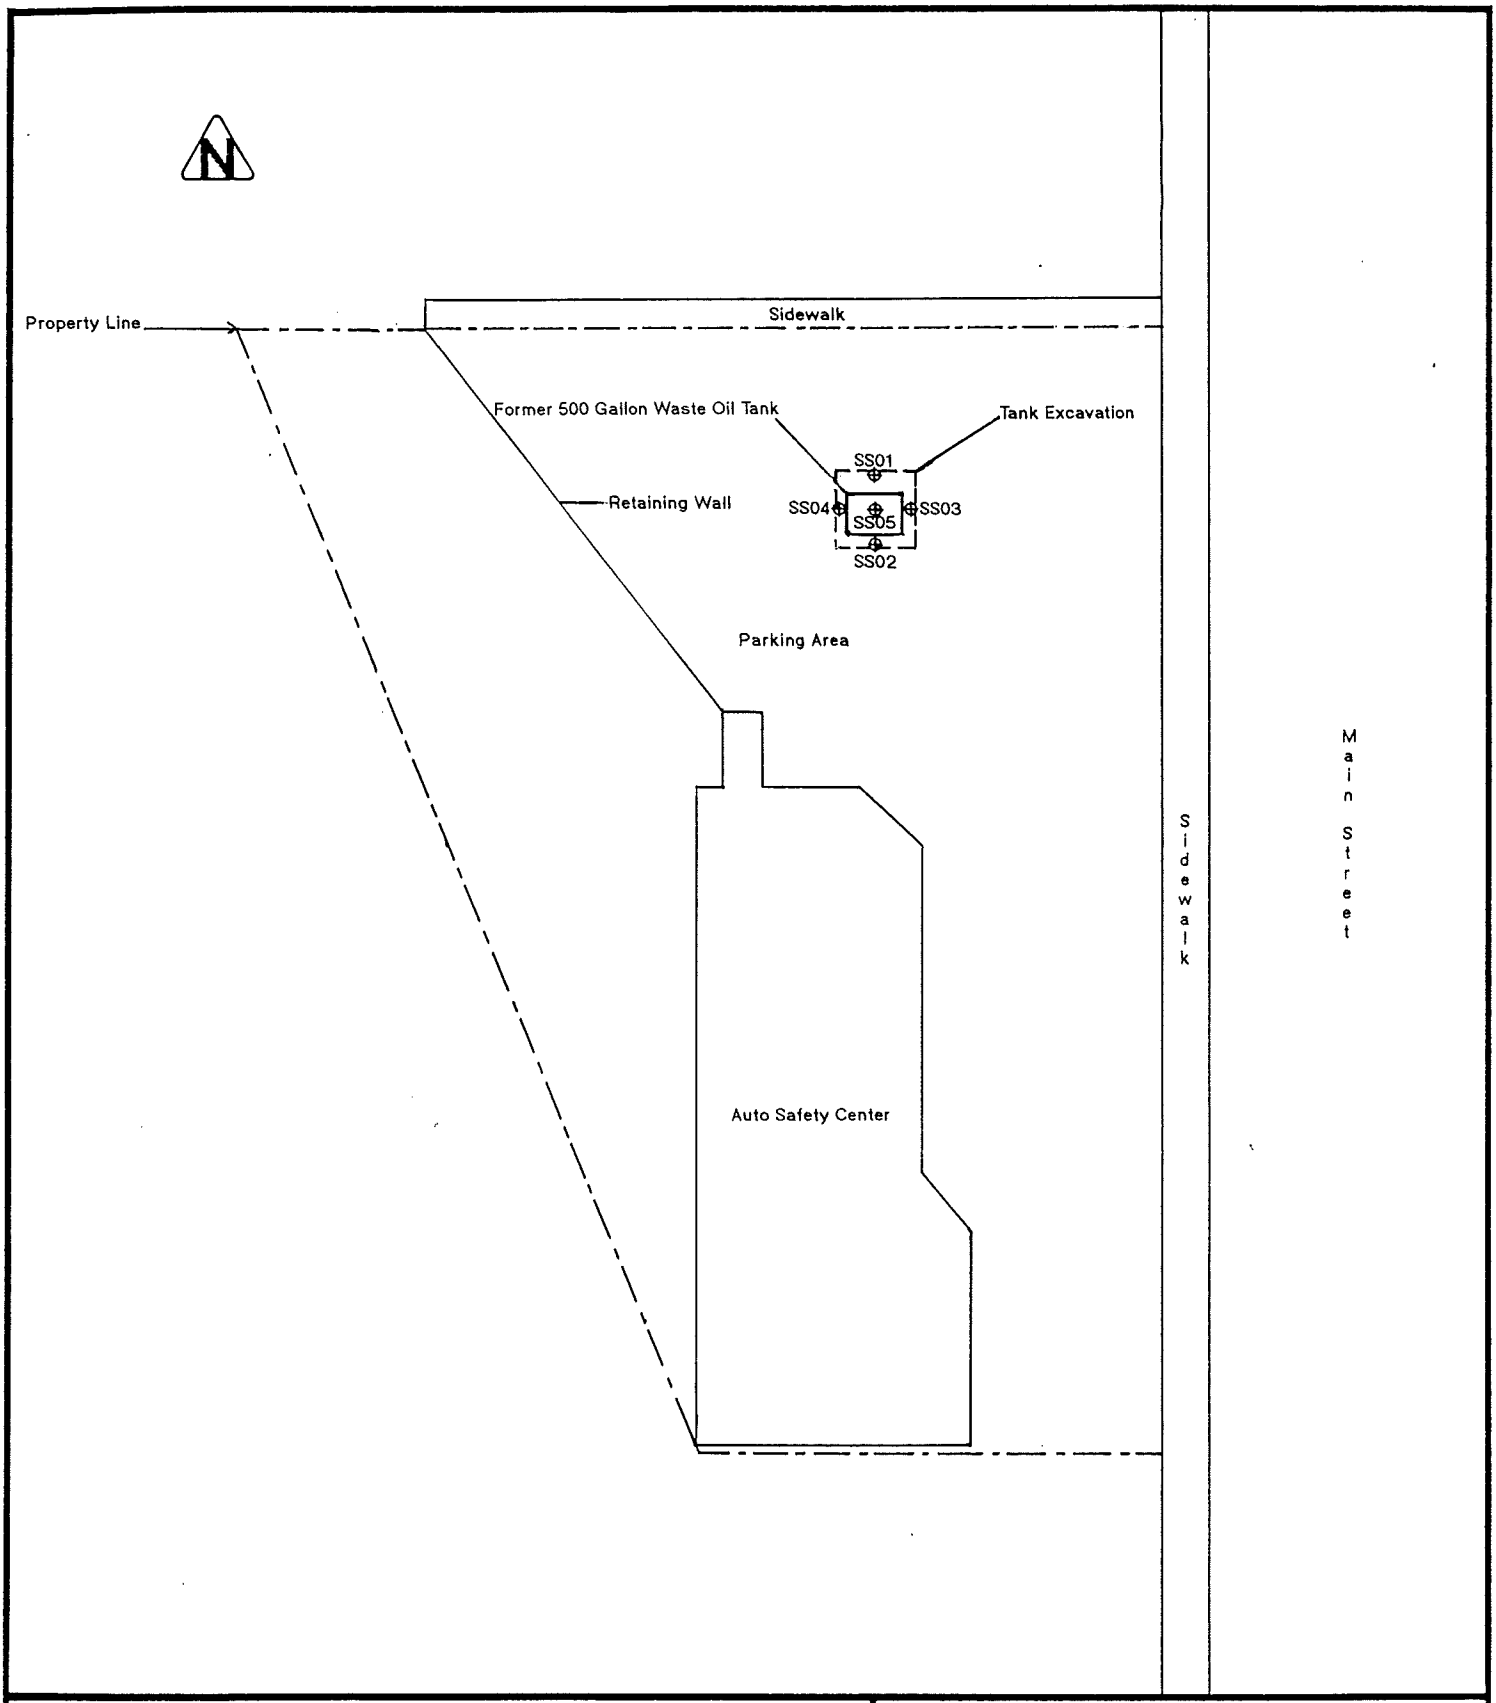
Figure 3-2
TANK EXCAVATION AND ANALYTICAL SOIL SAMPLE LOCATIONS

Representative soil samples were obtained from the base and each side of the excavation. A total of five locations were sampled (Figure 3-2). Each sample was split for OVM headspace analysis (described in Section 3.2) and submitted for laboratory analysis of Total Recoverable Petroleum Hydrocarbons (TRPH). In addition, all soil samples were visually inspected for petroleum staining. Visual staining was not observed upon the excavated soils. Analytical samples were placed in laboratory supplied four-ounce glass jars and secured with a Teflon-lined lid. Each analytical sample was immediately placed in a cooler with bagged ice, in order to maintain the sample at 4°C. A chain-of-custody document accompanied the samples to Precision Analytical Laboratories, Inc., 205 West Galena, Milwaukee, Wisconsin (WDNR certification #241369260). Chain-of-custody forms and analytical result sheets are presented in Appendix A.

Analytical data obtained from subsurface tank excavation soil samples indicates that site soils have not been adversely impacted by past waste oil UST operations. TRPH concentrations are below the 10 ppm cleanup guideline for the laboratory analyzed soil samples (Table 4-1).
