Auto Safety Center
444 N. Main Street
West Bend, Wisconsin 53095

UST REMOVAL AND SITE CLOSURE ASSESSMENT
Auto Safety Center
April 1, 1992

Submitted By:
Cooper Environmental Resources, Inc.
1411 N. Main Street
West Bend, WI 53095

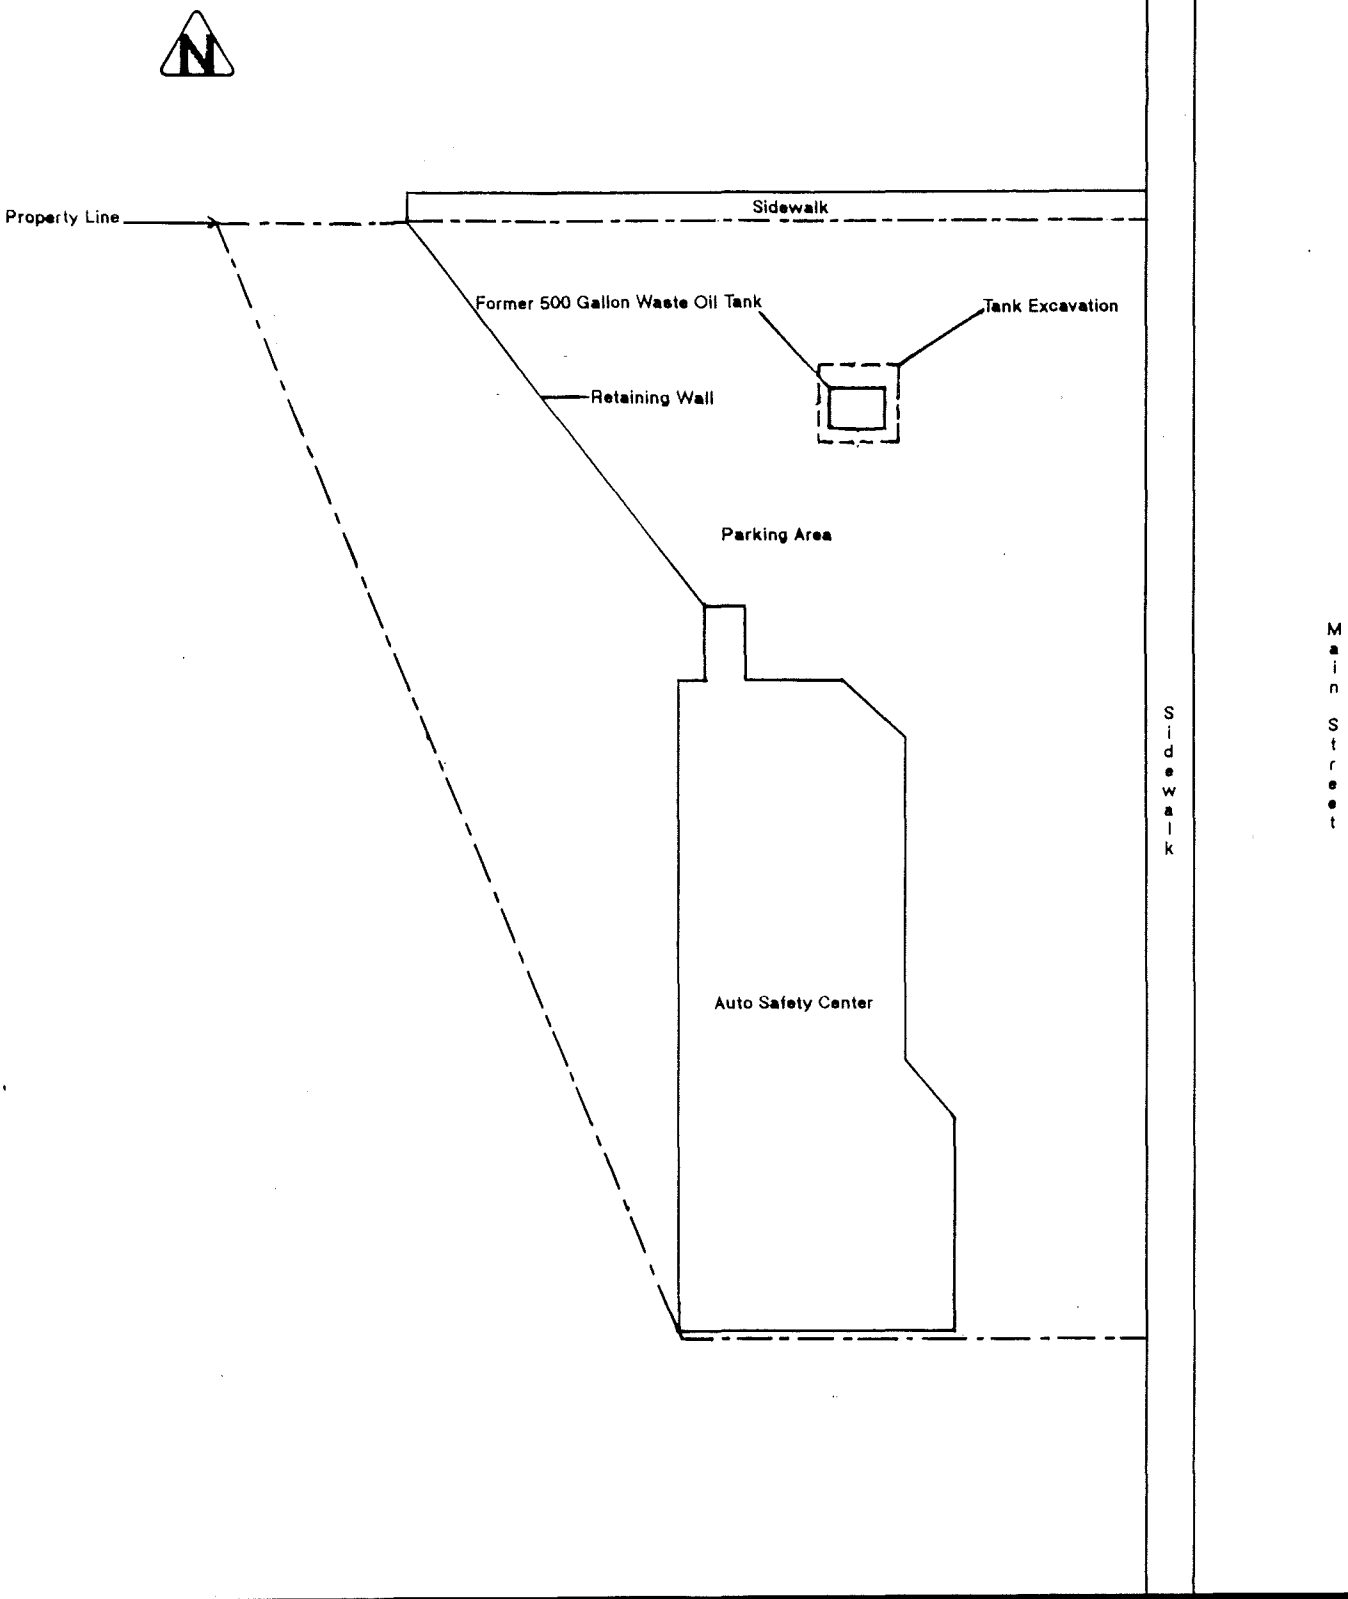
Figure 3-1
TANK EXCAVATION LOCATION

Guelig Brothers Construction Company of Hartford, Wisconsin excavated one asphalt coated steel 500 gallon UST containing waste oil. The excavation pit and the former location of the tank is shown on Figure 3-1. The tank measured four feet by six feet and had no evidence of holes. There was evidence of moderate rust and pitting. Excavated soils consisted primarily of fine-to-coarse grained sand with some cobbles and boulders. The excavation pit measured eight feet by eight feet. Total depth of the excavation was 9.5 feet. Groundwater conditions were not observed within the excavation.

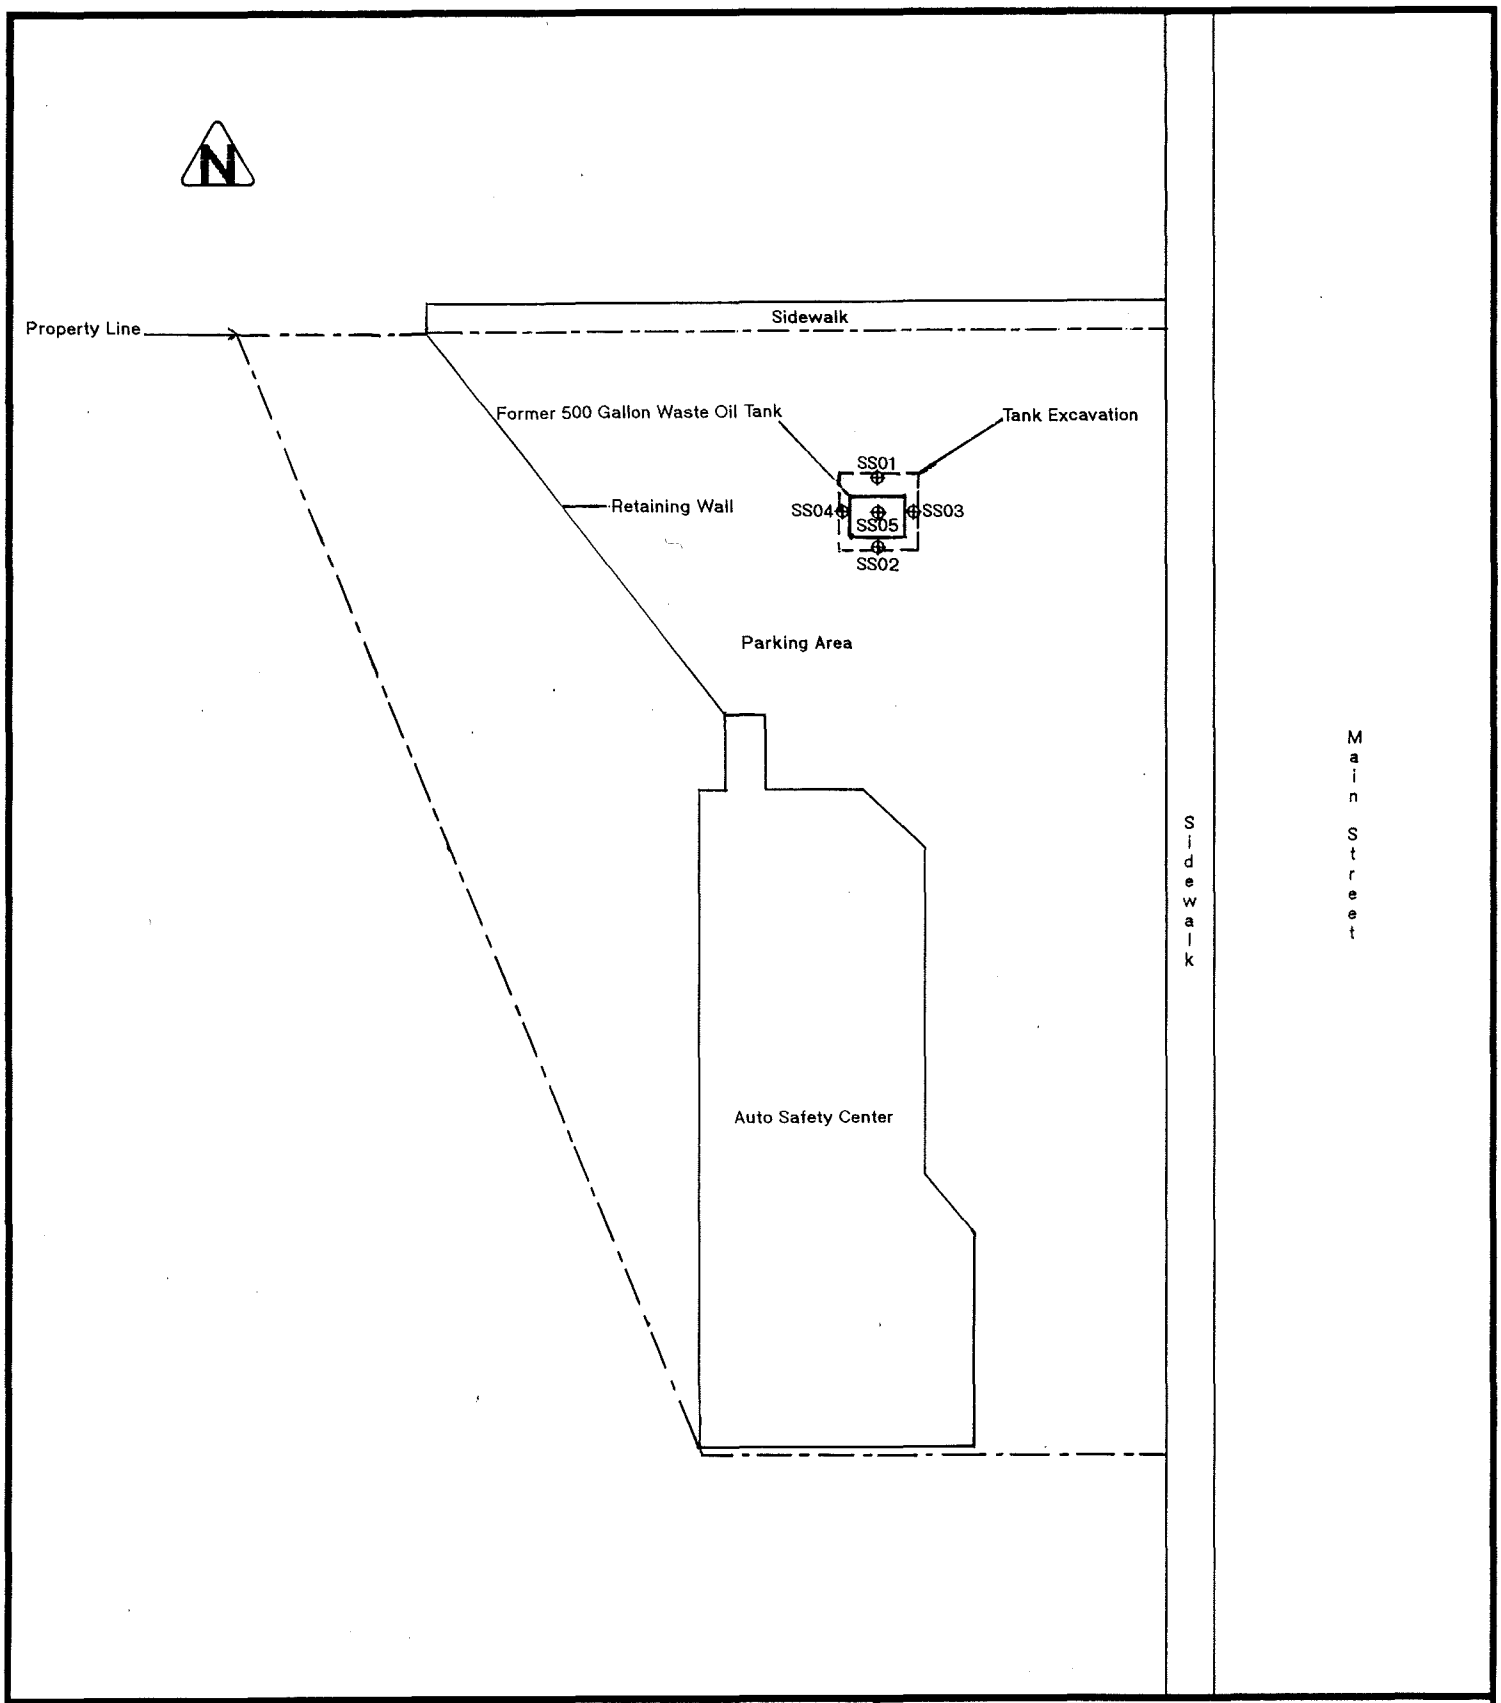
Figure 3-2
TANK EXCAVATION AND ANALYTICAL SOIL SAMPLE LOCATIONS

Representative soil samples were obtained from the base and each side of the excavation. A total of five locations were sampled (Figure 3-2). Each sample was split for OVM headspace analysis (described in Section 3.2) and submitted for laboratory analysis of Total Recoverable Petroleum Hydrocarbons (TRPH). In addition, all soil samples were visually inspected for petroleum staining. Visual staining was not observed upon the excavated soils. Analytical samples were placed in laboratory supplied four-ounce glass jars and secured with a Teflon-lined lid. Each analytical sample was immediately placed in a cooler with bagged ice, in order to maintain the sample at 4°C. A chain-of-custody document accompanied the samples to Precision Analytical Laboratories, Inc., 205 West Galena, Milwaukee, Wisconsin (WDNR certification #241369260). Chain-of-custody forms and analytical result sheets are presented in Appendix A.

Analytical data obtained from subsurface tank excavation soil samples indicates that site soils have not been adversely impacted by past waste oil UST operations. TRPH concentrations are below the 10 ppm cleanup guideline for the laboratory analyzed soil samples (Table 4-1).
