Technical Memorandum

Project Title: Sadoff Iron & Metal Company - Cutting Oil Site - BRRTS #02-20-543060
Fond du Lac, Wisconsin

Technical Memorandum No. 7

Subject: Results of June 2017 (2Q17) Groundwater Sampling and Analysis (39th Round)

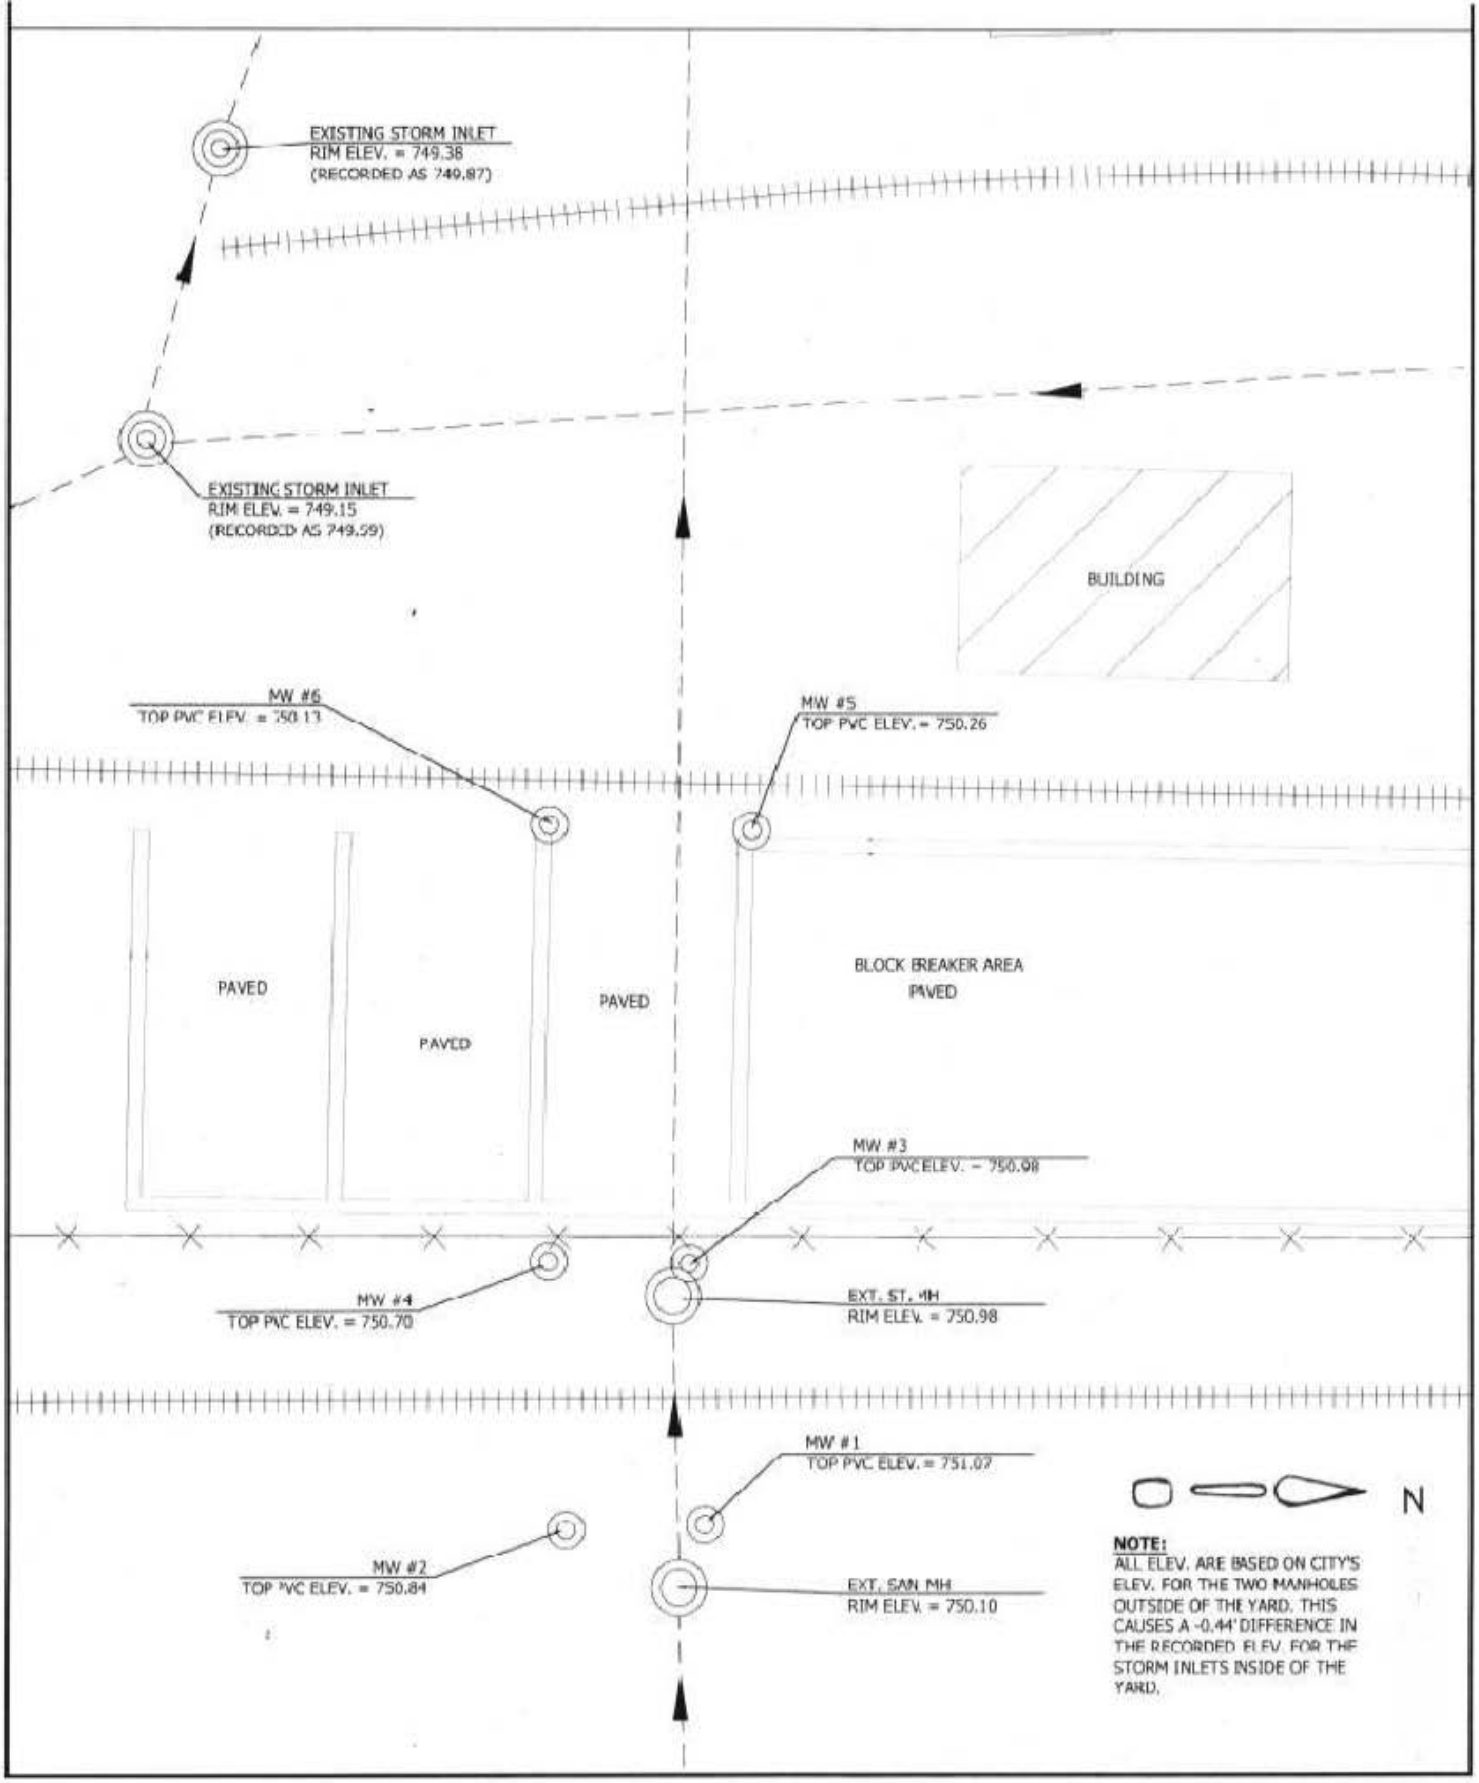
Figure

There are six (6) monitoring wells at the Site and one (1) sump (Figure 1). As requested in the report dated March 28, 2012 from Earth Science & Technology, LLC, summarizing the 25th round of groundwater data, and approved by the Wisconsin Department of Natural Resources (WDNR) shortly thereafter, groundwater samples are collected from MW-1 and the green sump (sump) only. The March 28, 2012 report requested that the two groundwater samples be analyzed for only iron and acetone. However, the WDNR granted approval to analyze the two groundwater samples for acetone only.

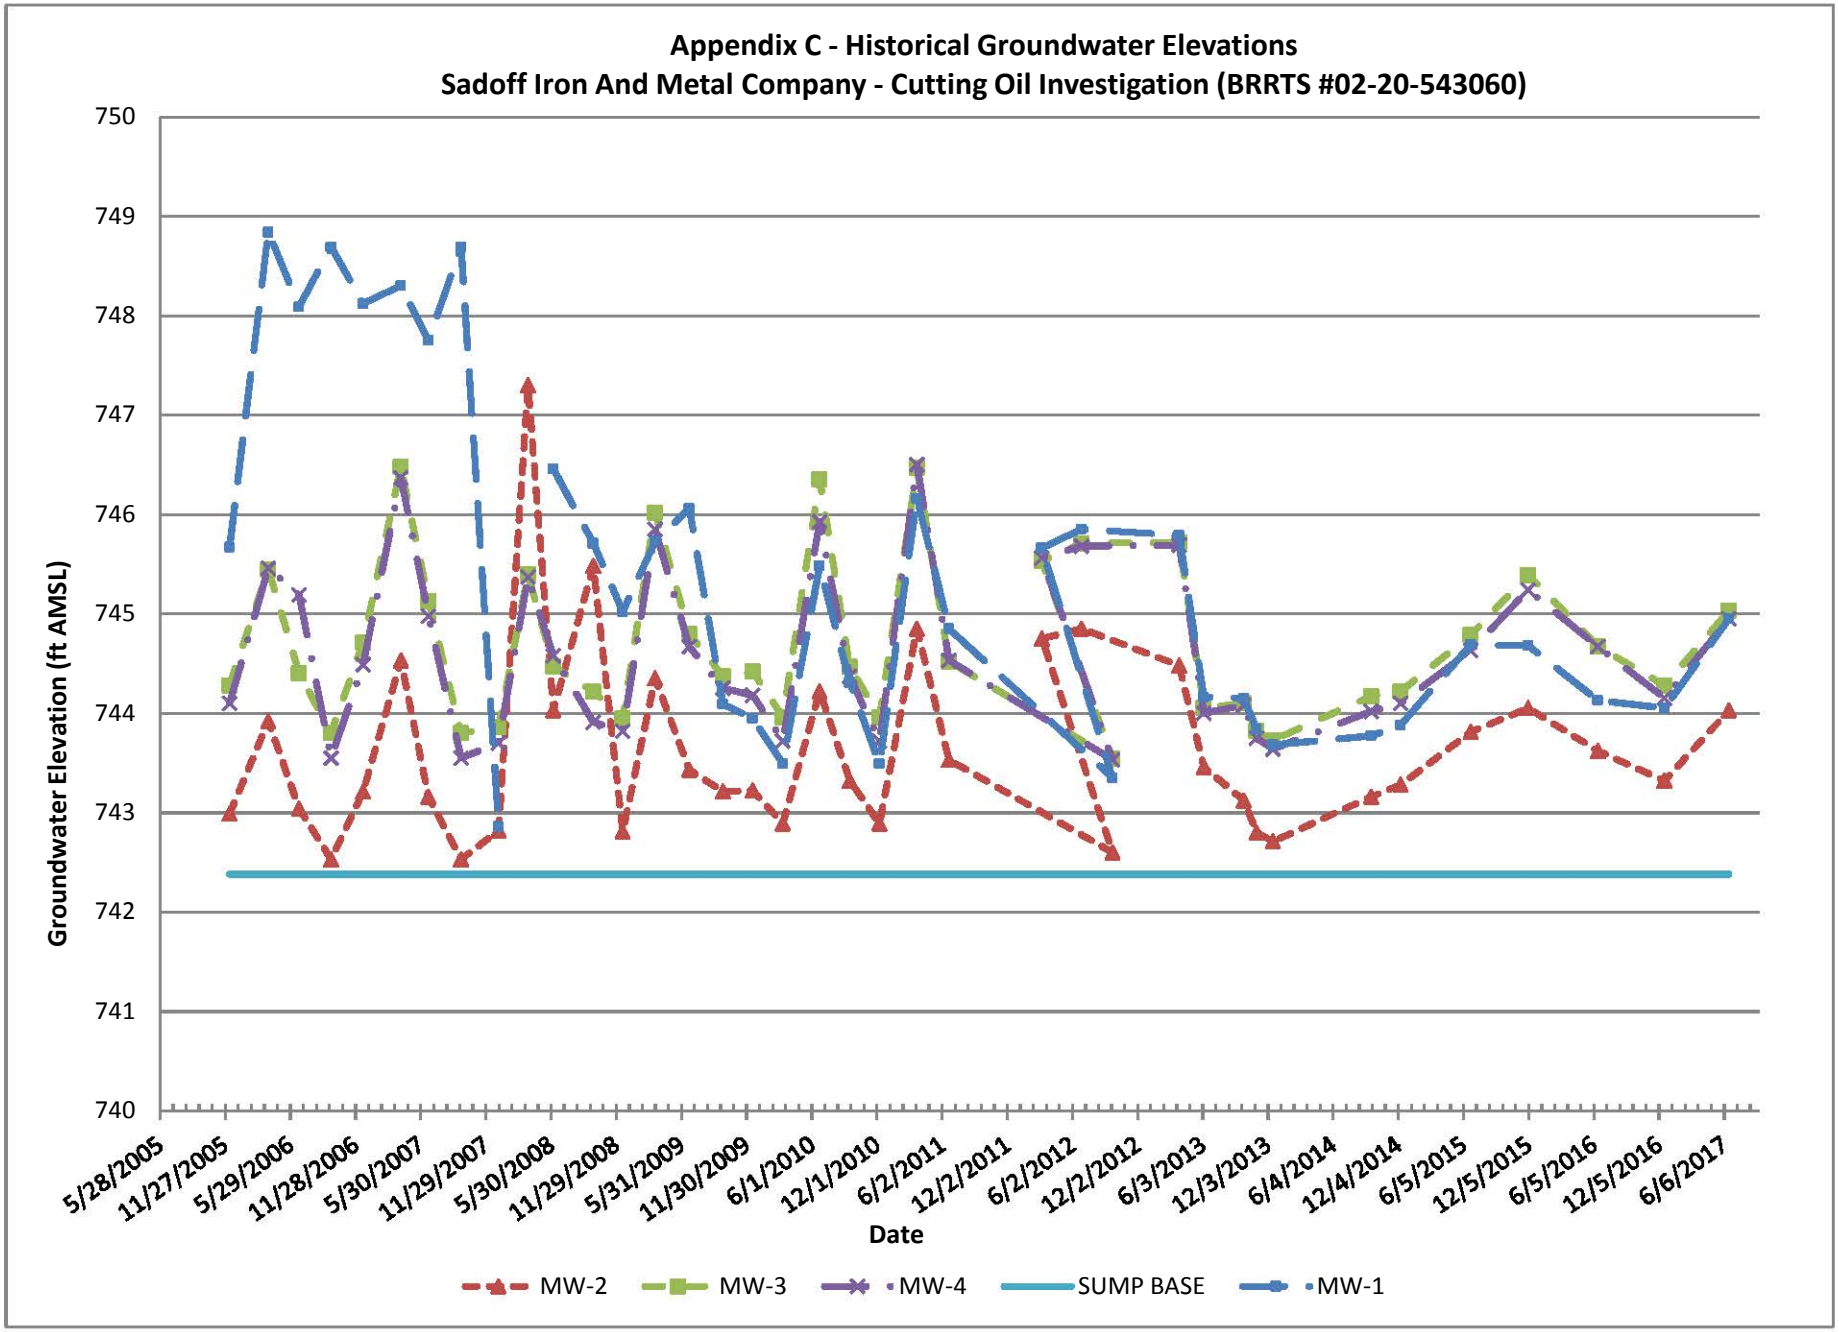
Appendix C: Historical Groundwater Elevations

REL measured static water levels in four (4) groundwater monitoring wells and the green sump (sump). Table 1 summarizes the 2Q17 groundwater elevations in feet above mean sea level (Ft AMSL), which were calculated by measuring the depth to water from the surveyed top-of-casing measurement at each monitoring well location. The elevation of the bottom of the sump is also included on Table 1. Historical groundwater elevations are graphically represented in Appendix C.
