From: Dave LaCrosse <davel@pagelsponderosa.com>
Sent: Friday, November 03, 2017 11:48 AM
To: Gruen, Andrea M - DNR
Cc: Joslin, Richard R - DNR
Subject: 10/30/17 manure spill

From: Joslin, Richard R - DNR
Sent: Tuesday, October 31, 2017 9:14 AM
To: DNR DL NER SIGNIFICANT SPILL; Wozniak, Ryan J - DHS; Chronert, Roxanne N - DNR; Sager, John E - DNR; Stoll, Richard C - DNR; McLennan, Robin - DNR; Meronek, Thomas - DNR; Burton, Kyle - DNR
Cc: Gruen, Andrea M - DNR; Jones, Casey L - DNR; Betsy_Galbraith@fws.gov; Gansberg, Mary K - DNR; Legler, Nicholas D - DNR; Uvaas, Benjamin J - DNR; Schmitt Marquez, Heidi S - DNR; Carviou, Erin E - DNR; Davina Bonness; Olson, Beth J - DNR; Romback-Bartels, Jean - DNR
Subject: FW: WI SPILL #12095 ID 20171030NE31-1 - MANURE [MANURE]

SERTS ID:
20171030NE31-1

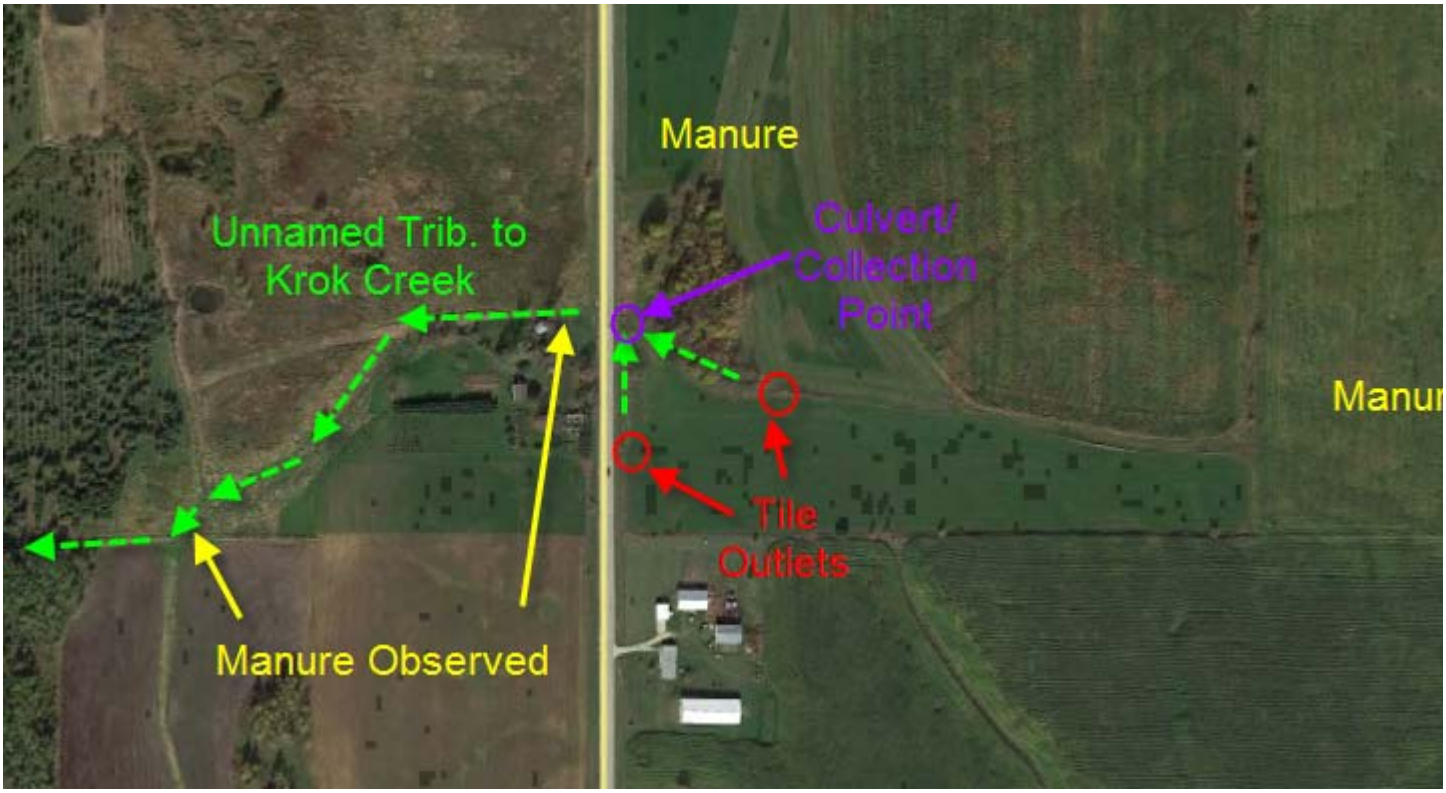
I met with Paul at 2:45 p.m. at the unnamed tributary to Krok Creek at CTH B and walked the intermittent stream to the west approximately 900 feet. The waterway appeared brown and opaque throughout this entire section. The downstream portion of the waterway at CTH F, just prior to the confluence with Krok Creek, was clear as of 4:45 p.m. Dave LaCrosse of Pagel's Ponderosa was immediately notified, and two tile outlets on the east side of CTH B were identified as the sources of manure-laden water. Pagel's Ponderosa plugged the two tile outlets that were discharging manure and had two vacuum tankers out (one from Pagel's and one from Timmar Sanitation) to begin removing the manure-laden water from the waterway at the time of my departure at 4:45 p.m. Prior to departure I confirmed with LaCrosse that he is aware of the farm's responsibility to continue collecting manure-laden water until the waterway begins to run clear again. Water samples were collected at the road culvert along CTH B and will be sent to the State Lab of Hygiene for analysis.
