Re: Wisconsin Power and Light Reportable Spill
3123 South 9th Street, Sheboygan, Sheboygan County

SPILL REPORT - ENERGY DELIVERY

SPILL RESPONSE REPORT

Incident Description:
Pad mounted transformer

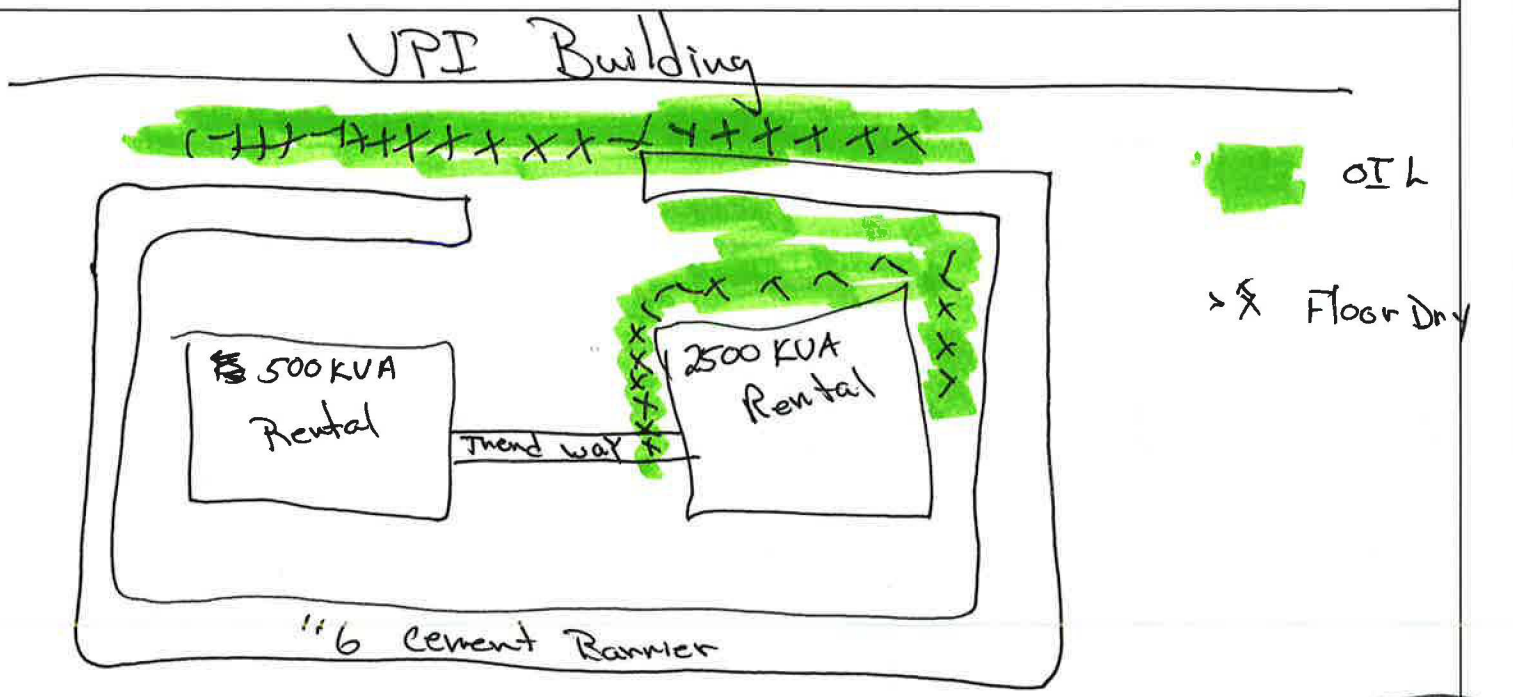
SKETCH

Vault under (A)

Pumped oil from Vault

Pads used to absorb oil in water mix

water-oil mix 40 Gal
