STREAM CLASSIFICATION SURVEY ON WILLIAMS CREEK AND AN UNNAMED TRIBUTARY BELOW STAUFFER CHEESE, BLUE MOUNDS, WISCONSIN

Department of Natural Resources - Madison Area November, 1985 Prepared by Dave Marshall

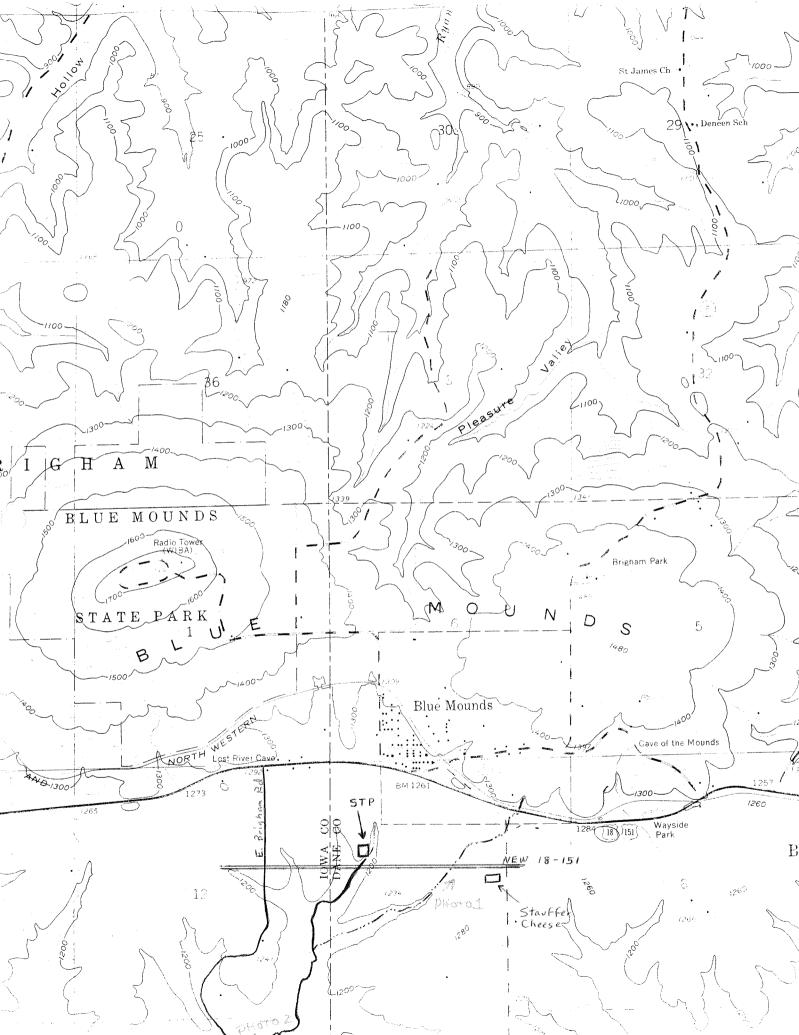
UNNAMED TRIB.

The intermittent tributary which runs west of Stauffer Cheese to the confluence with Williams Creek was dry when inspected on October 8, October 31, and November 5, 1985. The intermittent nature of this drainage course cannot support permanent aquatic communities. Therefore, the classification of the tributary is marginal (MARG-E).
