Site Investigation

April 2010

Prepared For City of Chilton 42 School Street Chilton, WI 53014

Former Larsons Dry Cleaners Site Property Located at 317 East Main Street Chilton, Wisconsin

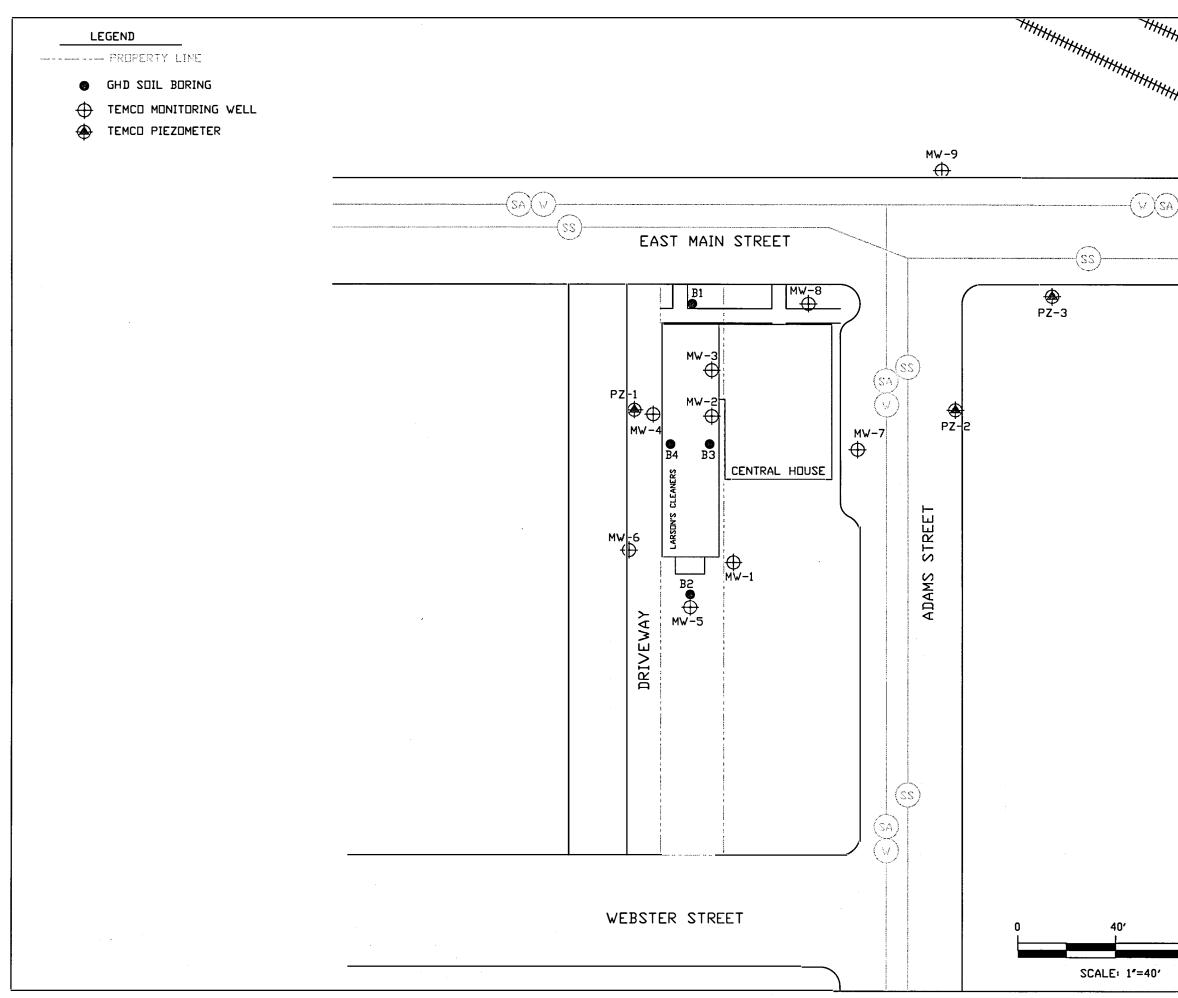
PZ-4 FIGURE 2 SOIL BORING & MONITORING WELL LOCATIONS N 80' THE ENVIRONMENTAL MANAGEMENT COMPANY LLC DRAWN BY: TJM DATE: 04/12/10 LOCATION: LARSON CLEANERS CHILTON, WISCONSIN

The site is a 0.15 acre, rectangular property located on the south side of East Main Street (Figure 2). It is bordered by East Main Street and commercial/industrial properties to the north, a restaurant and parking lot to the east, an unpaved extension of Webster Street and residential properties to the south, and a City owned unpaved lot and commercial properties to the west.

The initial scope of work for the site investigation consisted of drilling, logging, and sampling eight (8) soil borings (MW-1 through MW-8) in March 2007 and constructing groundwater monitoring wells in all eight (8) borings (Figure 2). The soil borings/monitoring wells were located to determine soil conditions and soil and groundwater contaminant types and levels in the source area, in the area surrounding the on-site buildings, and in the estimated direction of groundwater flow (east - northeast).

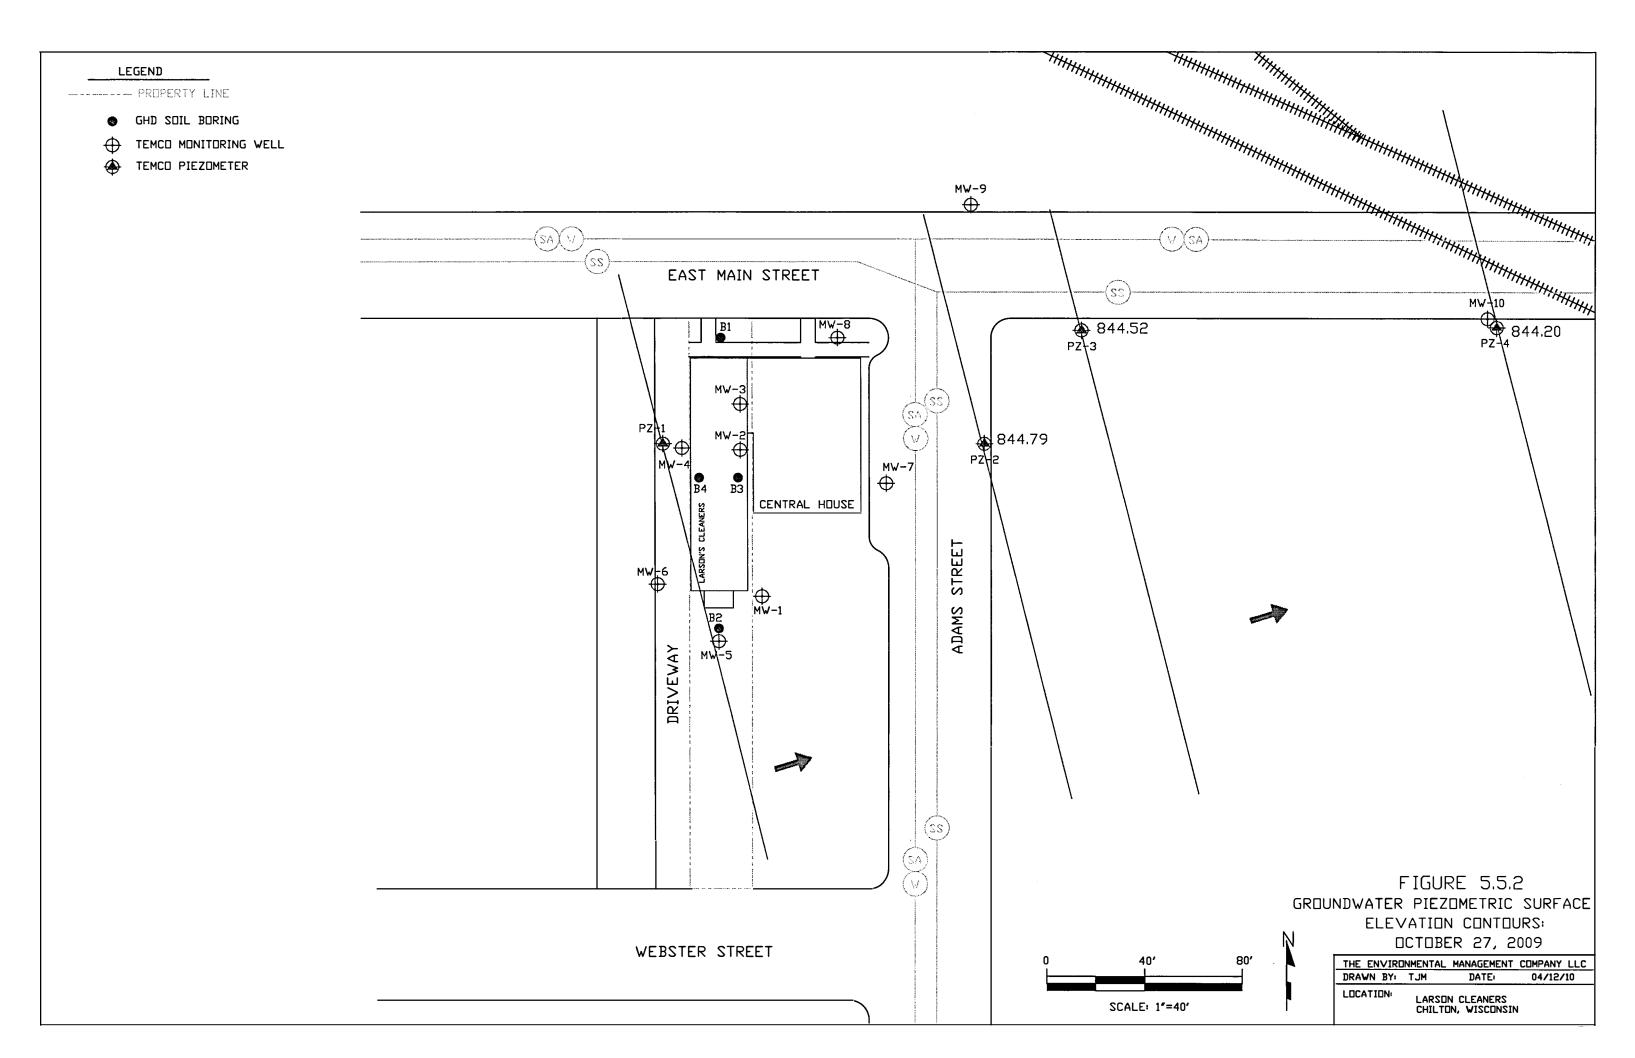
844.65^{MW-10} PZ-4 FIGURE 5.5.1 GROUNDWATER TABLE ELEVATION N CONTOURS: OCTOBER 27, 2009 80' THE ENVIRONMENTAL MANAGEMENT COMPANY LLC DRAWN BY: TJM DATE: 04/12/10 LOCATION LARSON CLEANERS CHILTON, WISCONSIN

The groundwater elevation data (Table 5) collected from the ten (10) monitoring wells (MW-1 through MW-10) during the five (5) monitoring events completed show a consistent direction of groundwater flow from the source area on the site to the east-northeast. Two (2) anomalous conditions appear on the groundwater elevation/flow direction figures for the water table monitoring wells (5.1, 5.2, 5.3.1, 5.4.1, and 5.5.1):

These anomalies are likely caused by one(1) or more of three (3) local features:

3) Variation in shallow soil conditions combined with a mixture of paved and non-paved areas surrounding the site may produce localized groundwater elevation anomalies as the water table responds to precipitation events and seasonal change.
