**From:** Byers, Harris <Harris.Byers@stantec.com>  
**Sent:** Wednesday, May 20, 2020 1:08 PM  
**To:** Van Der Kloot, James; Beggs, Tauren R - DNR; Adam Tegen  
**Subject:** Supplemental UST Assessment - 1512 Washington Street  
**Attachments:** UST Assessment.pdf

May 18, 2020  
File: 193706270

**Reference: Supplemental Underground Storage Tank Assessment**  
**Former Mirro Facility**  
**1512 Washington Street**  
**Manitowoc, Wisconsin**  
**BRRTS ID: 03-36-274209 (Closed LUST)**  
**USEPA ACRES ID: 169132**

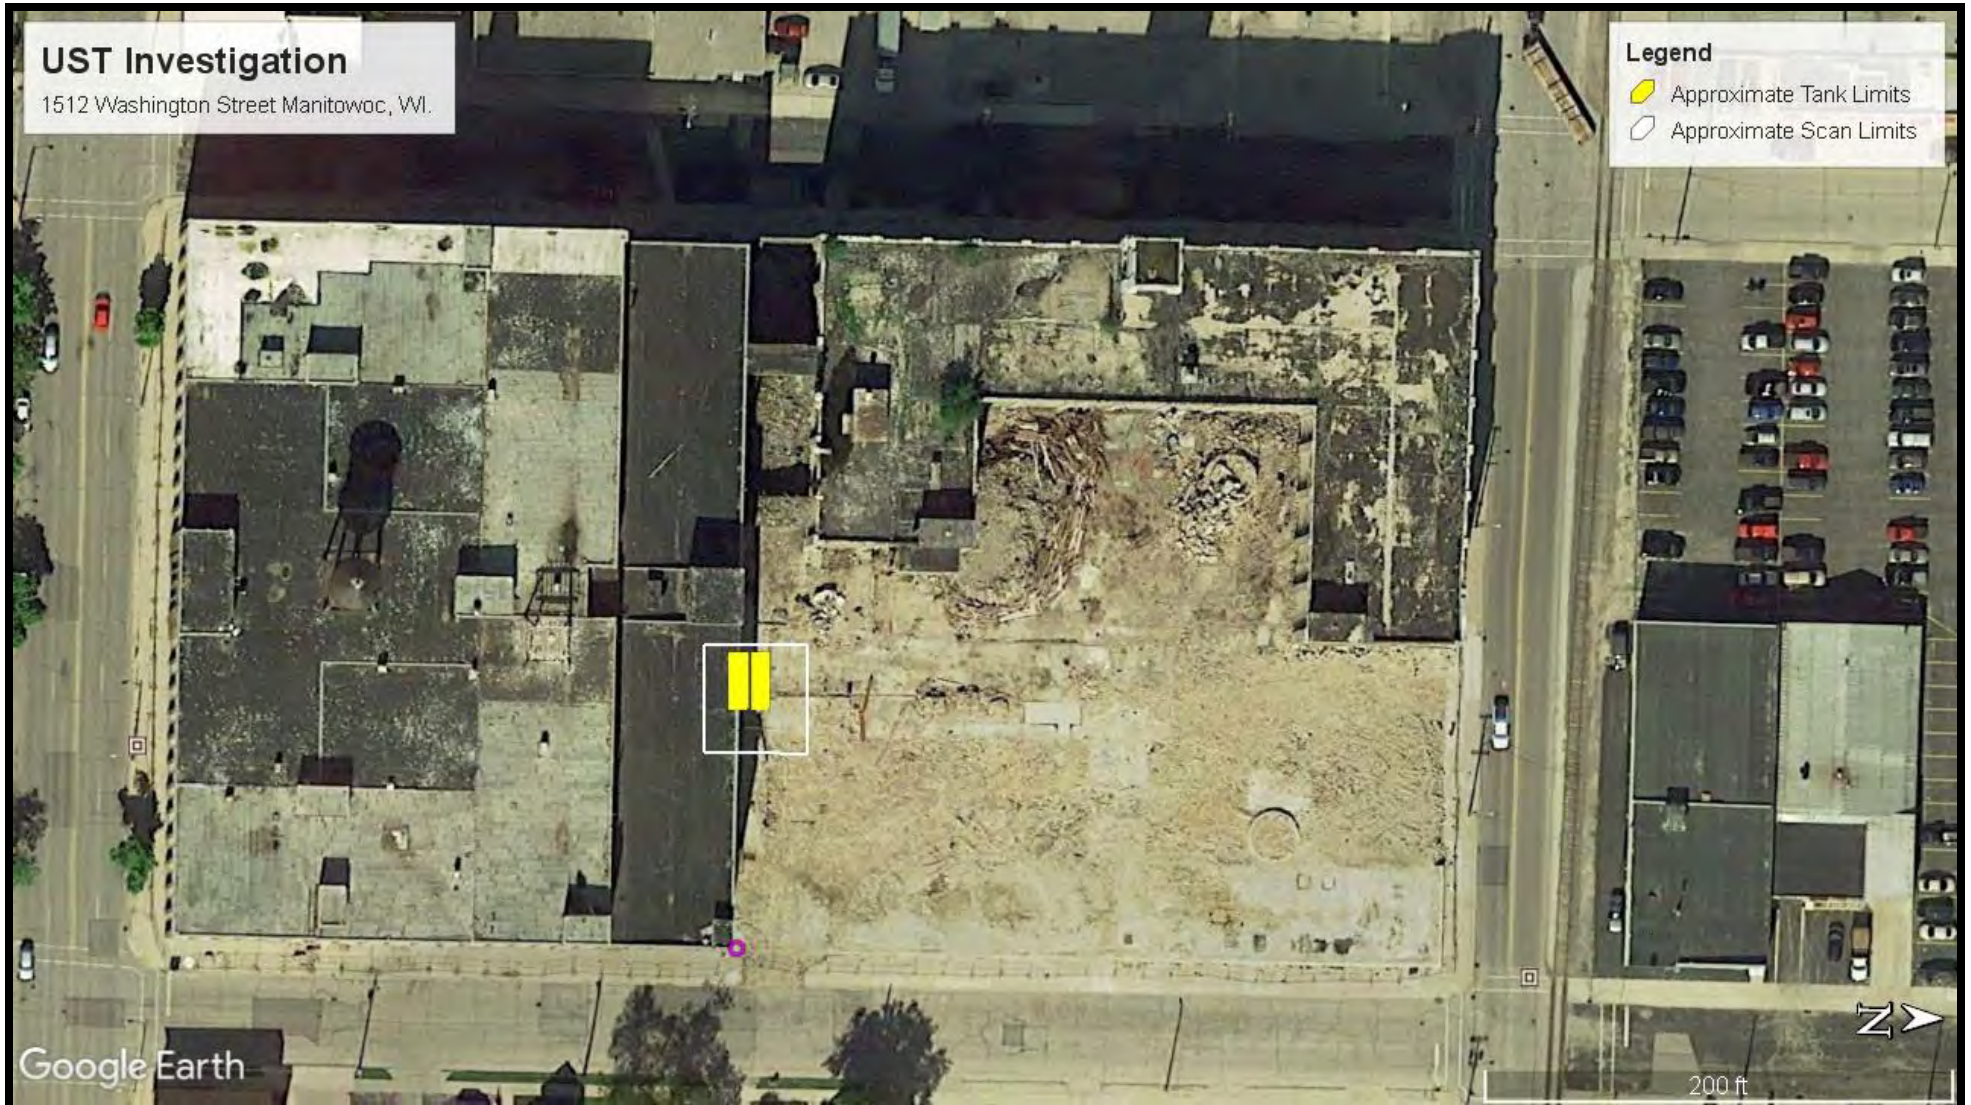
Approximate Scan Limits

On May 12, 2020, GPRS completed a geophysical survey using GPR of an approximately 2,000 square foot area where two possible tank anomalies had been identified during previous geophysical surveys. In summary, GPRS identified two subsurface anomalies consistent with USTs. The anomalies were marked in the field with yellow paint and were consistent with the locations of the two western USTs (UST 3 and UST 4; Figure 2) suspected to remain at the Property (Attachment A, Photo No. 1). The survey noted that the top of the suspected tanks was approximately 1.5 feet below grade. The GPRS scan included the area east of UST 3 and UST 4, but did not identify anomalies consistent with tanks. GPRS also investigated a manhole approximately 80 feet east of the scan area and observed piping of unknown nature that was unable to be traced using GPR or electromagnetic (EM) technologies.
