August 21, 2009

KPRG Project No. 10009

**AS-BUILT REPORT FOR DERF REMEDIAL ACTION
FORMER BASK DRY CLEANERS
WESTBROOK SHOPPING CENTER
WAUKESHA, WISCONSIN**

**BRRTS # 02-68-297669
FID # 268188800**

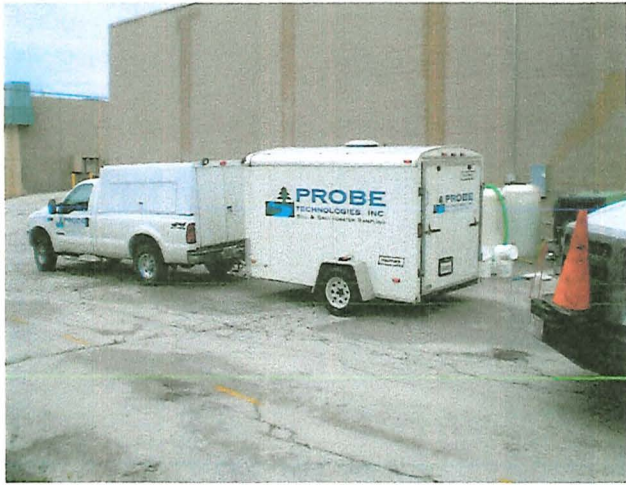
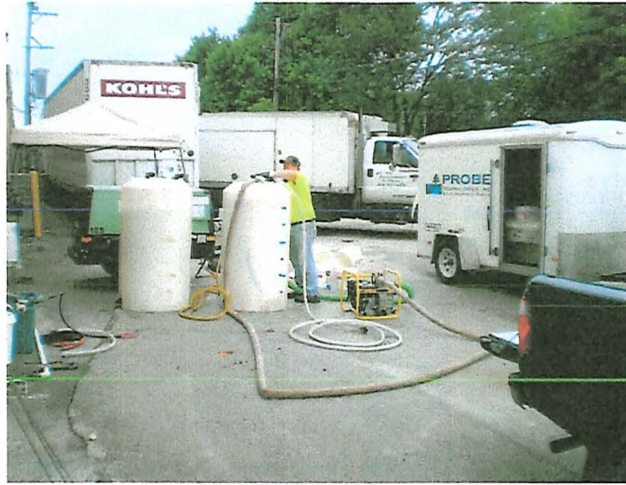
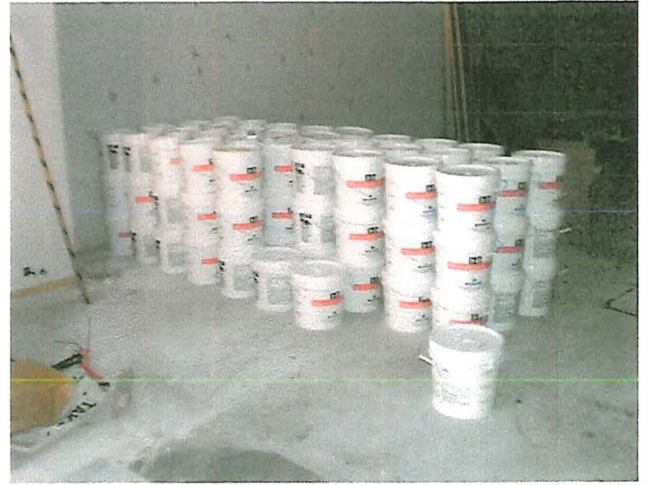
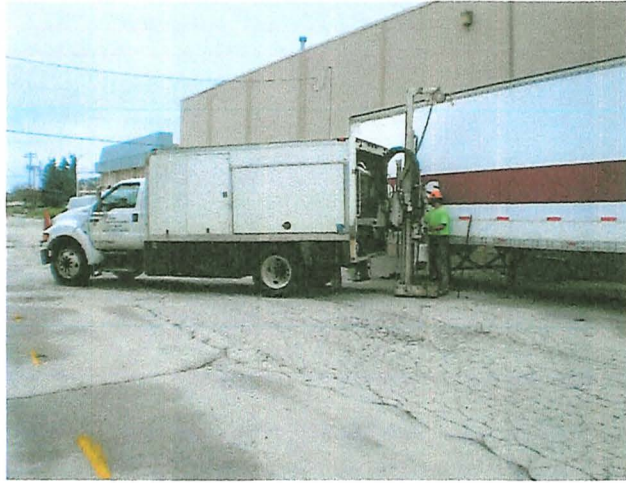
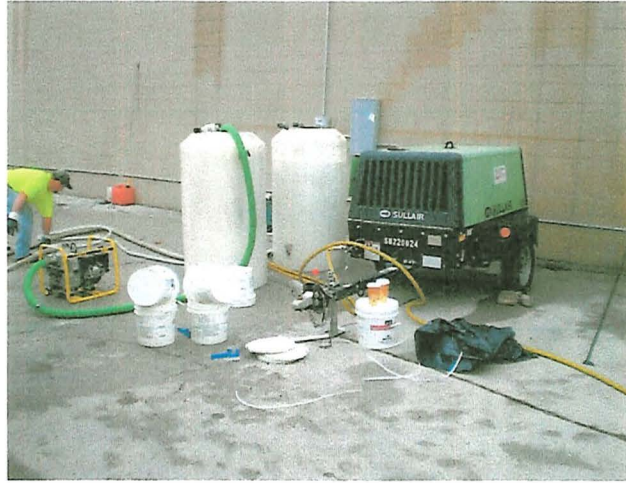
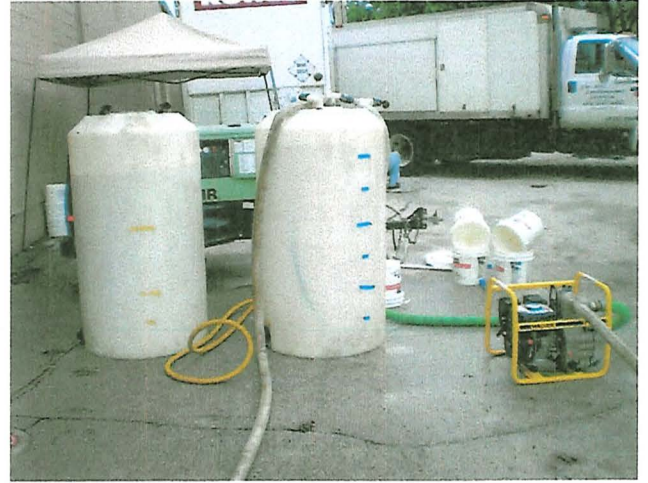
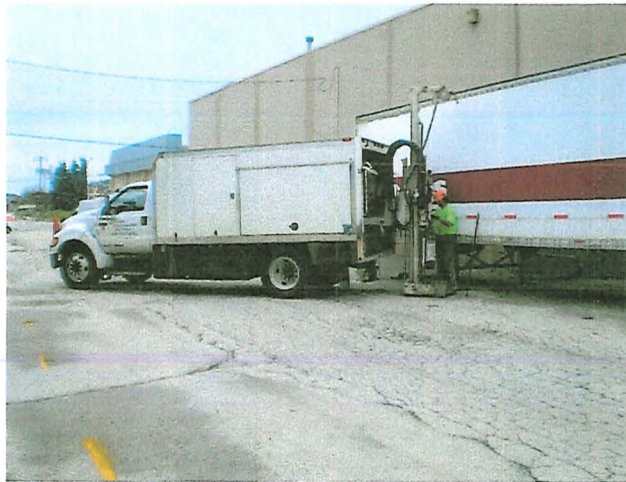
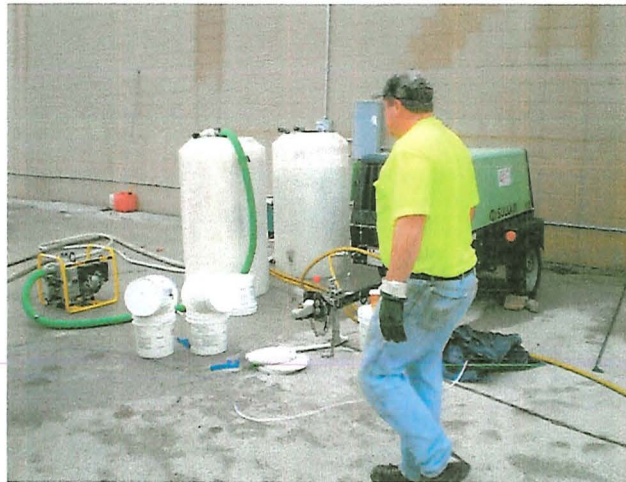
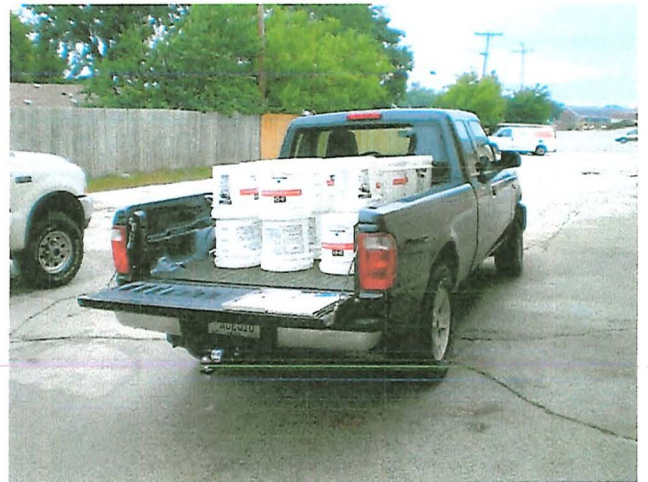
APPENDIX B
Injection Photodocumentation

It was noted during individual injections that the adjoining point was being influenced (points were spaced approximately 15 feet apart). This field observation suggests that sufficient radius of injection influence was occurring laterally within the formation. Photodocumentation of the work is provided in Appendix B.

The HRC injection was performed from July 10 through July 15, 2009. A total of 12 injection points were used (the proposal specified 10 injection points, however, based on the layout of the site in the field and the actual well locations, the injection line was extended by one point in both directions). The trace of the injection line is provided on Figure 2. It is noted that the points on the northwest side of the injection line were moved slightly north of the initial proposed locations. This was due to the presence of an outside semi-trailer, converted to a storage unit, which is being used by Kohl's for inventory as well as utility lines previously unknown. After inspection of the unit by Kohl's logistics personnel, it was determined that if the trailer was to be moved, it would probably be severely damaged and would at that point be unusable in the future. It was decided to relocate the affected points slightly to the north to preclude incurring substantial costs for replacing the storage unit if damaged. The relocation of the points will not impact the overall effectiveness of the remedy.
