Site Inspection - 10/3/18

# Former Koppers Inc. Facility – Superior, WI

**Post Construction Site Inspection Form**  
**Beazer East, Inc.**  
**Koppers Inc. Facility, Superior, Wisconsin**

Inspection Date: 10/3/18

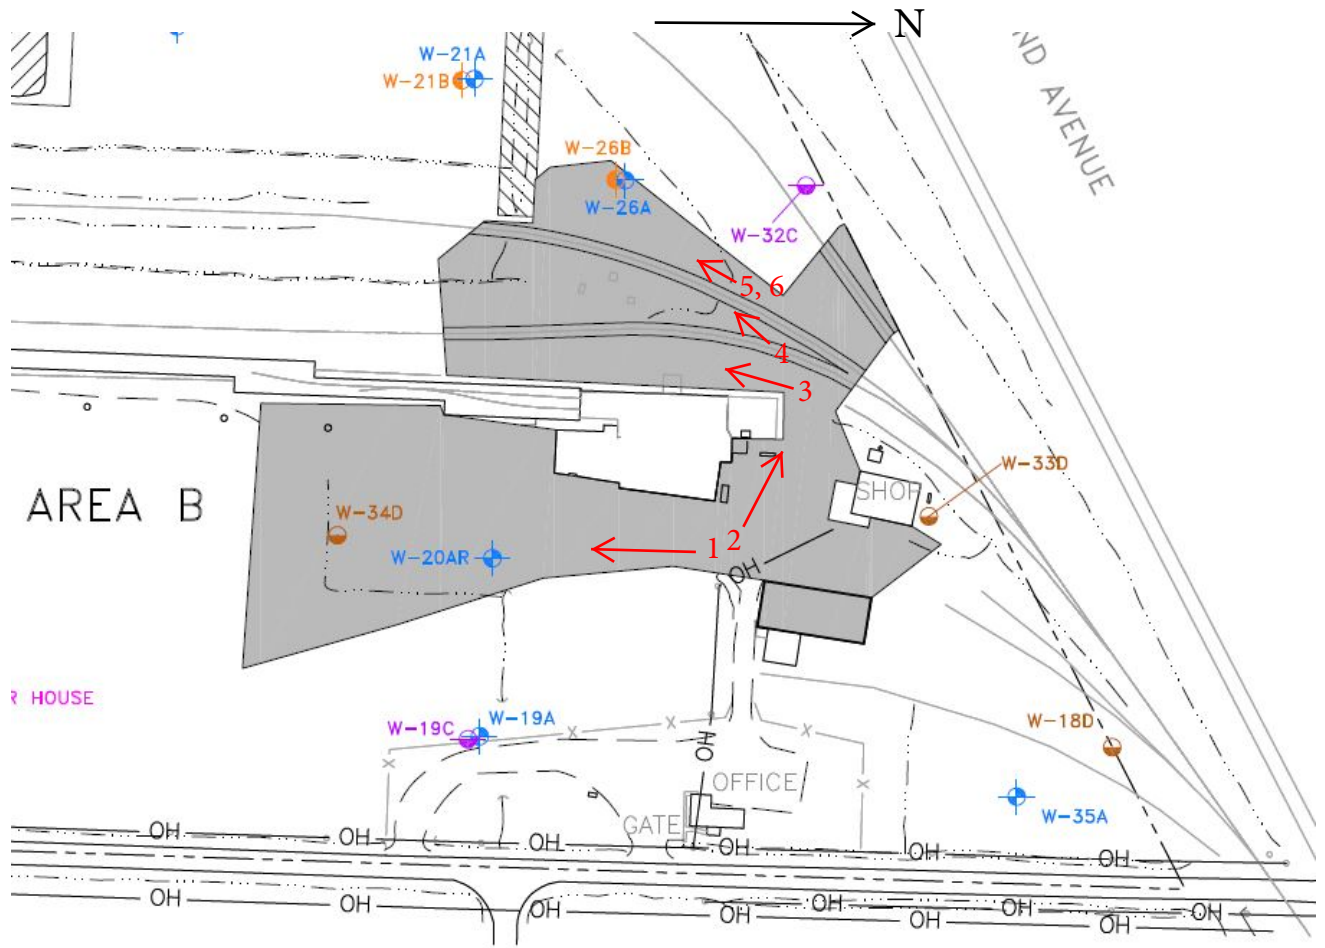
# Area B:

(check one)	No	Yes	If yes, provide description and take photos
Excessive erosion	X		
Evidence of excessive settling or ponding		X	<u>ruts on western area, photos 5+6</u>
Areas lacking well-established vegetation	X
