TS-AMD-86710-34
June 1986

AERIAL PHOTOGRAPHIC ANALYSIS OF TWO
HAZARDOUS WASTE DISPOSAL AREAS

Saukville and Stoughton, Wisconsin

*Freeman Chemical
Corp.*

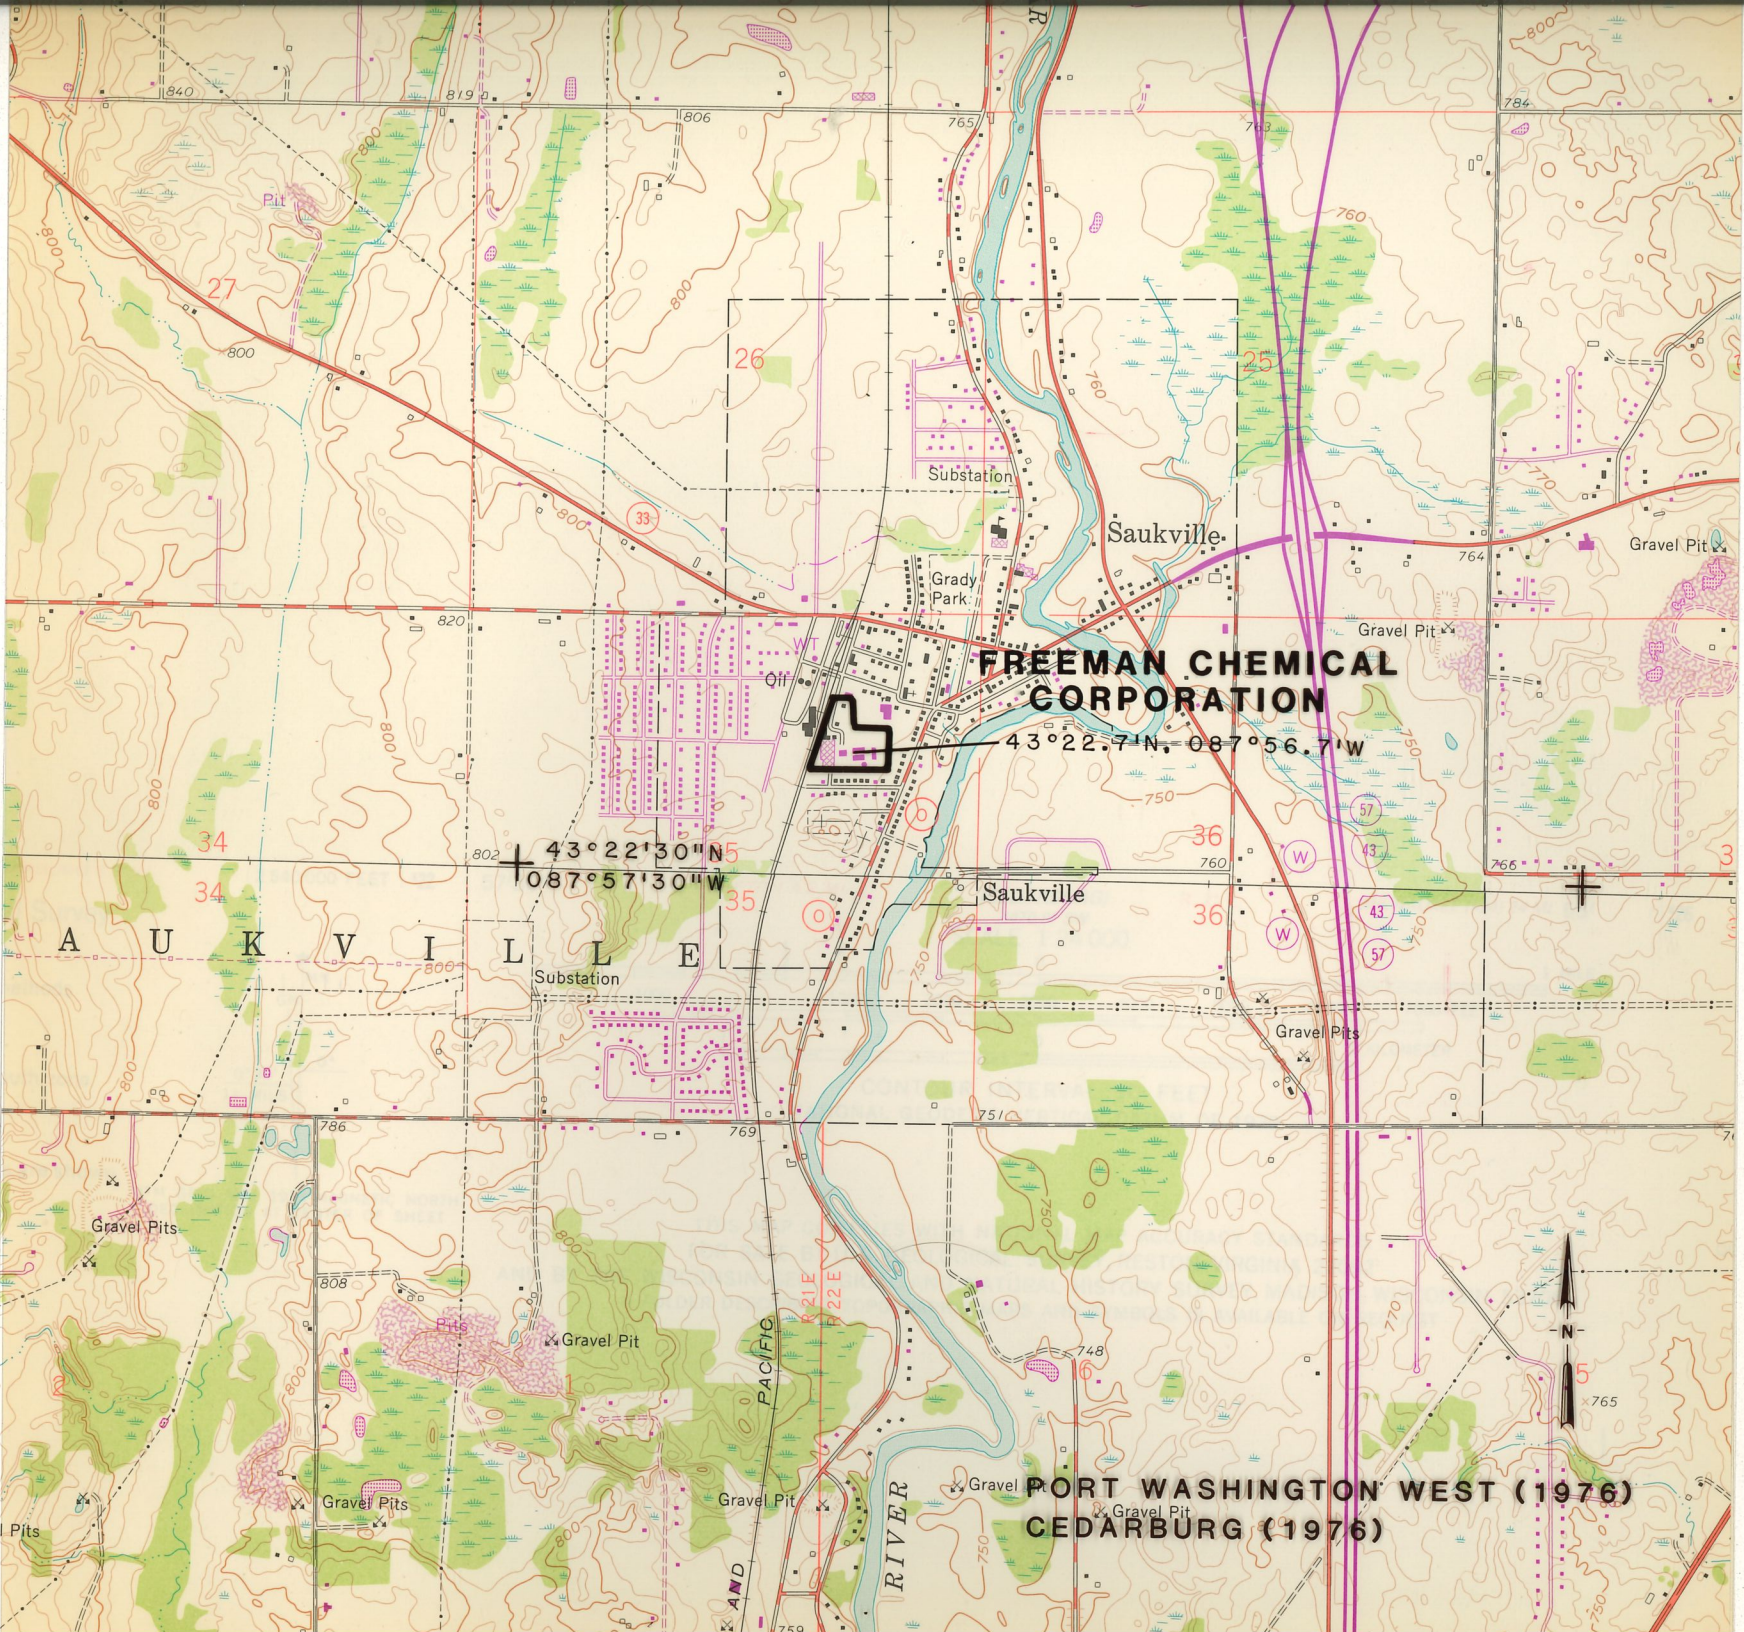
FREEMAN CHEMICAL CORPORATION

Waste disposal activities are in the northern portion of the site where there is a large incinerator (annotation A) and two dumpsters. No evidence of liquid waste lagoons is noted and there are no visible signs of spillage or leakage problems.
