Freeman Chemical Corporation  
Saukville, Wisconsin

Corrective Measure Activities

Site Construction Documentation Report

Hatcher Incorporated  
Richmond, Virginia  
Job No. 0001-003

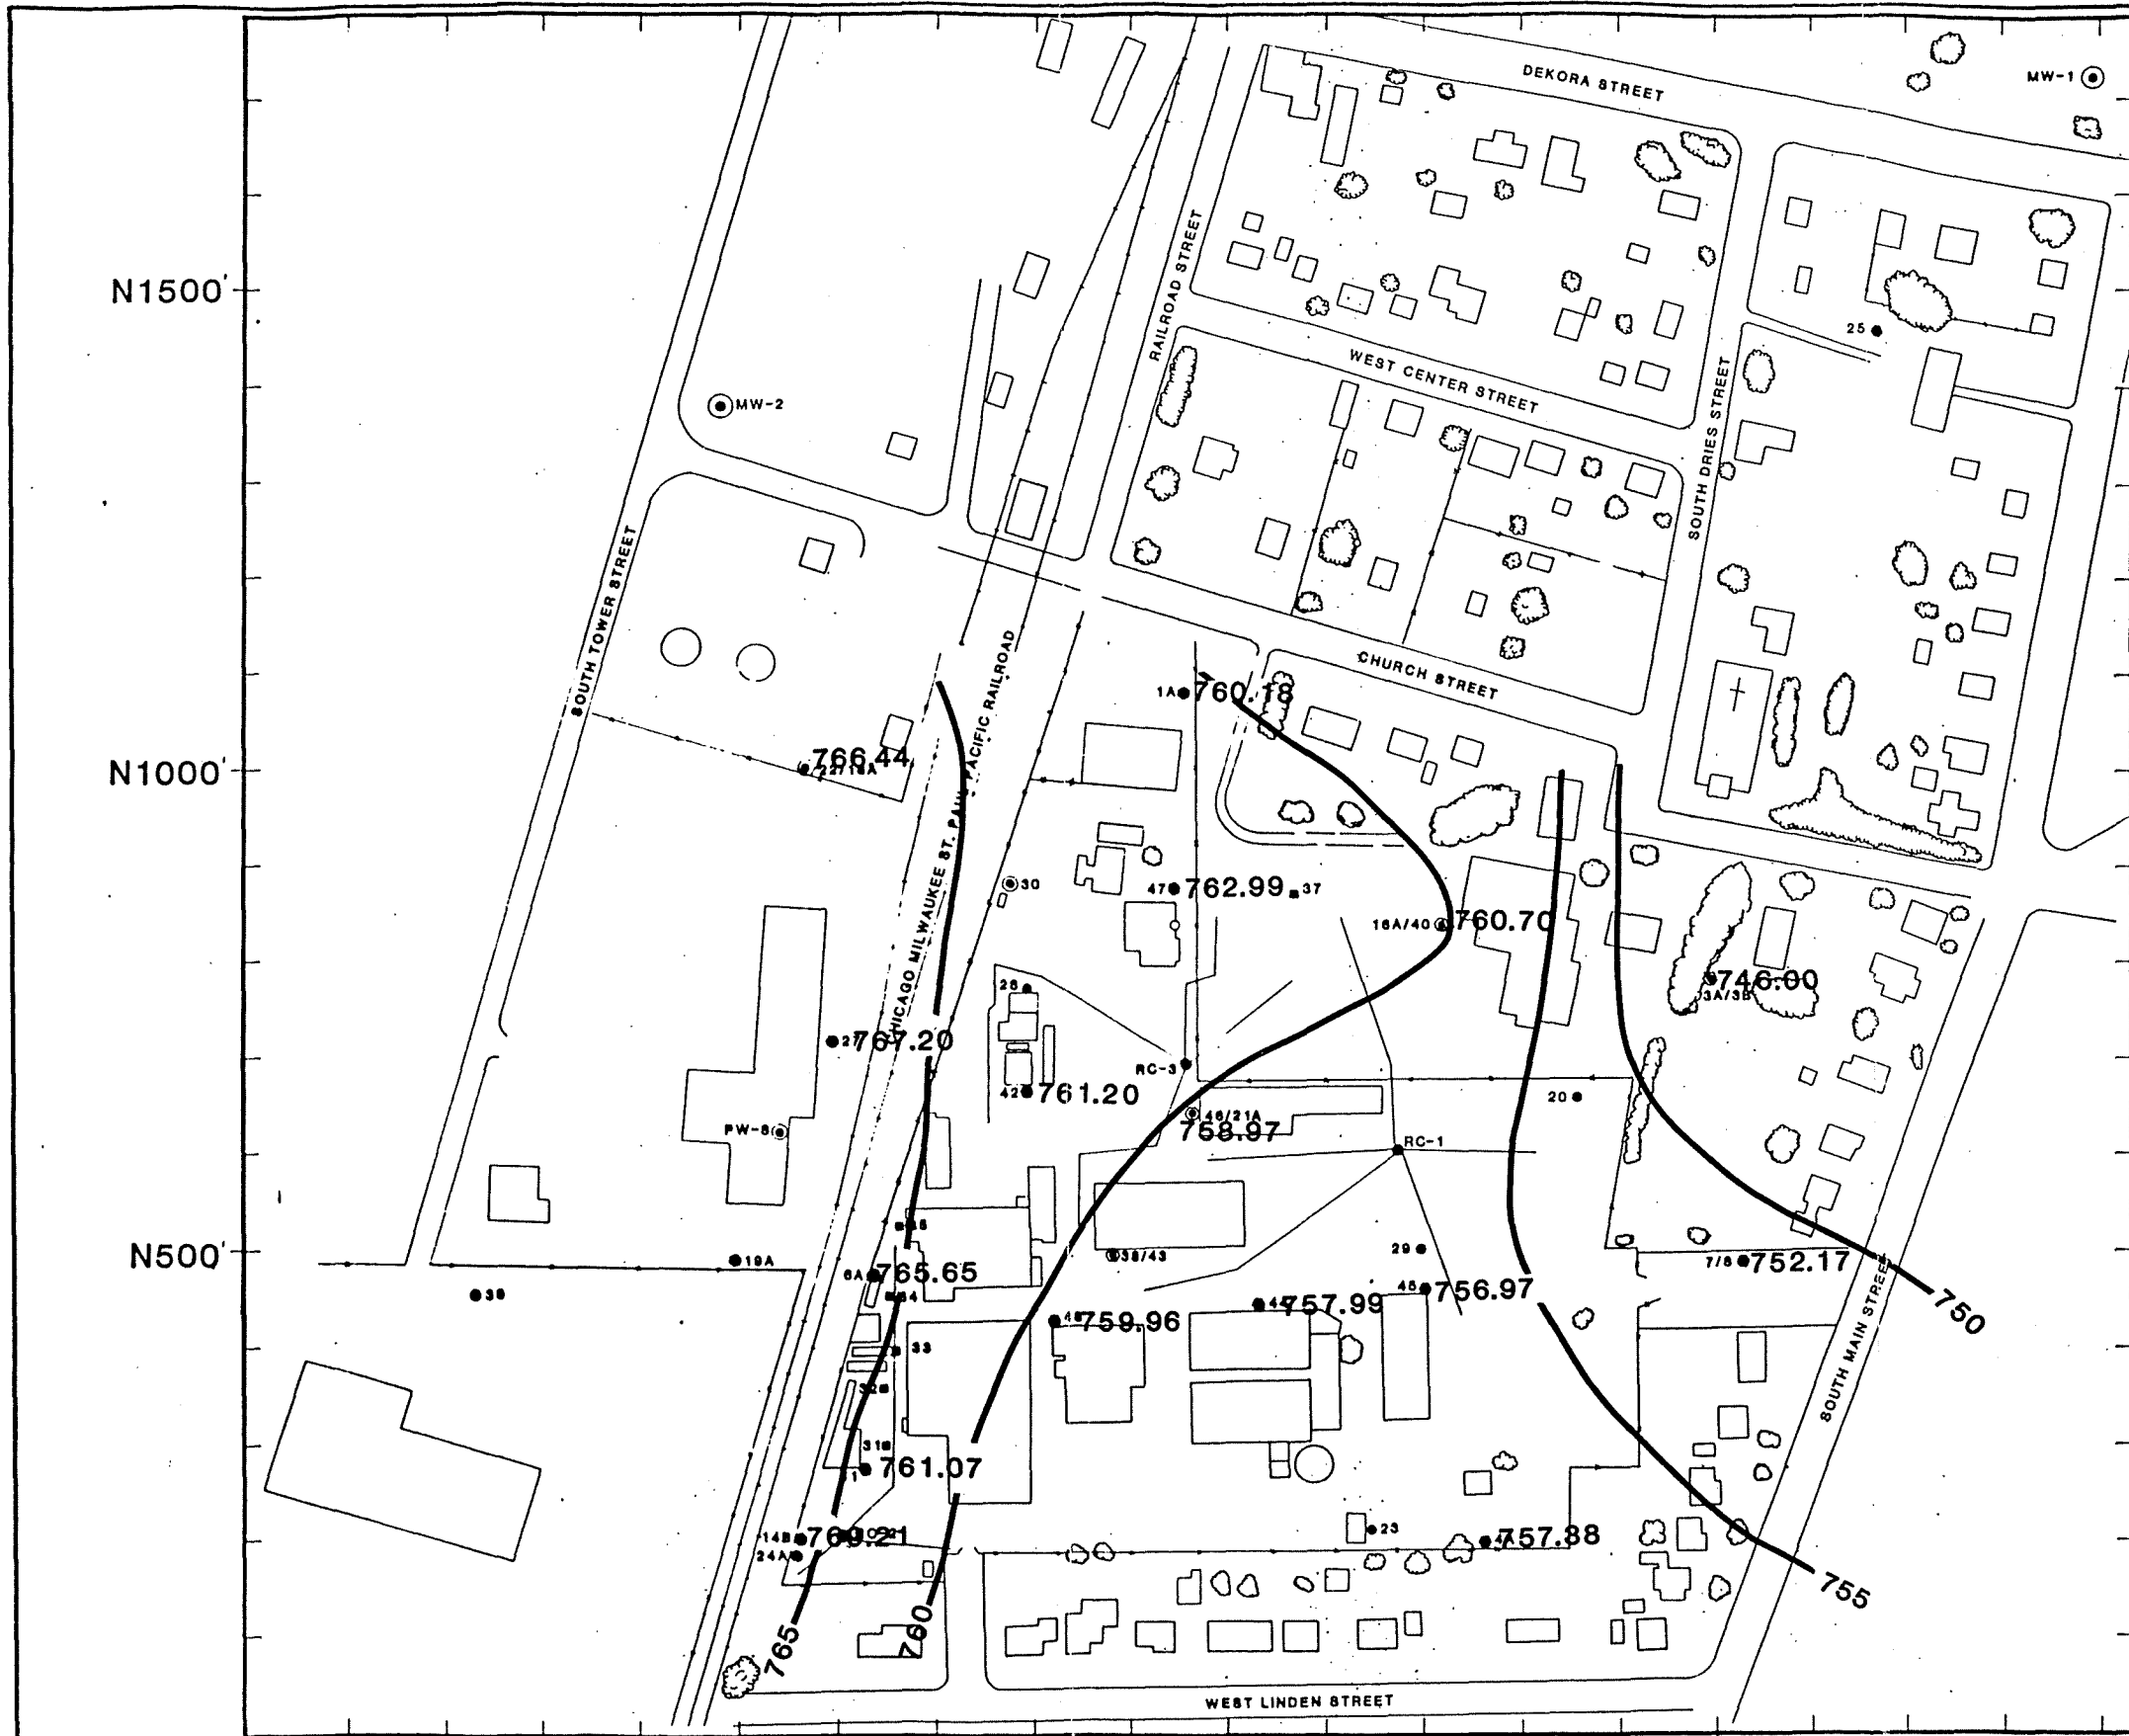
Date: 12/4/86	Fig. 1-7A	Drawn By: C.E.W.
Scale: As Noted		Approved By: G.L.B.

Recent potentiometric diagrams constructed from water level data collected from December, 1986 to October, 1987 (Figures 1-7A through 1-10A) generally indicate that the shallow groundwater continues to flow east to southeast toward the Milwaukee River. A cone of depression in the glacial aquifer is indicated from the potentiometric surface diagrams in Figures 1-8A and 1-9A. The head loss is centered around Piezometer 38, and is present in the April and June, 1986 aquifer conditions. This corresponds to the start-up of W-30 in early March and it is thought that this depression is caused by leakage of the glacial aquifer into the fractured dolomite. Many of the shallow piezometers on the site have exhibited head loss in response to pumpage of the dolomite aquifer. This effect has been noticed in the past when Well 30 has been pumped and local piezometers monitored, demonstrating a direct hydraulic connection between the two aquifers. The most recent potentiometric surface contour of the glacial aquifer shown in Figure 1-10A, also indicates a concentration of shallow groundwater flow in the area of Piezometer 38, the western part of the Freeman site. Generalized flow direction of the glacial

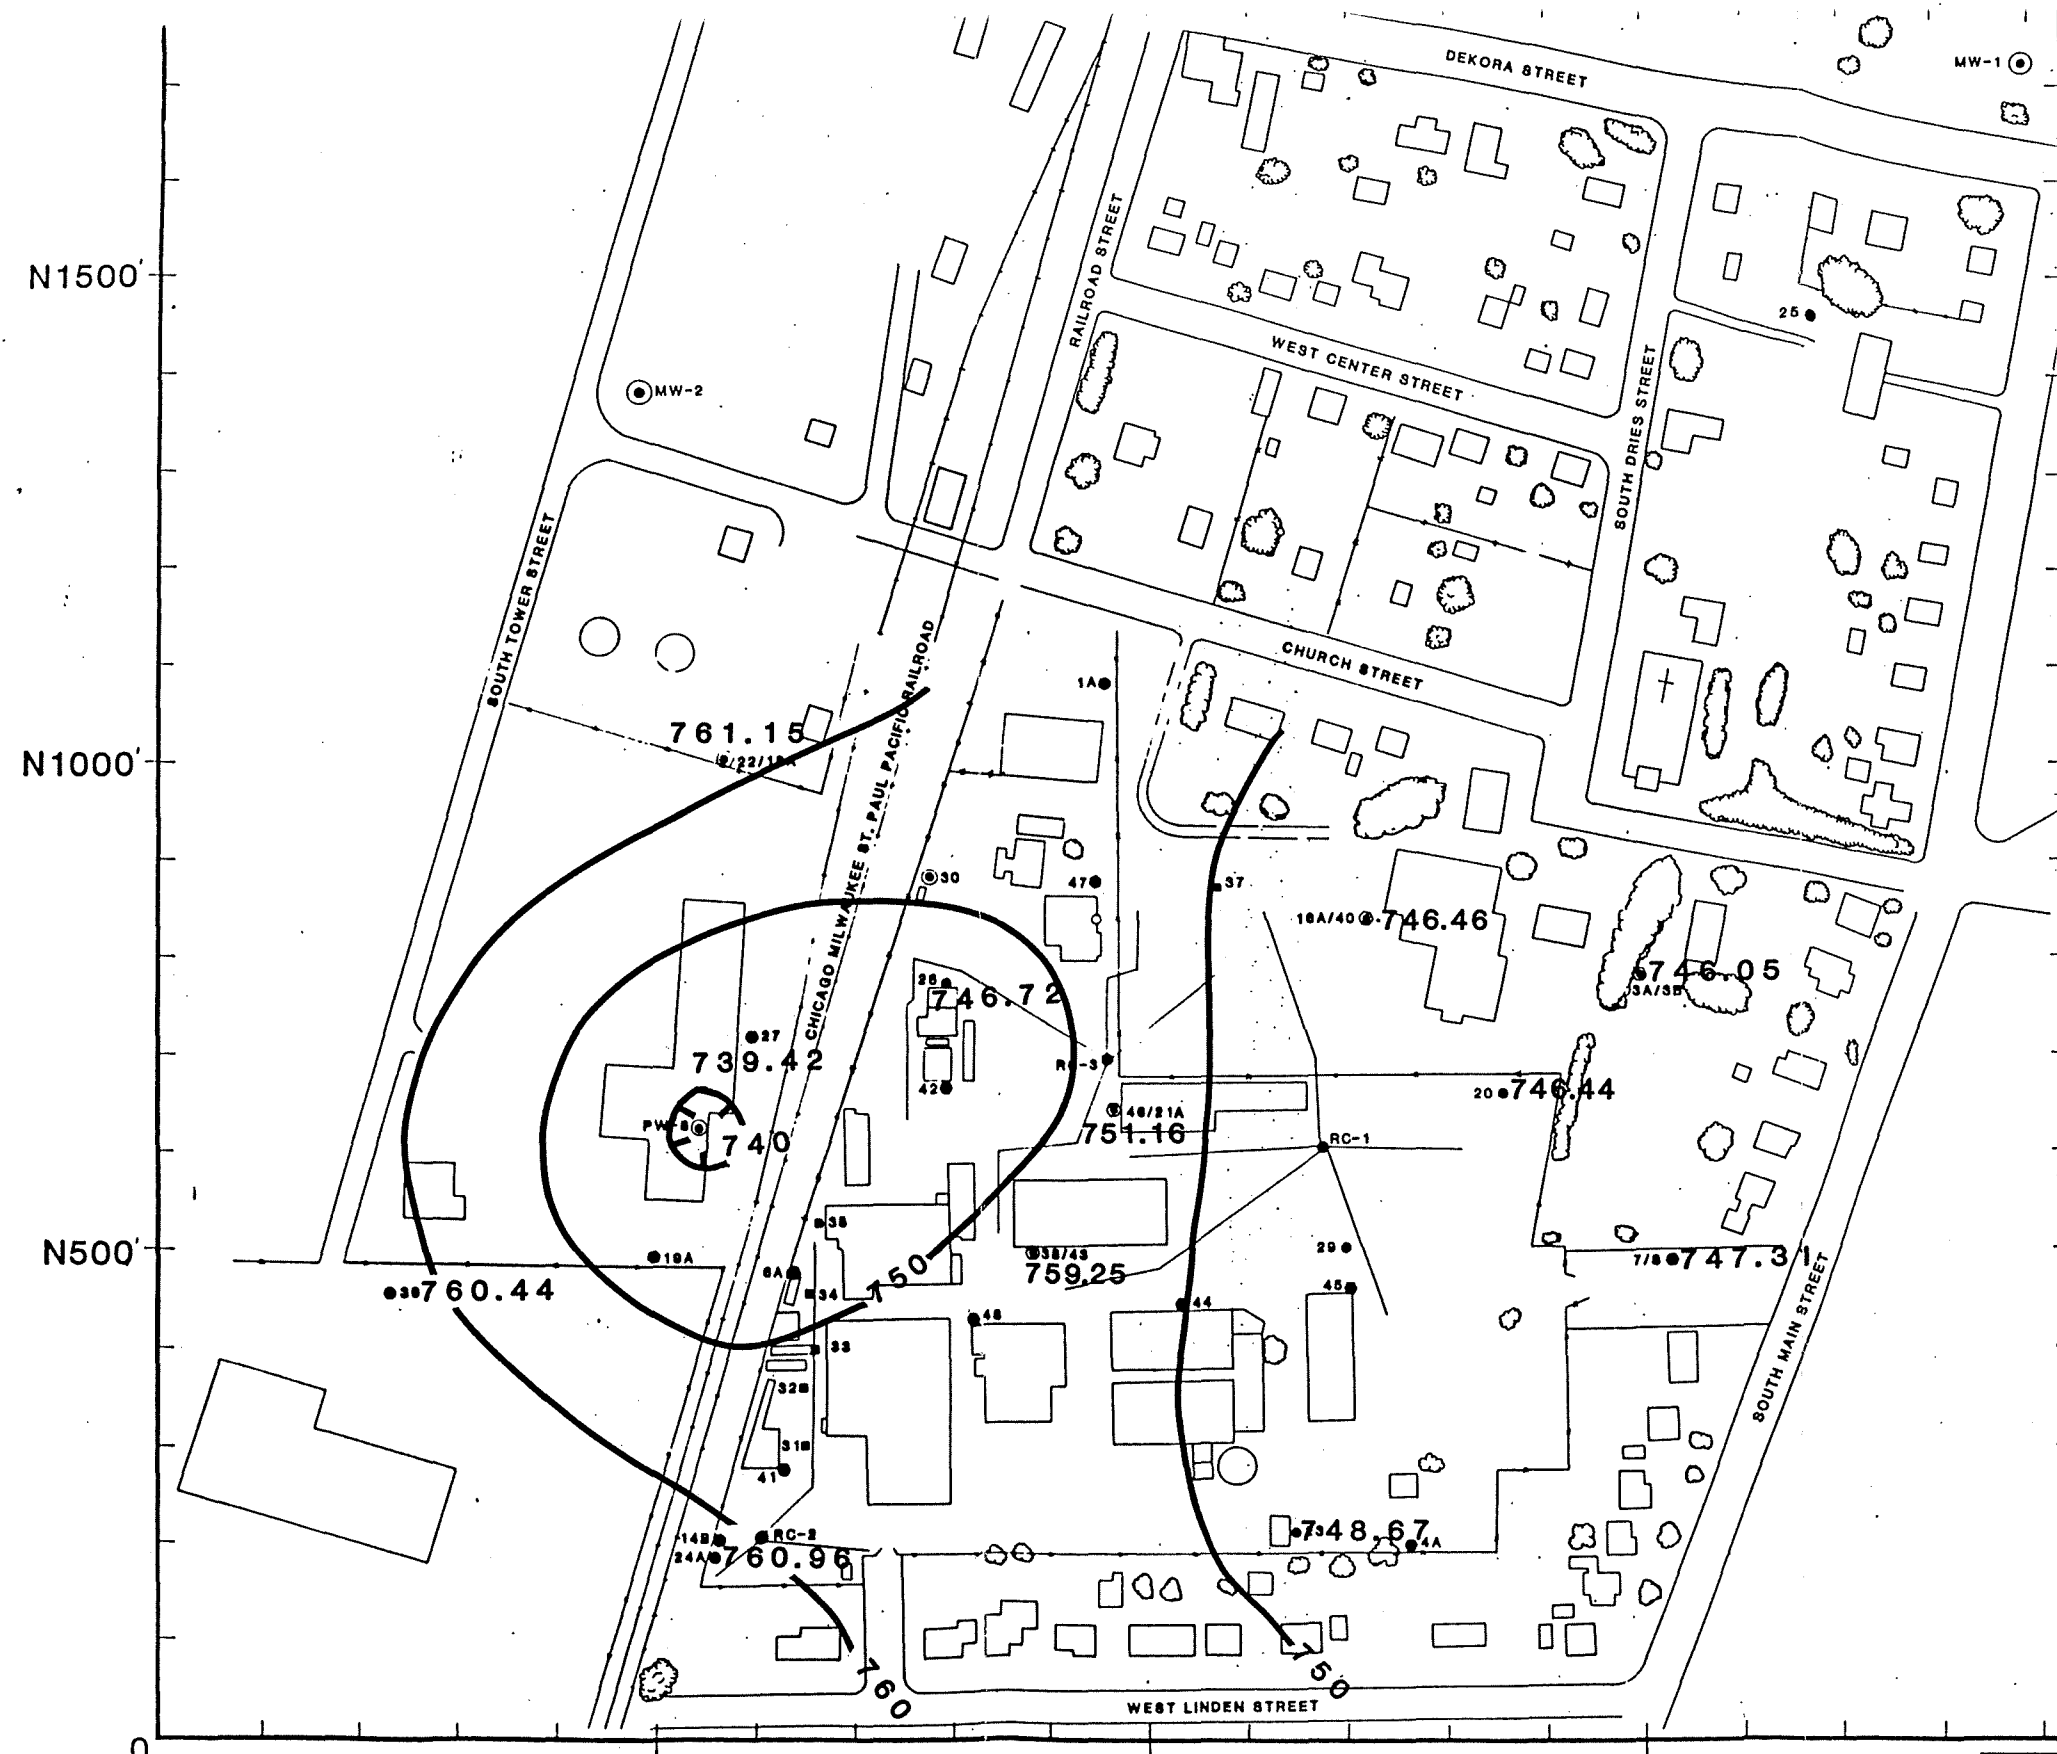
Freeman Chemical Co. Saukville, Wisconsin		
MONITORING WELL LOCATION MAP		
Date: 12/4/86	Fig. 1-11A	Drawn By: C.E.W.
Scale: As Noted		Approved By: G.L.B.
<b>HATCHER INCORPORATED</b>		
Job No.: 0001-003	1-11A6	Drawing No.: H-018

In the immediate area of the Freeman site, groundwater velocities have increased due to the effect of pumping on site. Referring to the potentiometric diagrams for the dolomite aquifer, average potentiometric gradients increase from December, 1986 to October 1987 from 0.05 to 0.11, respectively, corresponding to an increase in average groundwater velocity. The calculated velocity for the dolomite groundwater in December

Potentiometric Contour : Dolomite Aquifer.  
December 15 1986

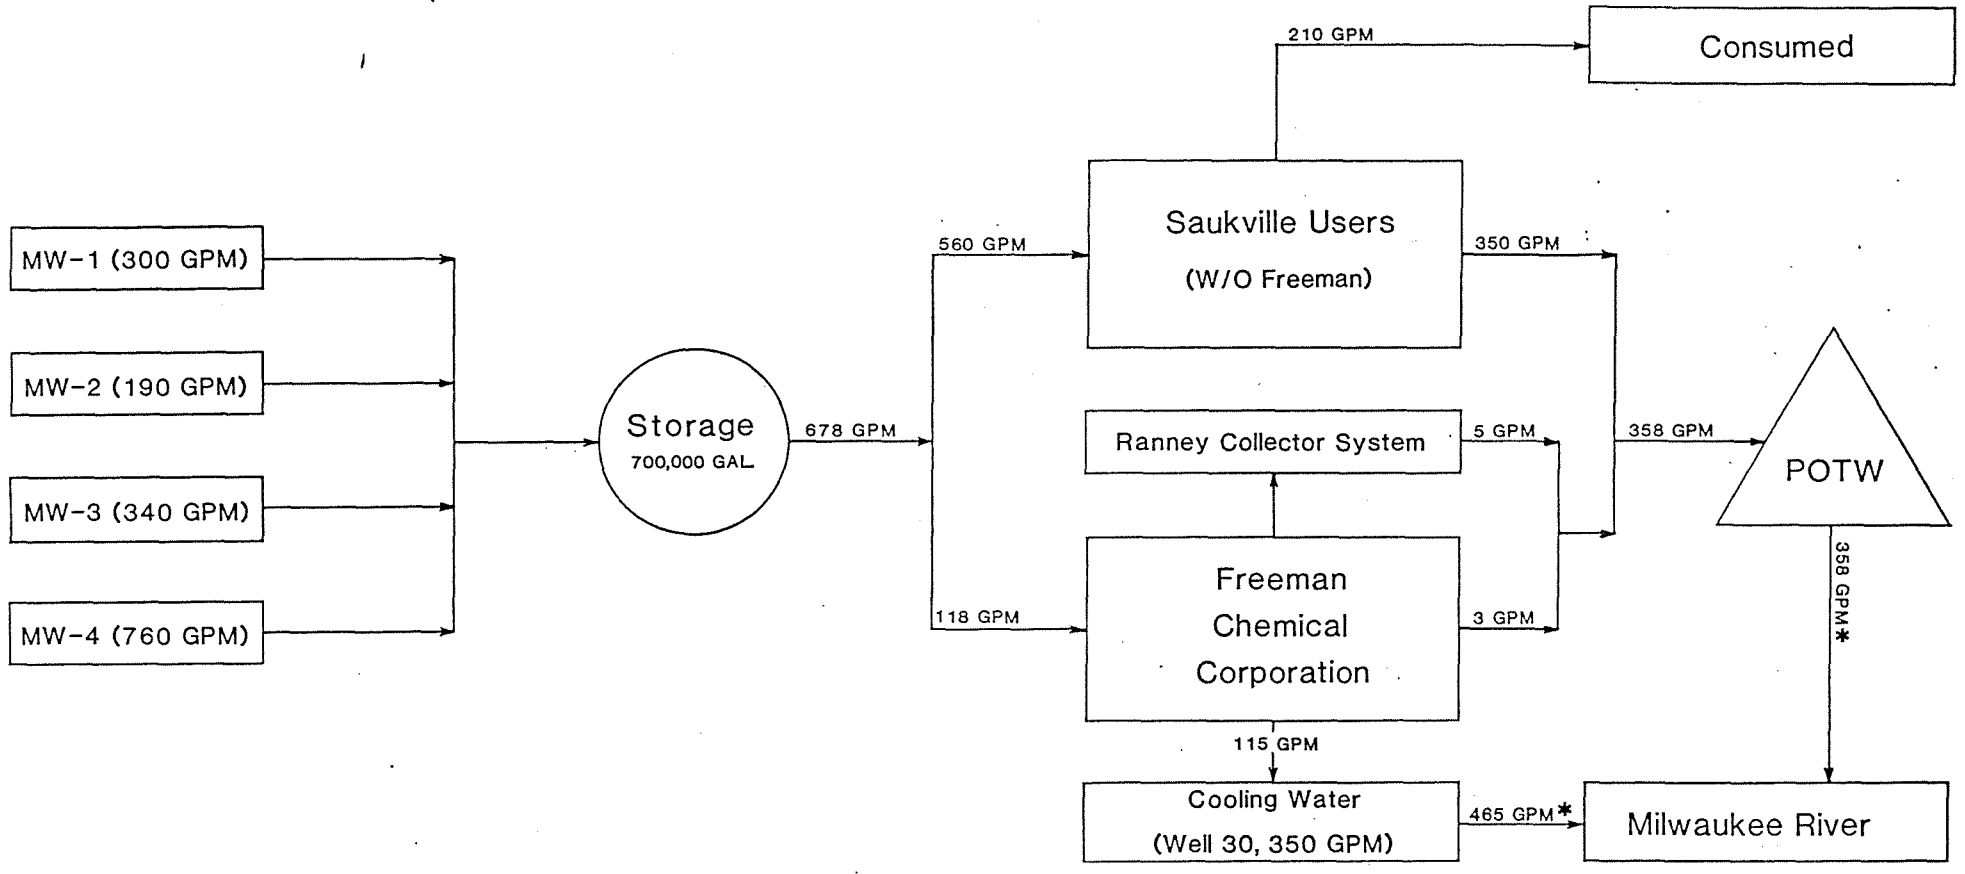
Figure 2.4A Existing Village Water Supply and Treatment.

The Village of Saukville presently has four municipal wells with a total pumping capacity of 1590 gpm. Current usage for the Village including the Freeman Plant averages 675 gpm, as depicted on Figure 2.4A, and represents approximately 42% of their total capacity or 48% of total capacity with MW-2 shut down. They have a total storage capacity of 700,000 gallons; a 400,000 gallon stand pipe and a 300,000 gallon underground tank. Their peak demand occurred during 1986 at 1.2 million gpd or about 833 gpm. This total rate has remained relatively constant over the past 3 years (1985-1987). Future known demands consist of an alum plant with a projected usage rate of 20 gpm and a couple of smaller plants with presently unknown demands. [Gerald Dickmann, Personal Communication]

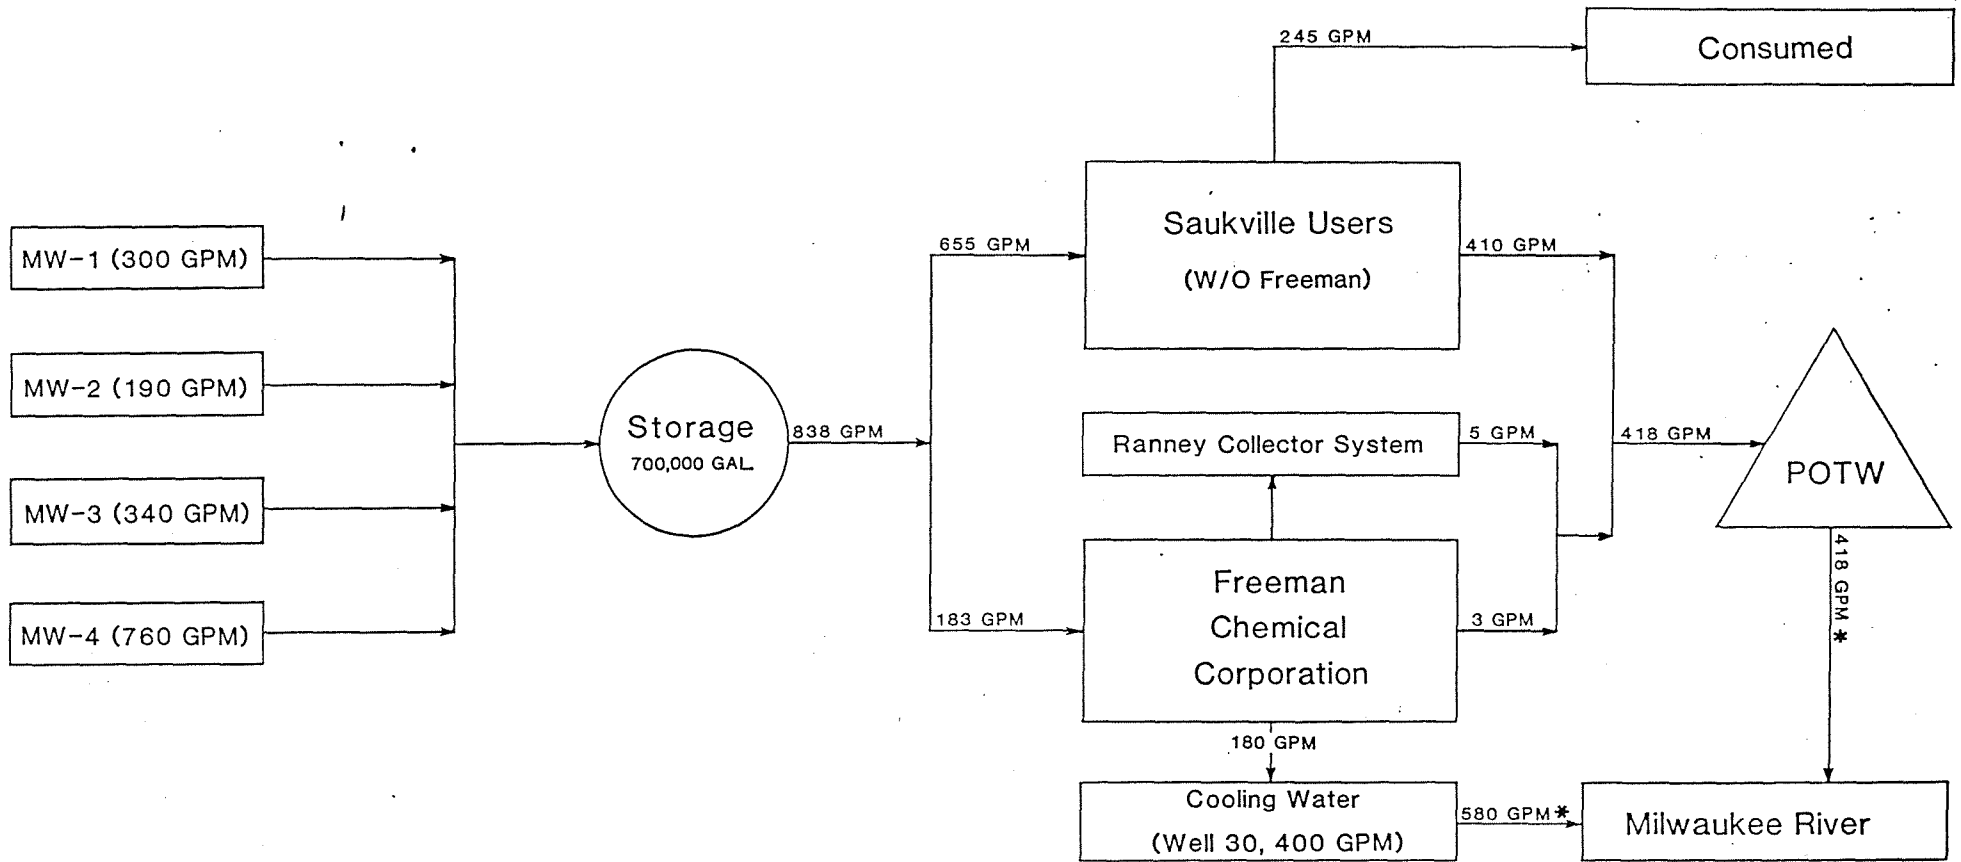
Figure 2.5A Five - Year Projected Village Water Supply and Treatment.

This future water demand scenario has been depicted in Figure 2.5A. The estimated future demand of 838 gpm represents approximately 53% of the current total capacity of the Village and nearly 60% of the capacity with MW-2 shut down. The projections indicate that if MW-4 is out of service for more than 2 days, MW-2, if possible, would have to be brought on-line. Extensive pump tests are scheduled for this next year that are to provide input for a mathematical model which will indicate interactions between the groundwater remediation pumping and the Village wells. The projected 418 gpm to be treated by the Saukville POTW 5 years from now represents about 60% of the current plant treatment capacity.
