# Five-Year Review Report

Third Five-Year Review Report
for
Ripon City Landfill
(a/k/a Ripon FF/NN Landfill)
Town of Ripon, Fond du Lac County, Wisconsin

September 2011

Prepared by:
Wisconsin DNR for the
United States Environmental Protection Agency
Region 5
Chicago, Illinois

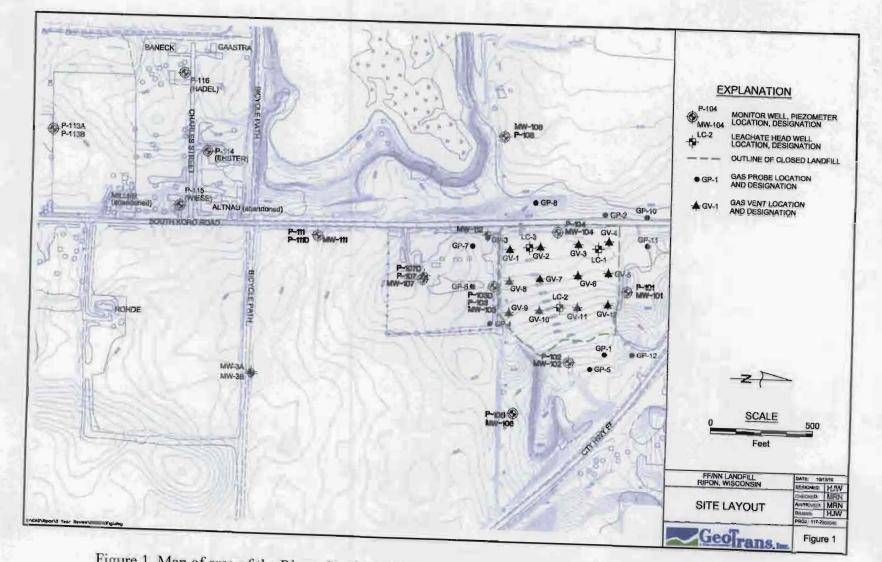
Figure 1. Map of area of the Ripon City Landfill site showing sampling locations (source: GeoTrans, Inc.)

The MW wells listed above are water table wells that are located near the landfill. In the two well nests (107 and 111) located some distance from the landfill toward the residences where VC has been detected (see Figure 1), VC has not been detected in MW-107 or in MW-111, going back to the time of the RI, which shows that VC is not present in the upper part of the aquifer away from the landfill. Wells P-114 and P-115 are former water supply wells at two residences.
