**DAKOTA  
INTERTEK  
CORP.**

Re: Key Engineering Group, LTD. December 18, 2000 Final Report for the Former Hein-Werner Property, 1005 Perkins Avenue, Waukesha, Wisconsin; Key Engineering Group, LTD. File No. 0810009  
WDNR FID No. 268091890

Attachment A  
Figures

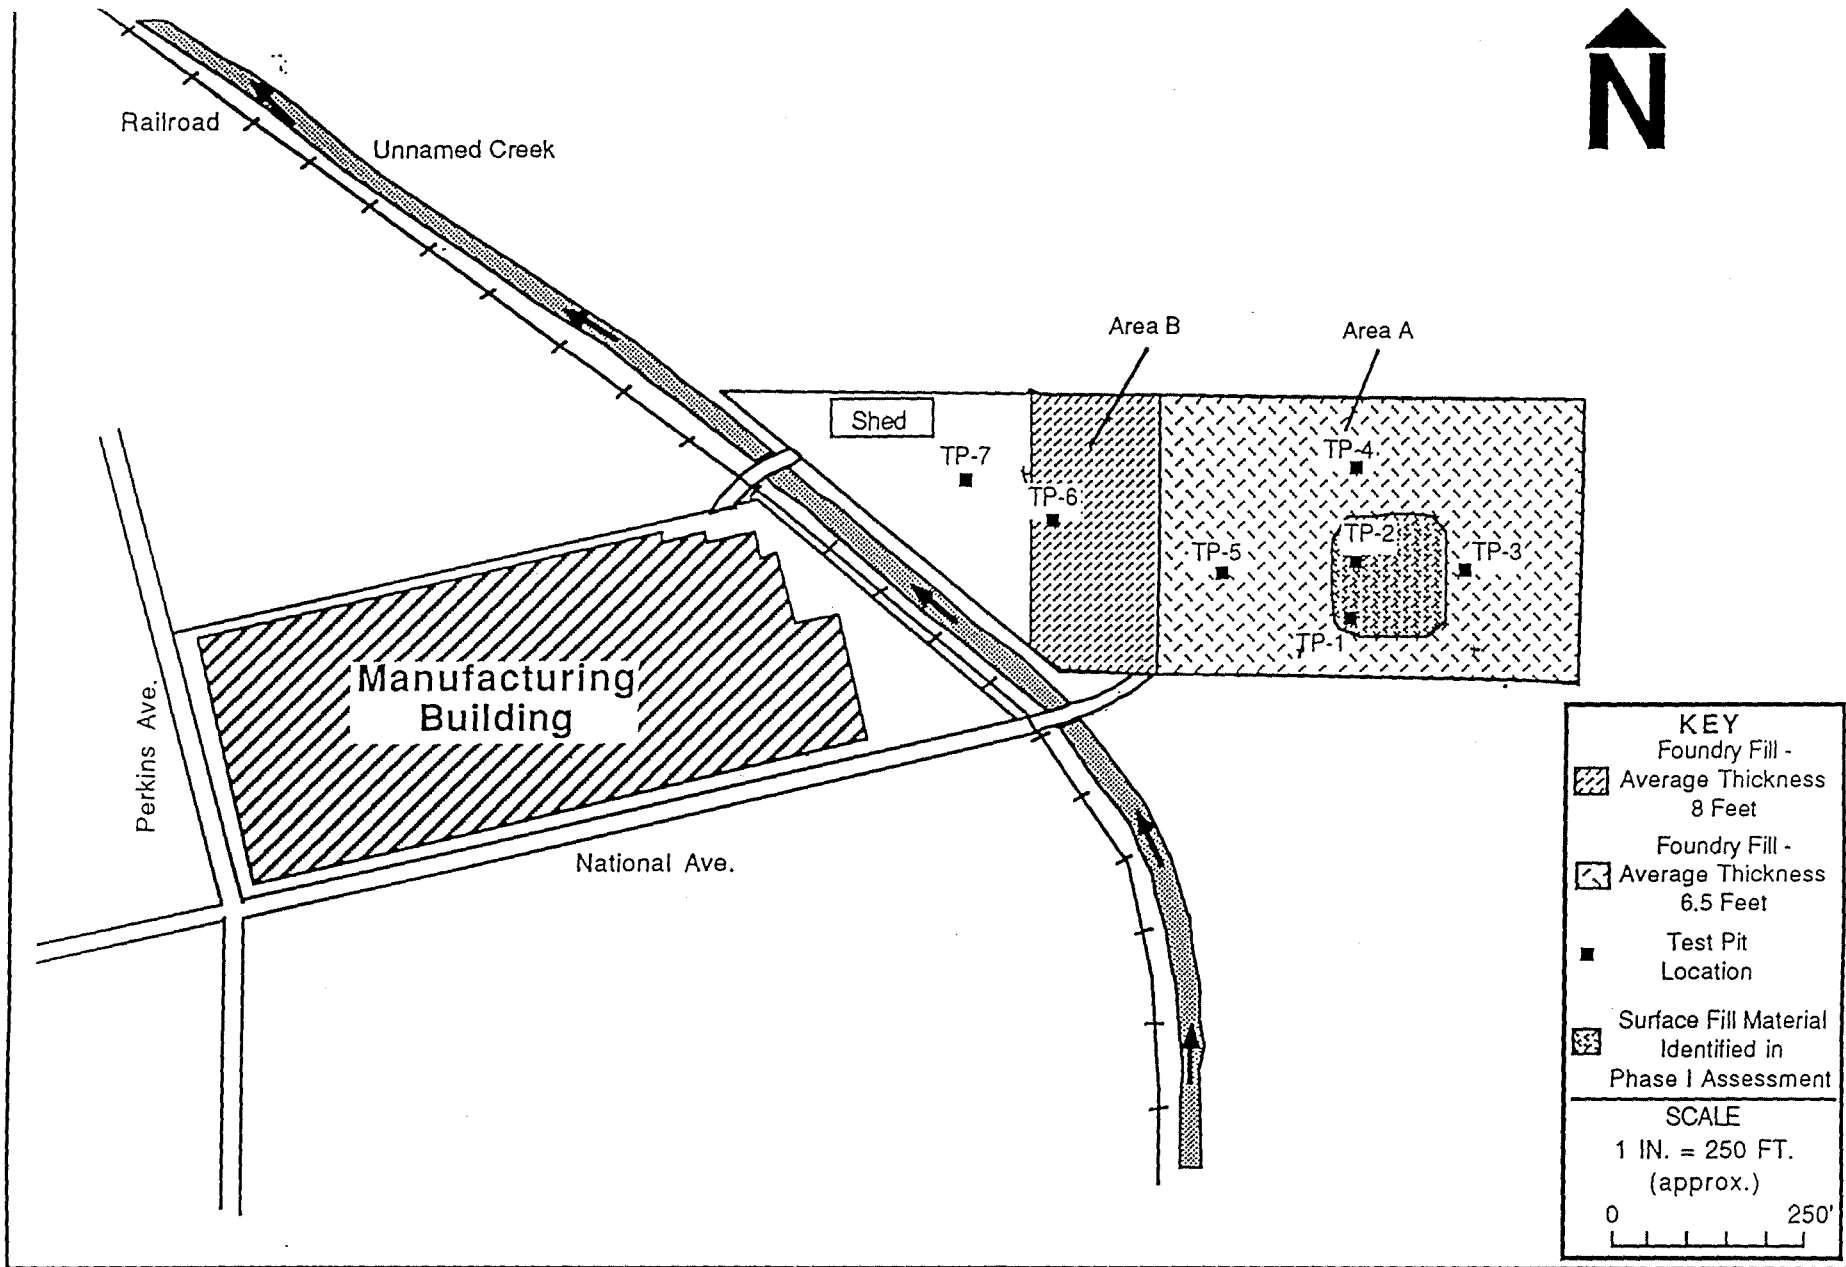
FIGURE 1

- There are no Key borings or monitoring wells in the immediate vicinity of laboratory-confirmed PCB and DRO-impacted soils (groundwater not tested), nor historic TCE-impacted groundwater (Figure 1 of Attachment A, "Figures");

- There are no Key borings or monitoring wells downgradient of laboratory-confirmed PCB and DRO-impacted soils, nor historic TCE-impacted groundwater (Figure 1, Attachment A);
