Phase I Environmental Assessment Report

**Try Chem Corporation Site
1333 W. Pierce Street
Milwaukee, WI**

August 1996

Waste Management Specialist/ Project Manager
Brownfield Environmental Assessment Pilot
Wisconsin Department of Natural Resources

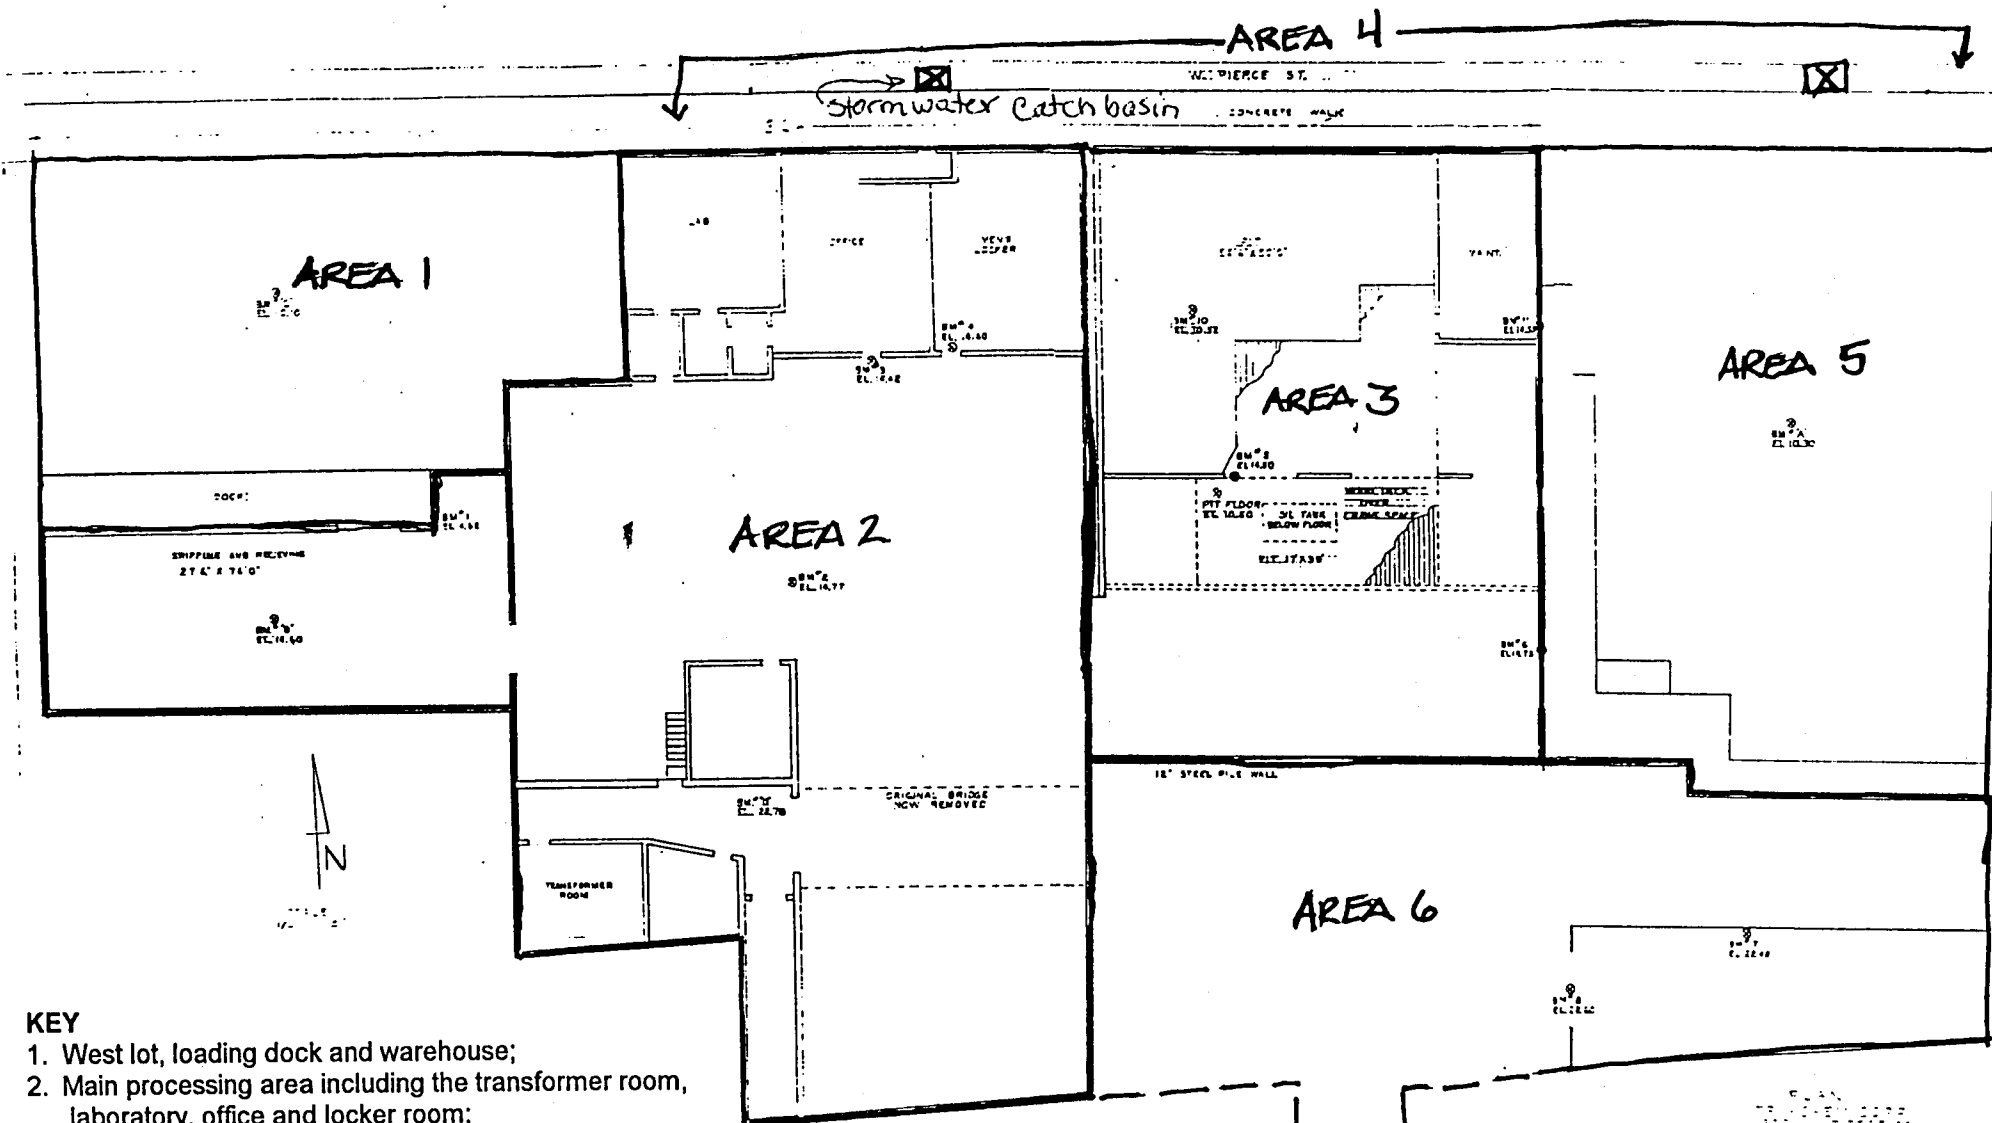
Figure 13 - Areas of Concern

Although the building was razed on July 15, 1996, leaving only the building foundation, retaining wall and concrete pads, the areas of concern at the site are described by their locations within the building or surrounding areas, and include a list of the processes or activities conducted in each area. The areas of concern are labeled on Figure 13.

1. West lot, loading dock and warehouse;
2. Main processing area including the transformer room, laboratory, office and locker room;
3. Pit near sidewalk and the pit with the oil tank below floor;
4. Sidewalk and storm water catch basins;
5. East lot and loading dock; and
6. Outdoor storage area, storage shed and driveway.

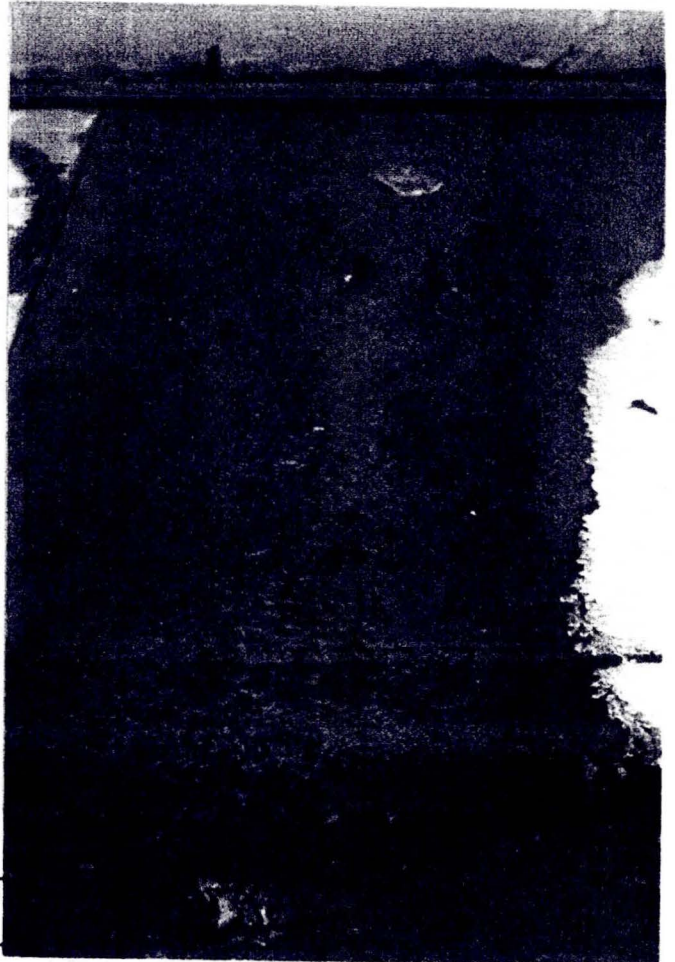
Chemicals released through the northeast and northwest corners of the building, which etched the concrete sidewalk and gutter, drained into the stormsewer and discharged to the Burnham Canal and ultimately to the Menomonee River (Figure 1 & 11). MHD and WDNR files document the leaking of chemicals through the building foundation beginning in 1983 and continuing intermittently until fall 1984. Samples of the leaking liquids were analyzed and found to contain chromium, nitrates, zinc, phosphate, fluoride, lead, cyanide, cadmium, and hydrochloric acid with pH ranging from 0.3 - 10.0. The types of chemicals and their concentrations detected in the liquids sampled varied with each sample, ranging from .01 - 10,000 parts per million (ppm) (Appendix M).

DAMAGED SIDEWALK + GUTTER
FROM BUILDING DISCHARGE.
