September 13, 2023

Subject: Cap Maintenance Inspection - Repair/Replacement Required
Village Clean, 180 S. Pine St., Burlington, WI
BRRTS #02-52-472623 FID #252202170

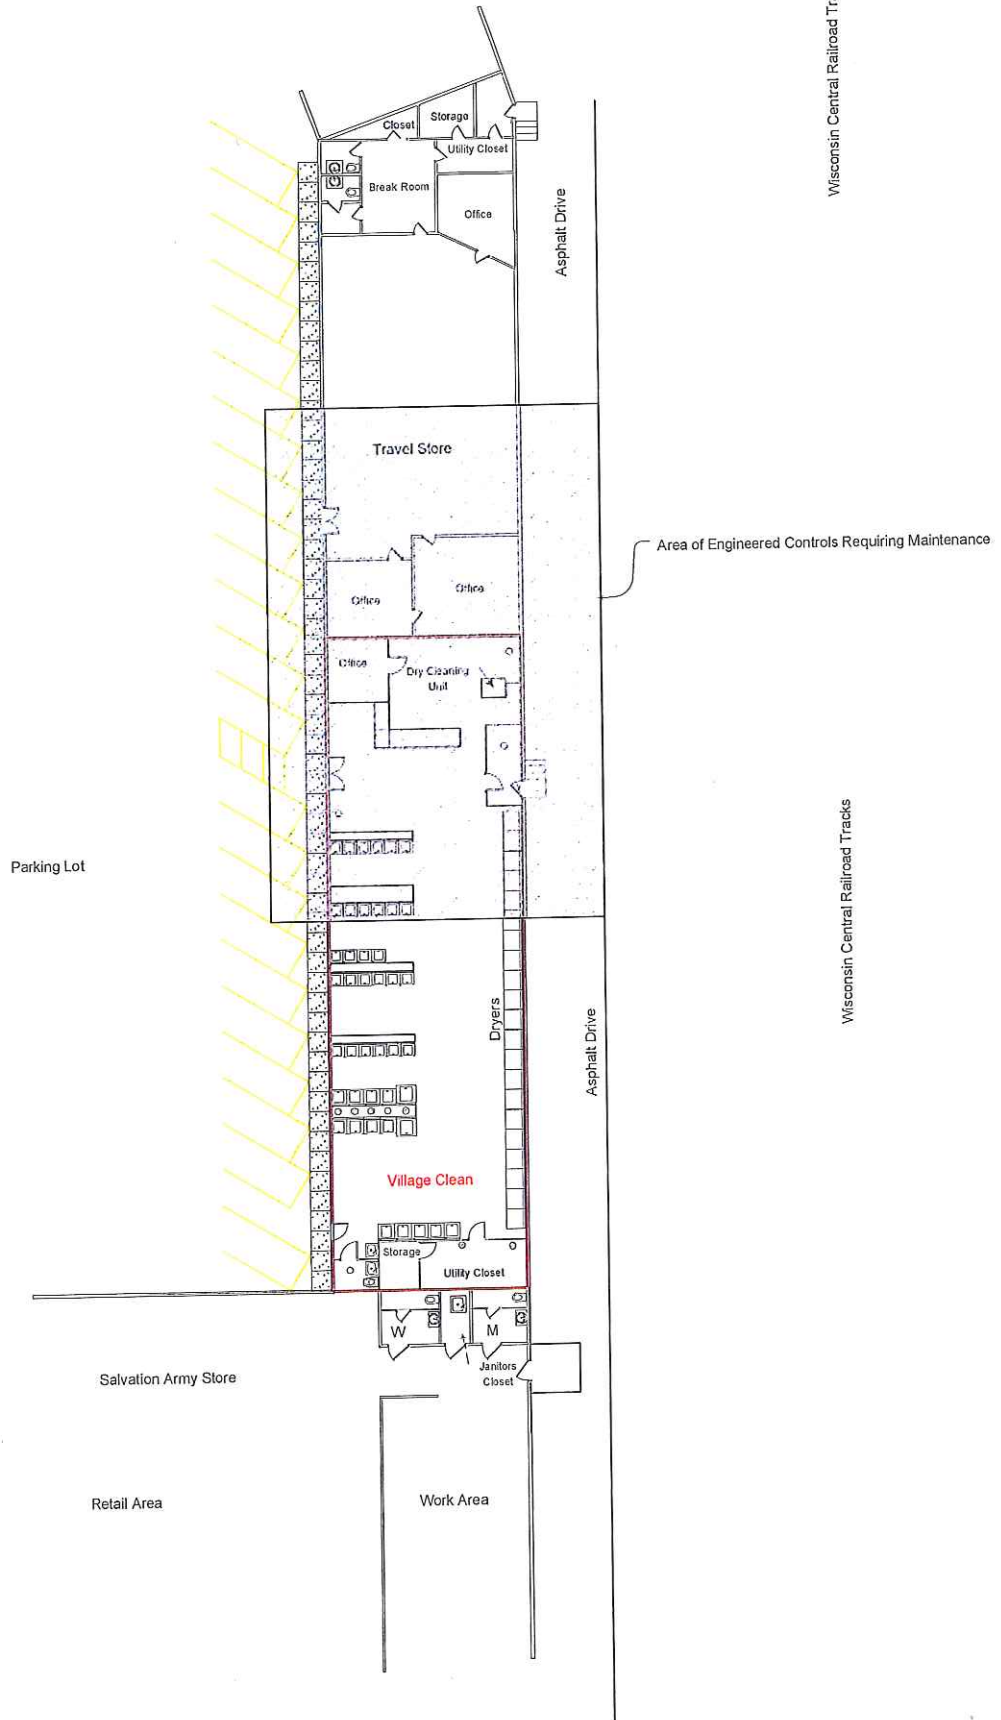
Figure 7, Area of Engineered Controls

The building floor and asphalt pavement that exists in the locations shown on the **attached map** Figure 7, Area of Engineered Controls, shall be maintained in compliance with the **attached maintenance plan**, Village Clean Sub-Slab Mitigation System and Barrier Maintenance Plan, in order to minimize the infiltration of water and prevent additional groundwater contamination that would violate the groundwater quality standards in ch. NR 140, Wis. Adm. Code. The building floor must also be maintained in order to prevent or limit vapor intrusion into the building.

The integrity of the floor within the dry cleaner space as shown on the **attached map**, Figure 7, Area of Engineered Controls, must be maintained in compliance with the maintenance plan. This will help ensure proper functioning of the vapor mitigation system, limiting vapor intrusion to indoor air spaces.

Annual inspections of the Village Clean facility will include the surface cover interior to the facility and the exterior areas as indicated in Appendix F (MHEEnvironmental Inc. Figure 7 – Area of Engineered Controls). The effectiveness of the SSDS is dramatically affected by the presence of floor breaches that are not quickly addressed. It is the responsibility of the owner to assure that the floor of the Village Clean and the asphalt areas located outside of the building are properly maintained. In order to maintain total competency of the system, breaches in either the concrete or asphalt must be immediately repaired.

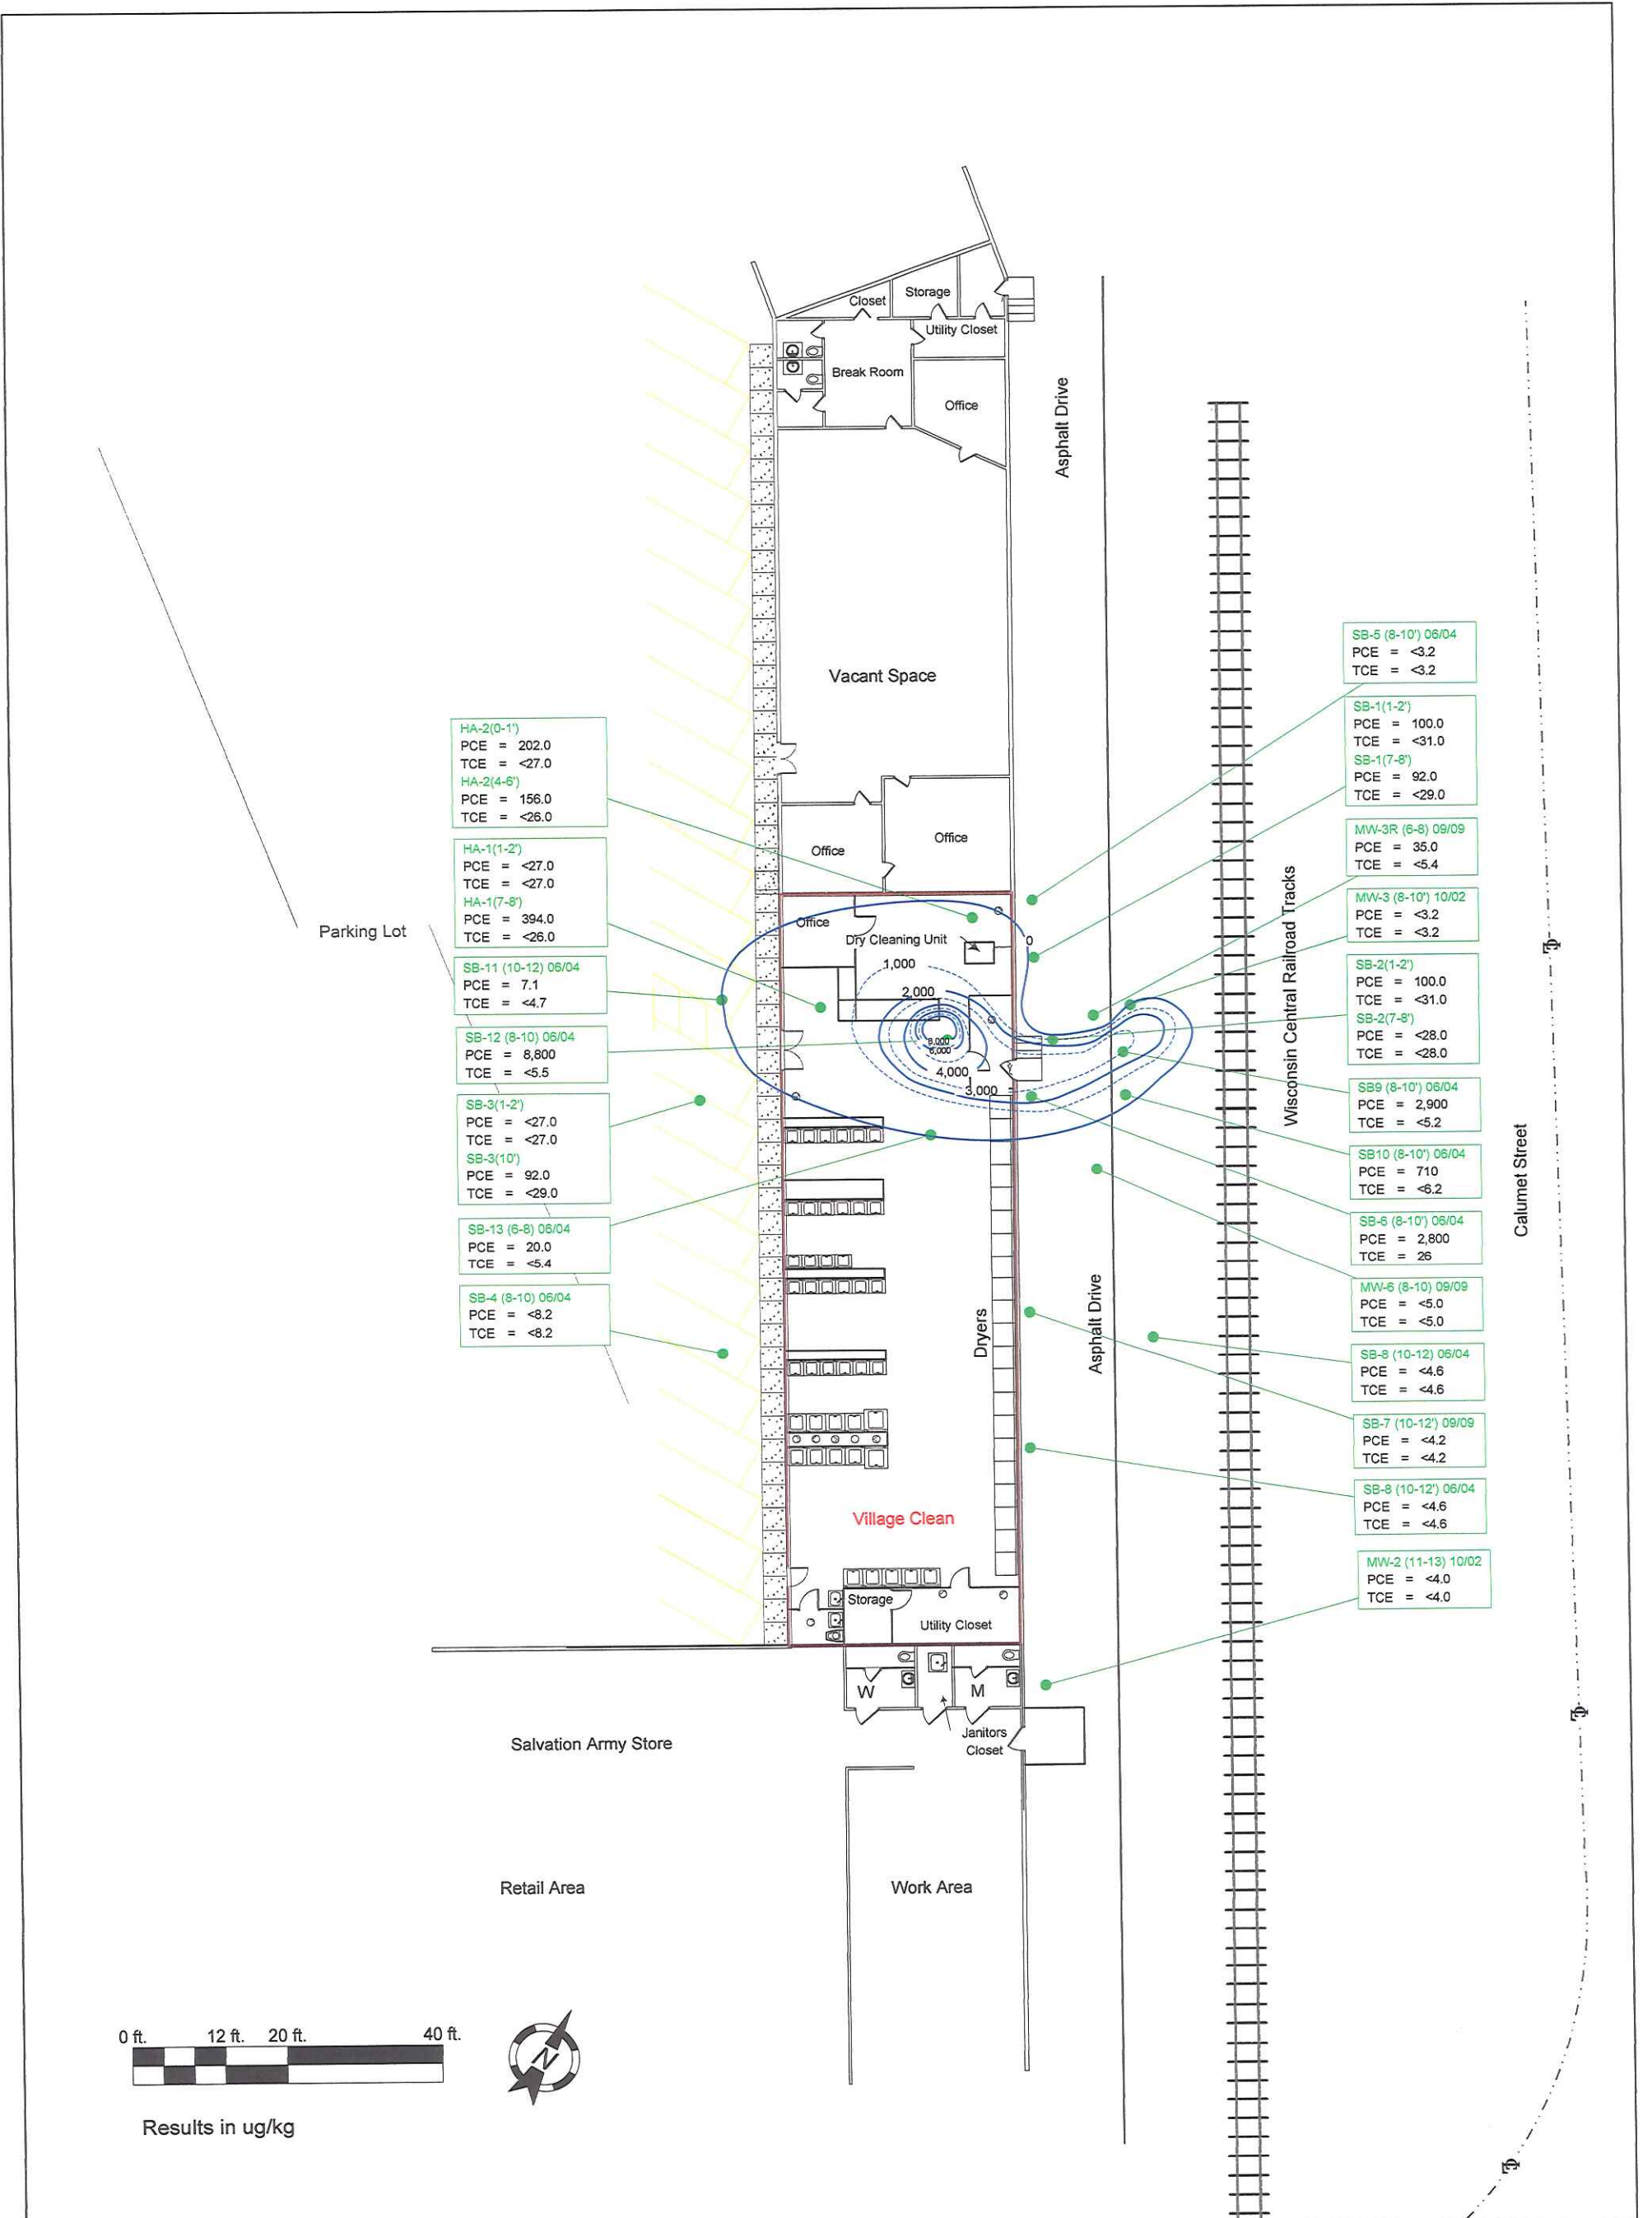
Figure 3, Area of Soil Contamination

Soil contamination remains as indicated on the **attached map** Figure 3, Area of Soil Contamination. If soil in the specific locations described above is excavated in the future, the property owner at the time of excavation must sample and analyze the excavated soil to determine if contamination remains. If sampling confirms that contamination is present, the property owner at the time of excavation will need to determine whether the material is considered solid or hazardous waste and ensure that any storage, treatment or disposal is in compliance with applicable standards and rules. Contaminated soil may be managed in accordance with ch. NR 718, Wis. Adm. Code, with prior DNR approval.

Future Concern: Chlorinated volatile organic compounds remain in soil below the asphalt drive, as shown on the **attached map** Figure 3, Area of Soil Contamination, at levels that may be of concern for vapor intrusion in the

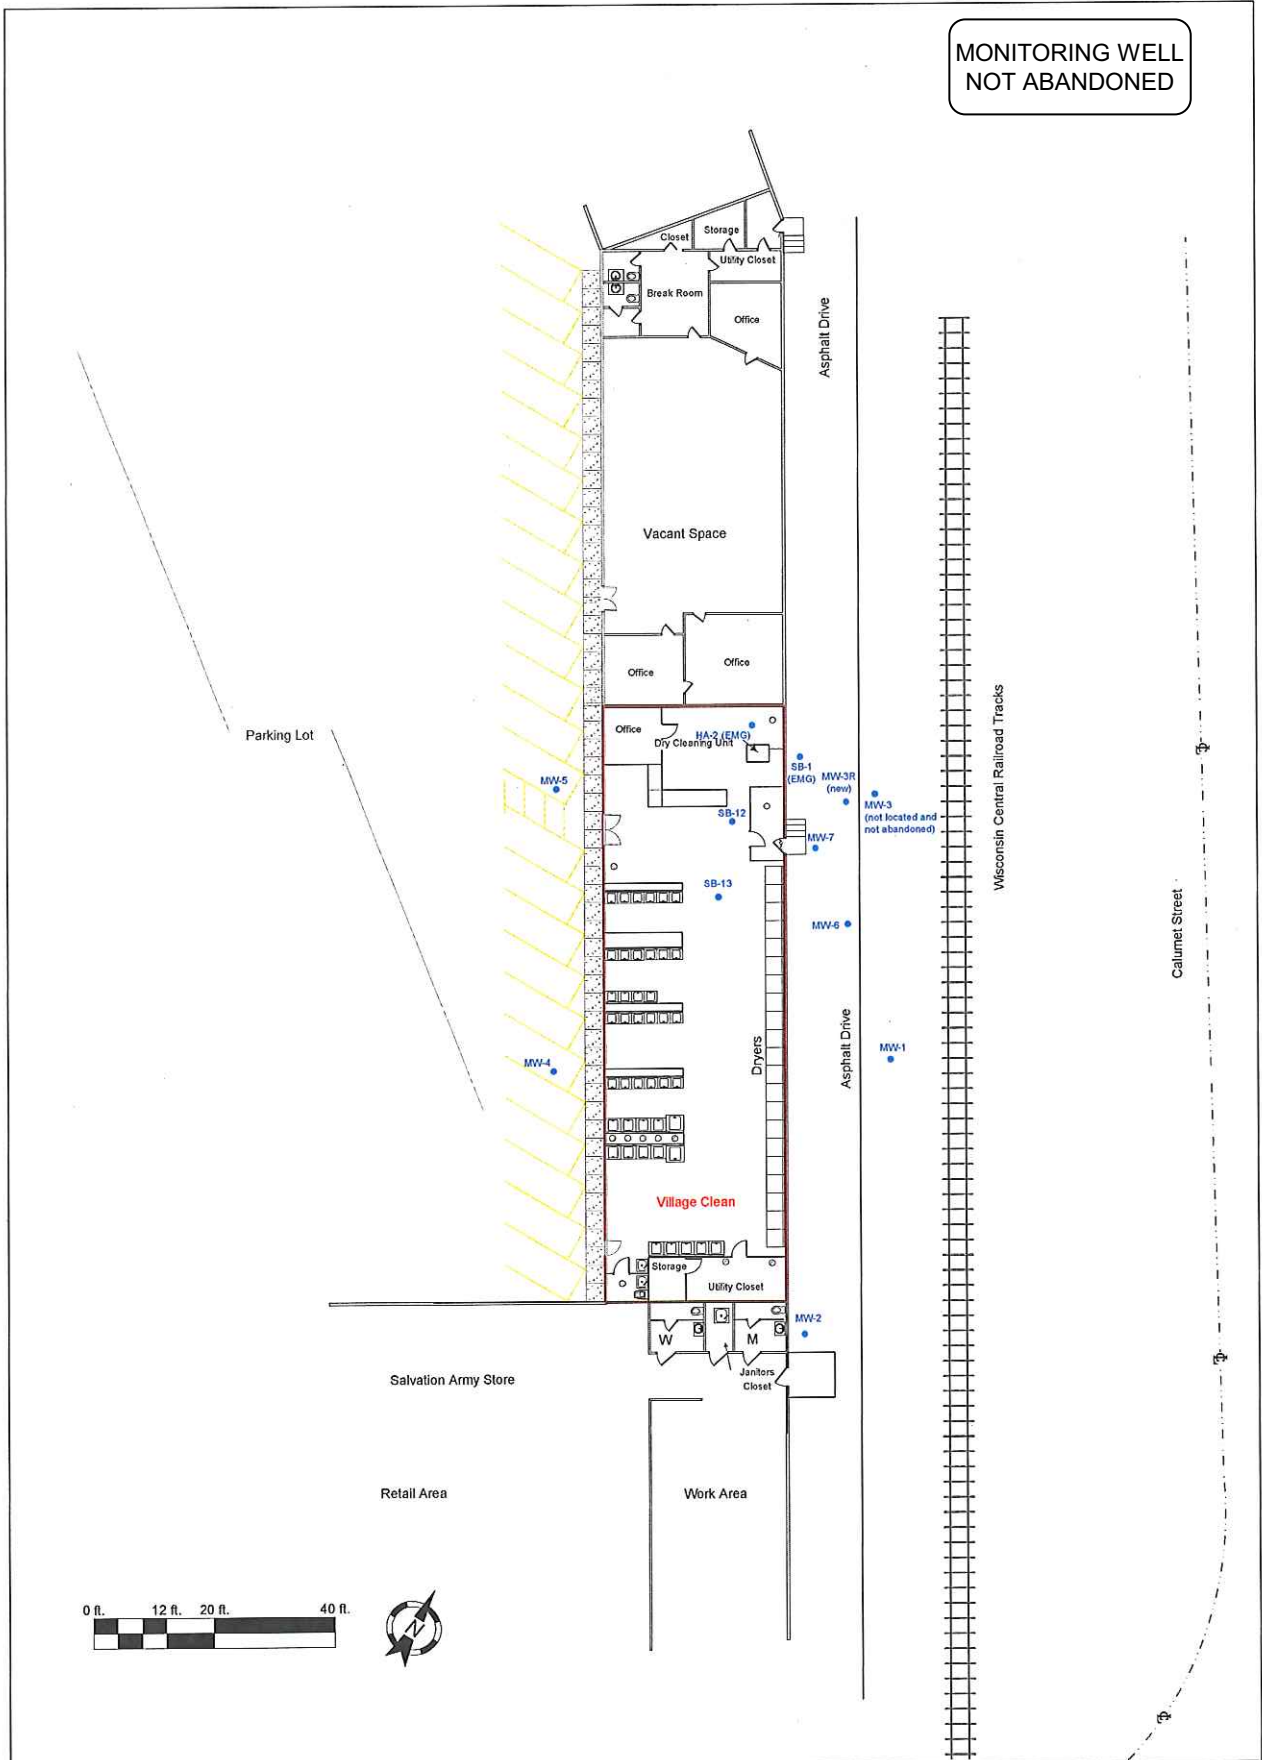
Figure 3, Monitoring Well Locations

Monitoring well MW-3 located on the property as shown on the **attached map** Figure 3, Monitoring Well Locations, could not be properly filled and sealed because it was missing due to being paved over, covered or removed during site development activities. Your consultant made a reasonable effort to locate the well and to determine whether it was properly filled and sealed, but was unsuccessful. You may be held liable for any problems associated with the monitoring well if it creates a conduit for contaminants to enter groundwater. If the groundwater monitoring well is found, the then current owner of the property on which the well is located is required to notify the DNR, to properly fill and seal the well and to submit the required documentation to the DNR.

MONITORING WELL
NOT ABANDONED
