ANNUAL INSPECTION REPORT

BARRETT LANDFILL

New Berlin, Waukesha County, Wisconsin

January 18, 2018

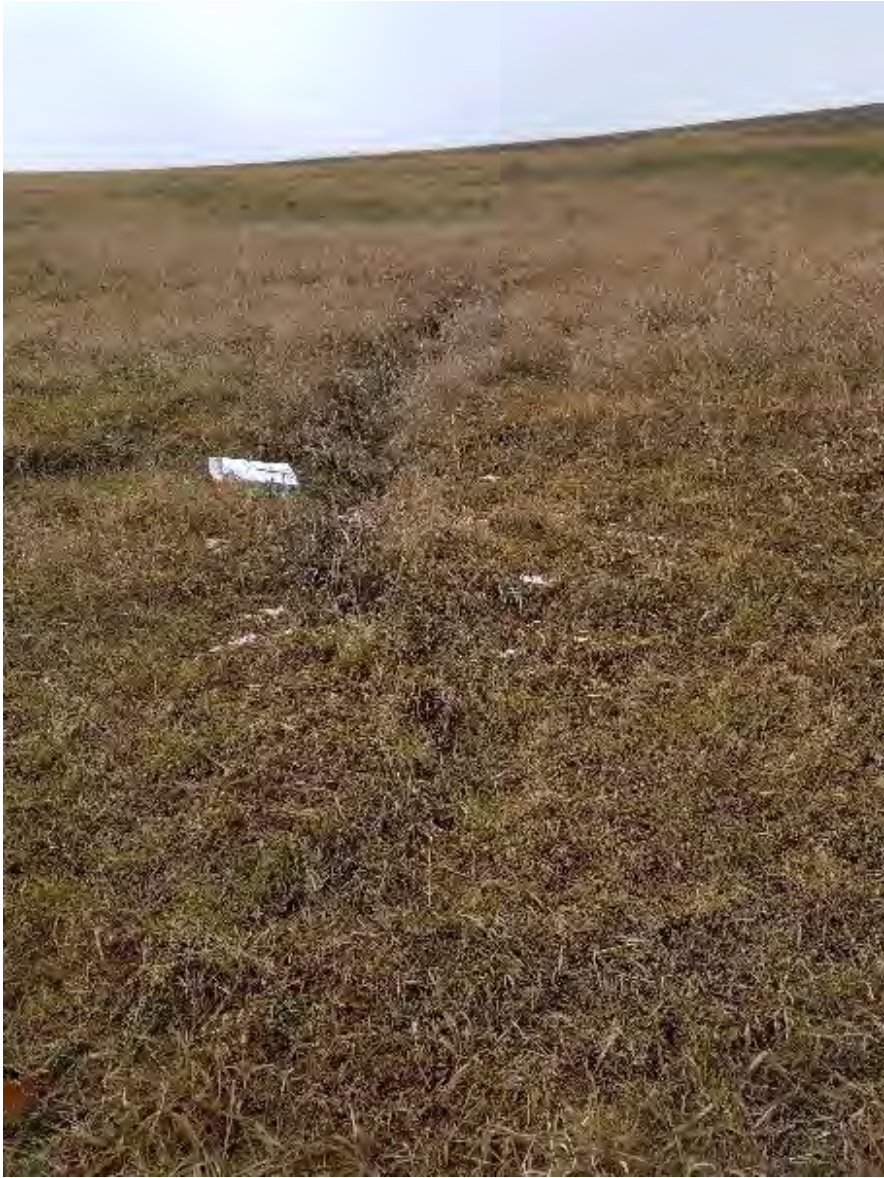
19. Erosion on NE hill face, looking SW towards GV-6

- Erosion channels were observed on the northeast face of the landfill hill, extending towards Sedimentation Basin 1; these channels will need to be filled and reseeded.
- Several tire tracks or erosion channels on the southwest corner (near GV-44) will need to be filled and reseeded. Light erosion on the north face of the landfill hill (near GV-11 and GV-14) should be filled and reseeded or monitored for further erosion.
- A total of six animal burrow holes need to be filled.
- A burrow hole located east of GV-8 appears to have damaged the liner; filling and reseeded of this area, in addition to liner repairs if deemed necessary, are recommended.
- A drain pipe located near GV-26 is flattened and damaged; this should be repaired.

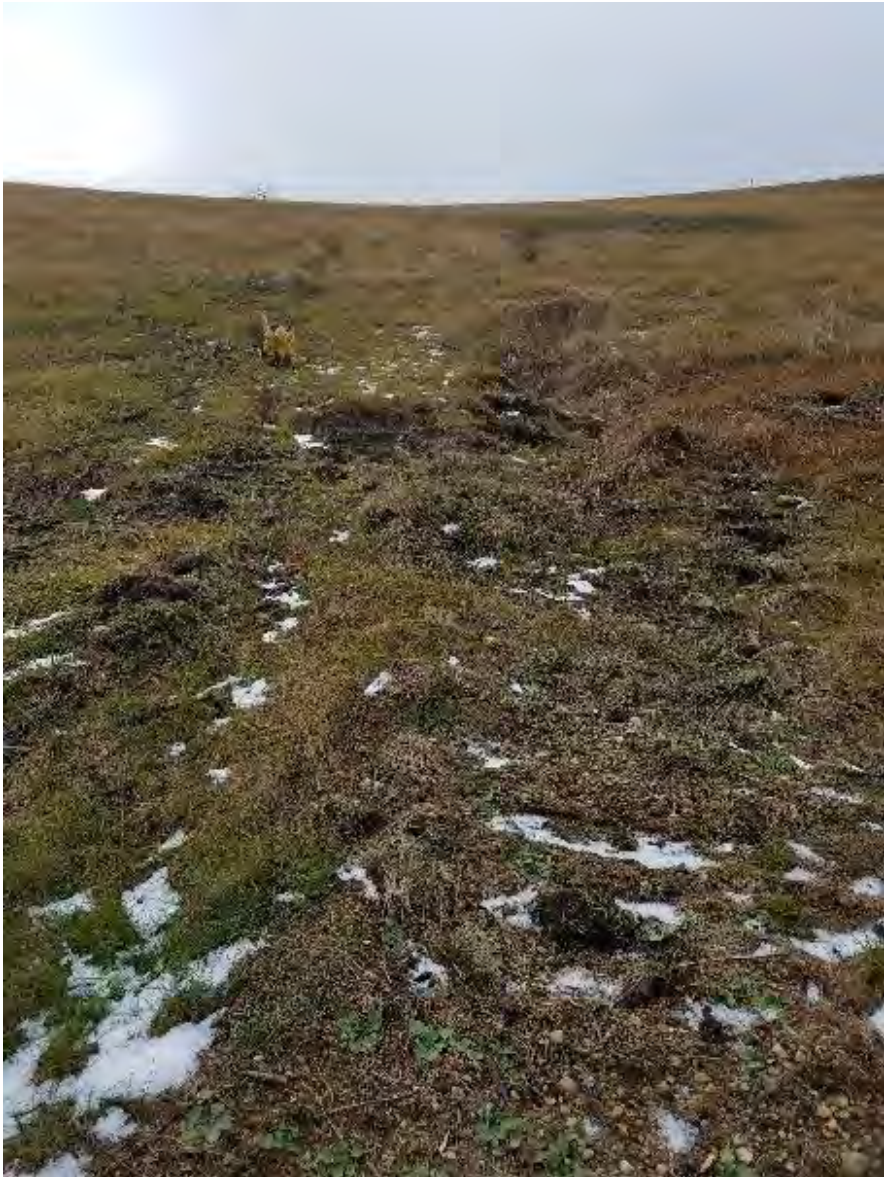
21. Erosion on NE hill face, looking SW towards GV-6

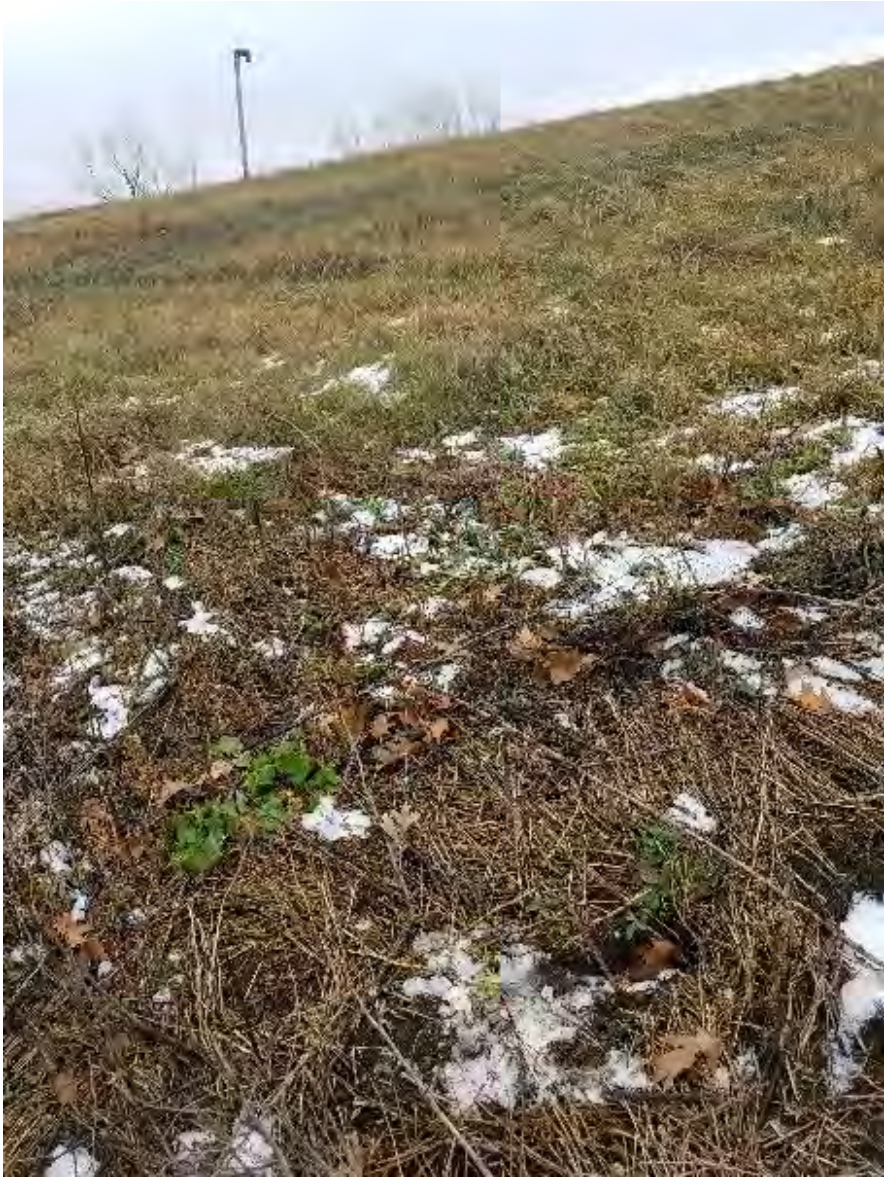
25. Bare spot in vegetation, looking uphill SE towards GV-2

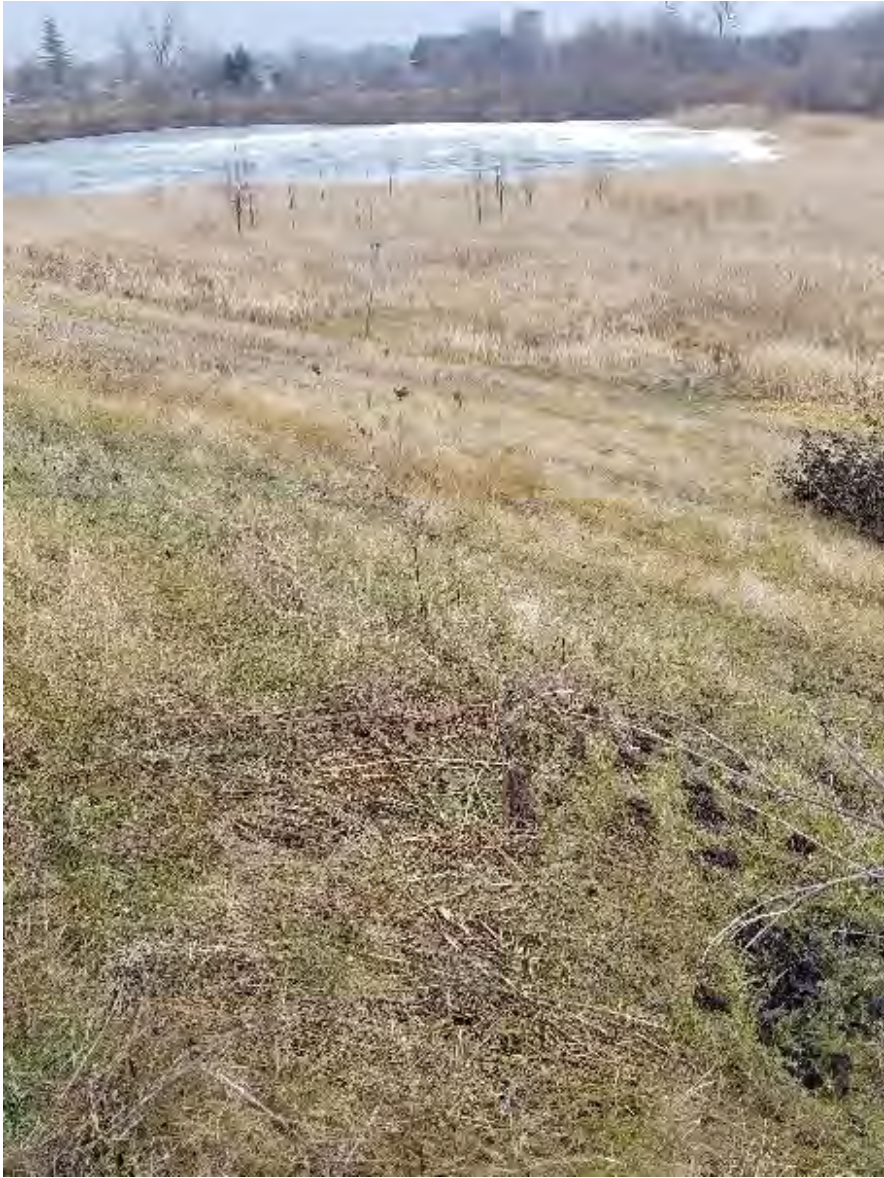
27. Tree stump in middle of bare spots of vegetation, NW of GV-2, looking NNW

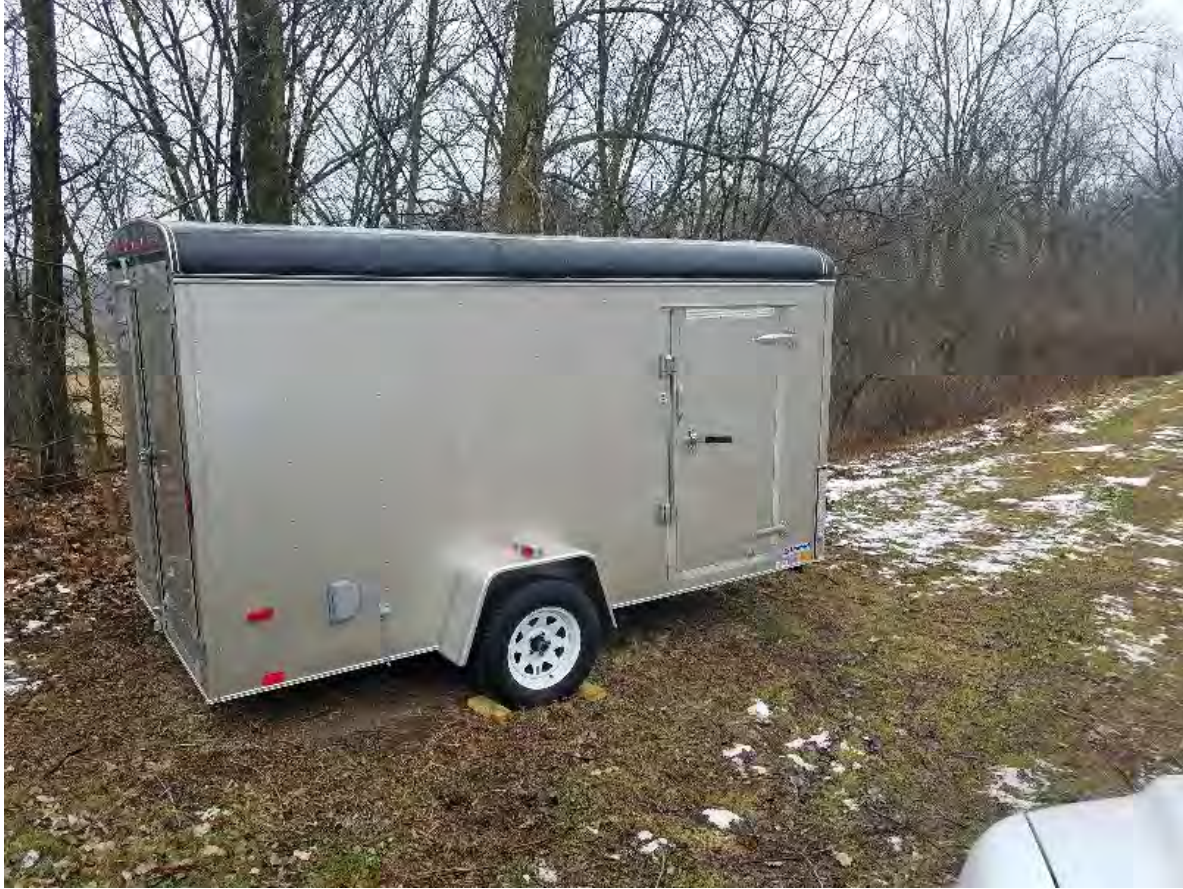
33. Trailer on SE corner, looking S

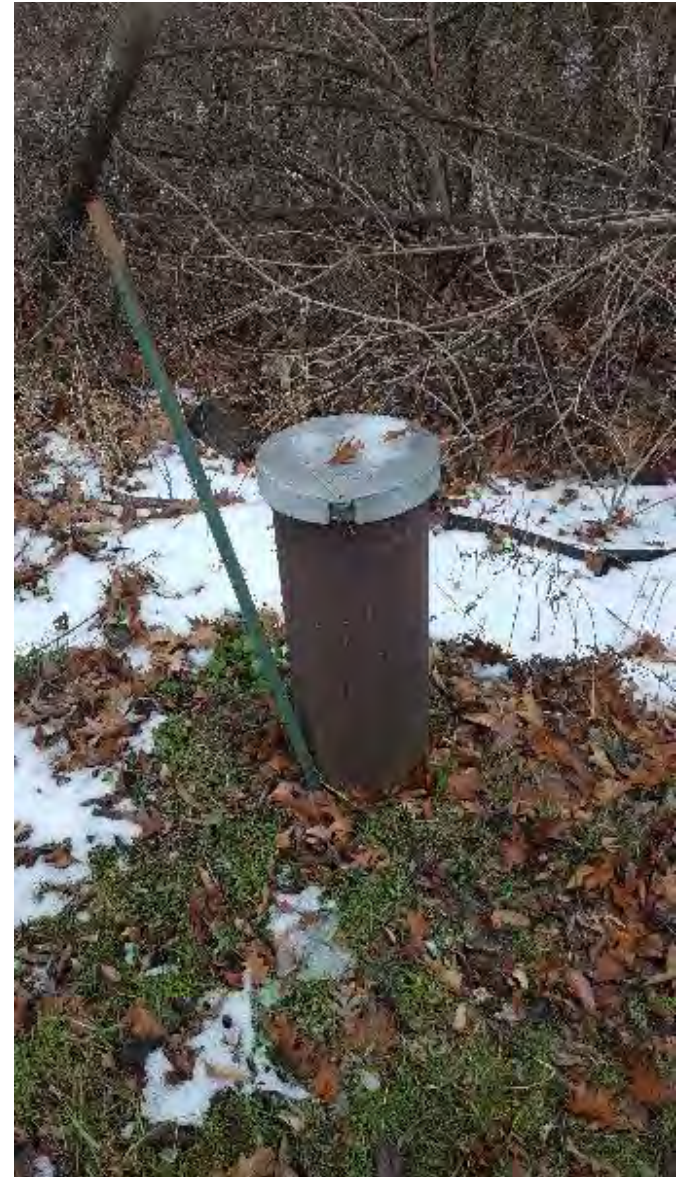
42. B-94-26 looking S, no lock

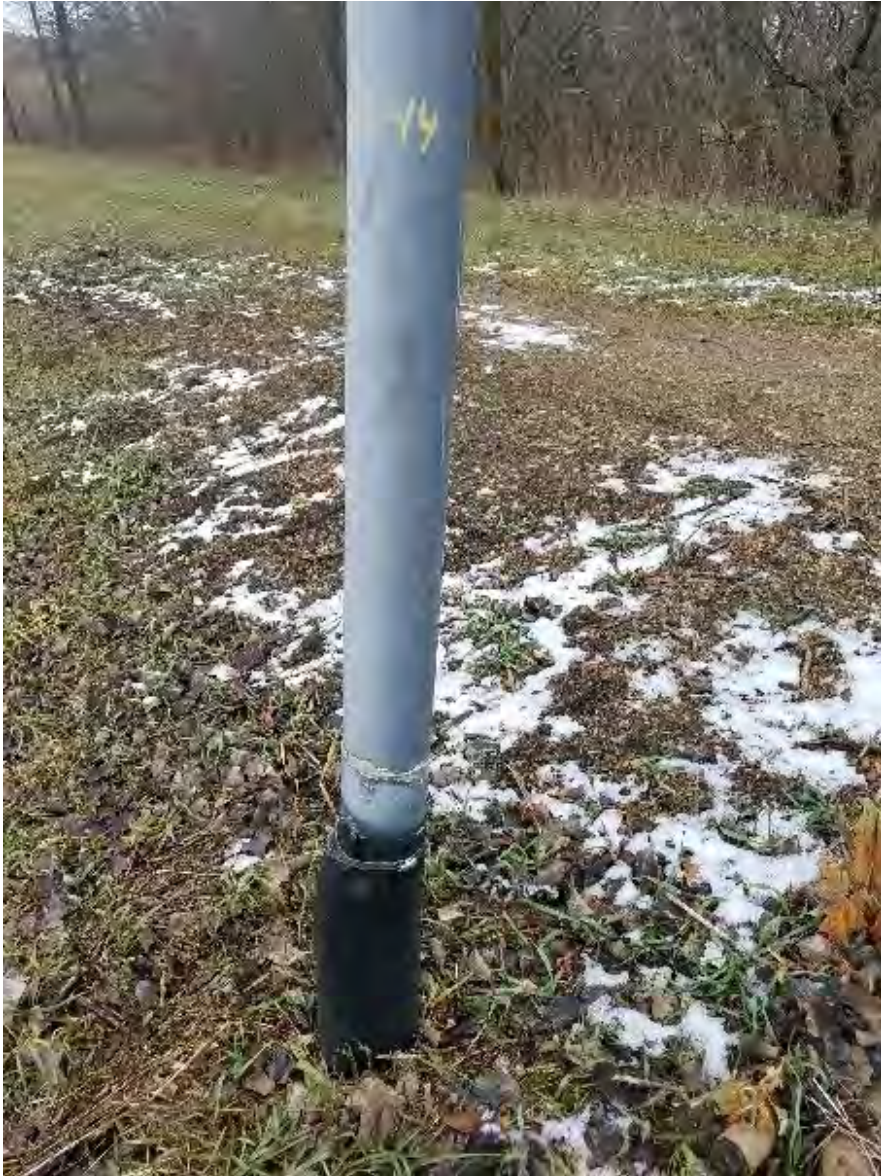
55. GV-44 looking SE at tightened hose clamp

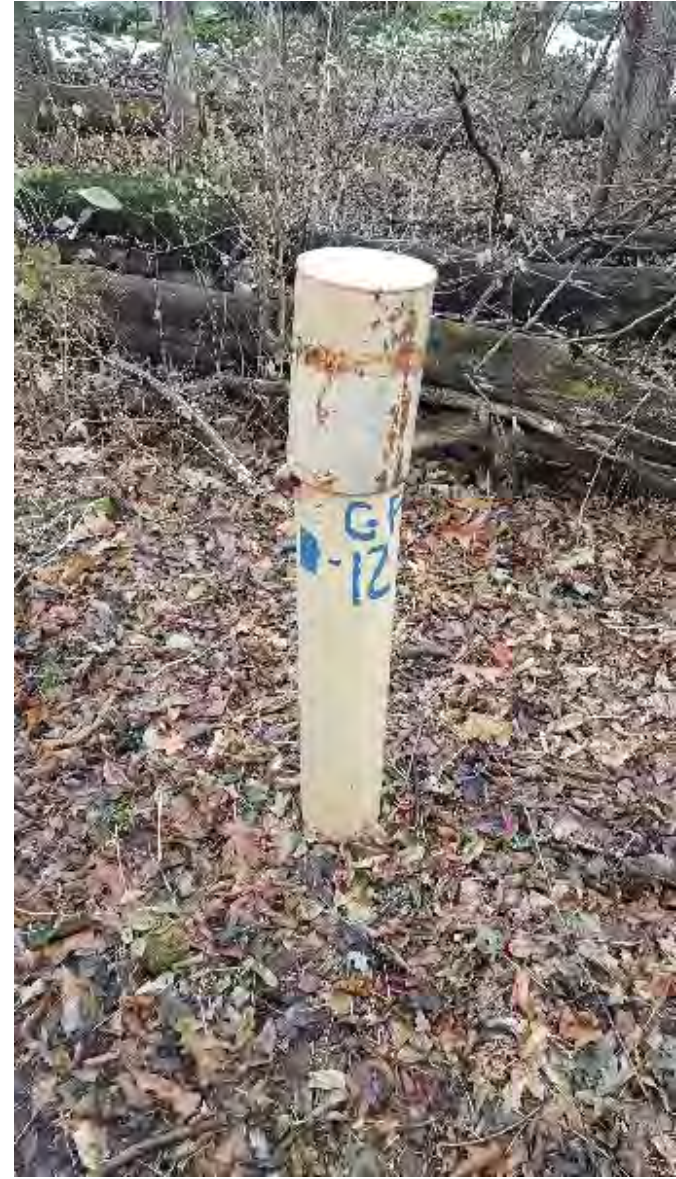
58. GP-12, not locked, looking W

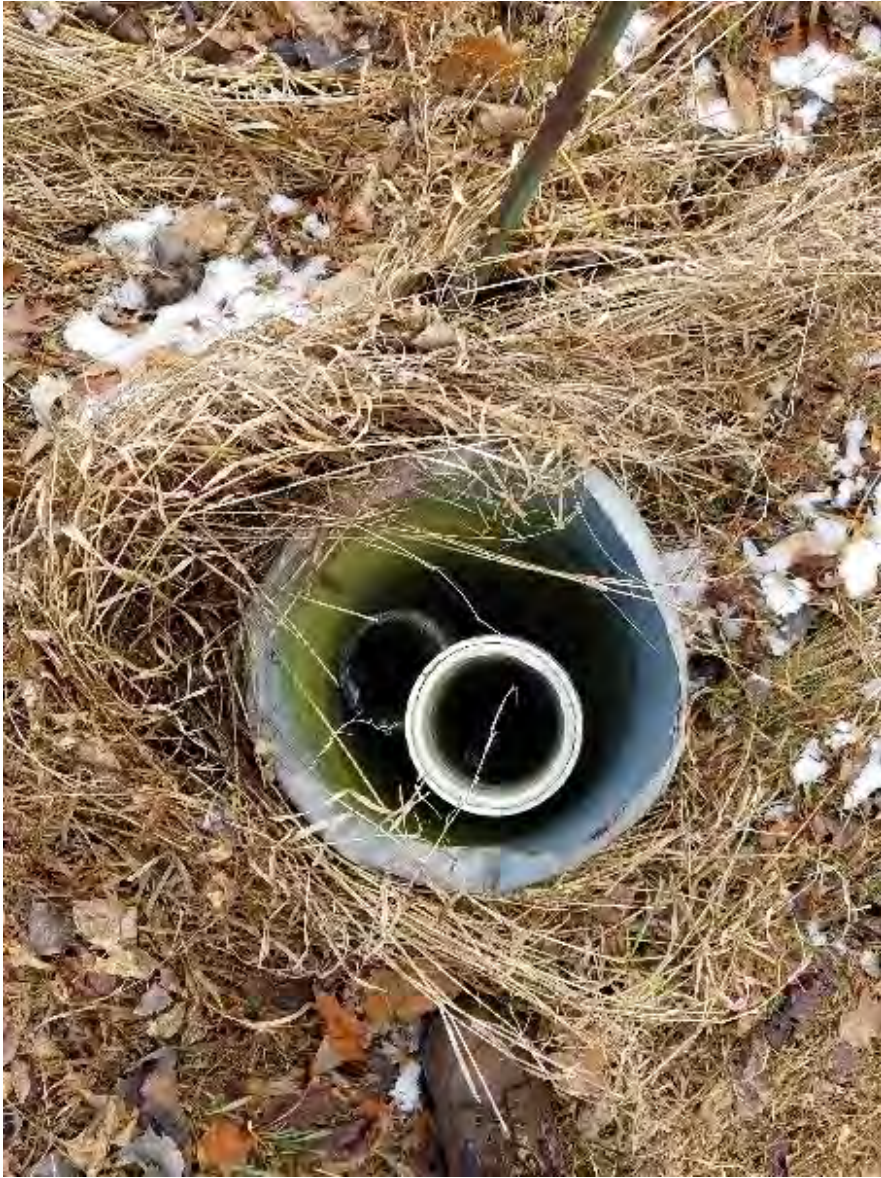
63. Unknown pipes in ground, not marked, N of B-96-17

- Leachate head wells (LHW) and unknown pipes will be identified or renumbered and placed on a revised Site Map.
- One LHW (near GV-46) had a hole/tear in the boot that will need to be repaired.
- If the protective casing is lockable, locks will need to be added. If the protective casing cannot be locked, a cap or plug that can be locked will need to be installed.

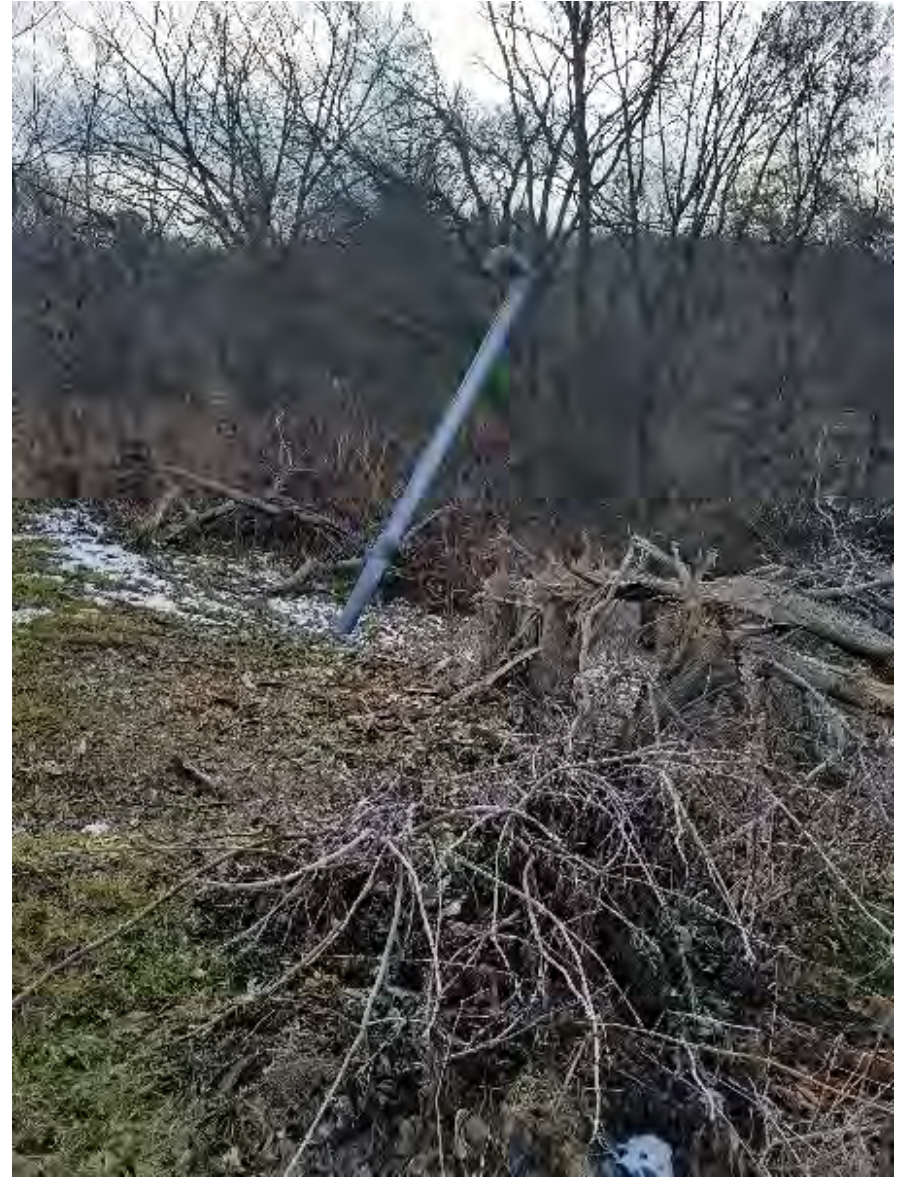
64. Un-marked GV, SE of B-21 and SW of B-39, looking S

- Gas vents need to be renumbered. Some vents are not assigned a number and others are assigned duplicate numbers. The newly numbered vents will be placed on a revised Site Map.
- Five gas vents (GV-3, GV-11, GV-18, GV-50, and an unmarked gas vent near GP-9) had holes or tears in the boots at the base of the vent. Hose clamps need to be replaced on GV-17 (a duplicate number) and GV-26. Screens need to be replaced on GV-1 and GV-33, and screens need to be cleared (not fully blocking screen) at GV-2 and GV-50.
- Gas probes GP-3, GP-5 and GP-12 need locks as there are none on these protective casings. GP-1, GP-2S/D, GP-5S/M/D, GP-6S/M/D, GP-9S/M/D and GP-10S/M/D need caps on the individual probes; the vented caps that were present on gas probes were plugged with mud and should all be replaced (27 caps in total).

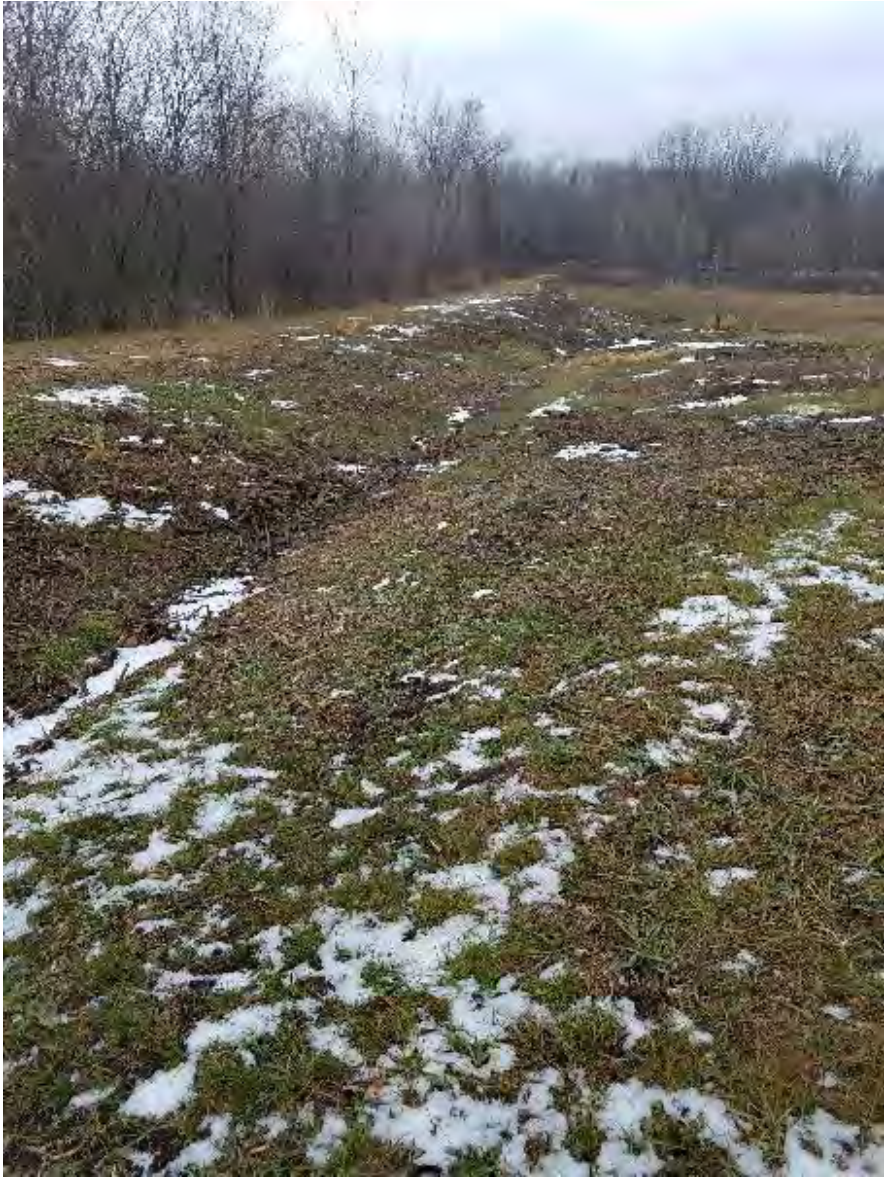
73. Woodchips in ditch, looking N towards GV-38

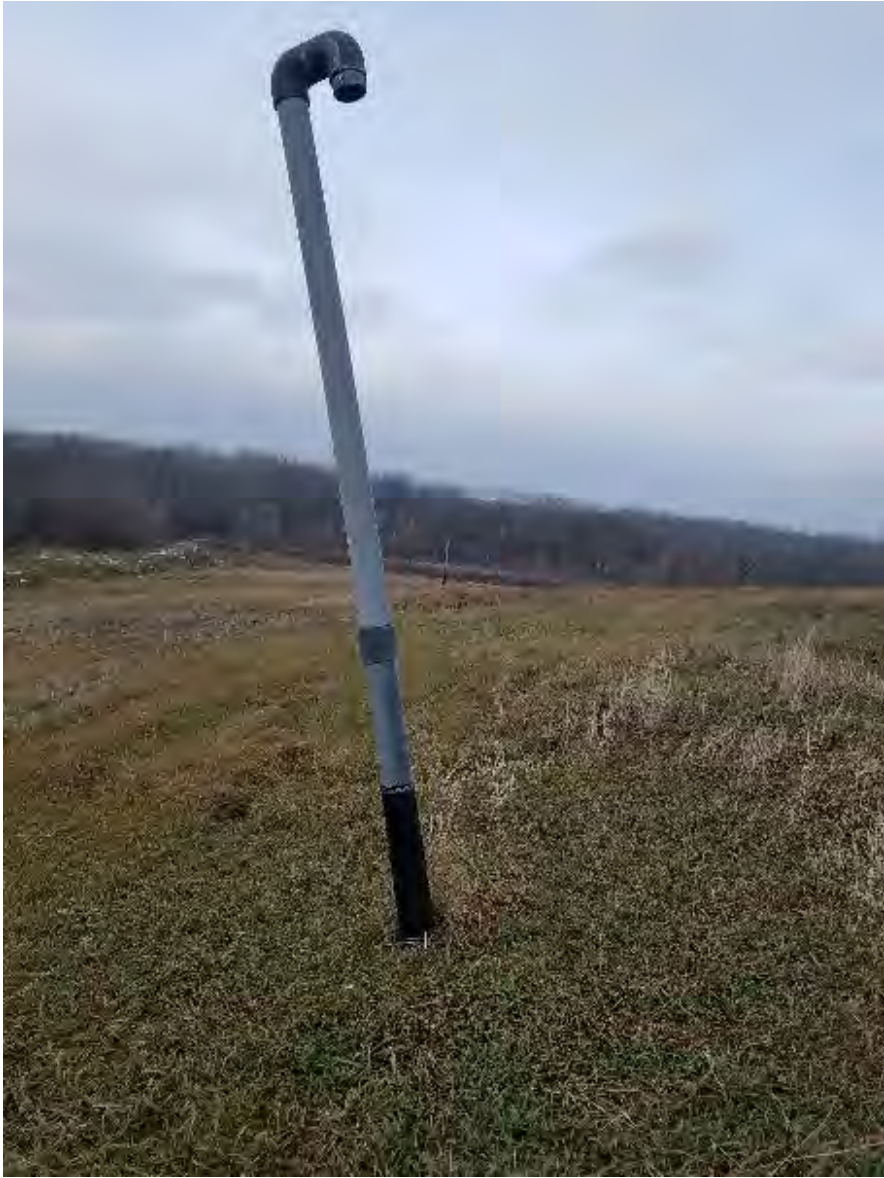
75. Unmarked GV with slight tilt to N, N of GV-39, looking N

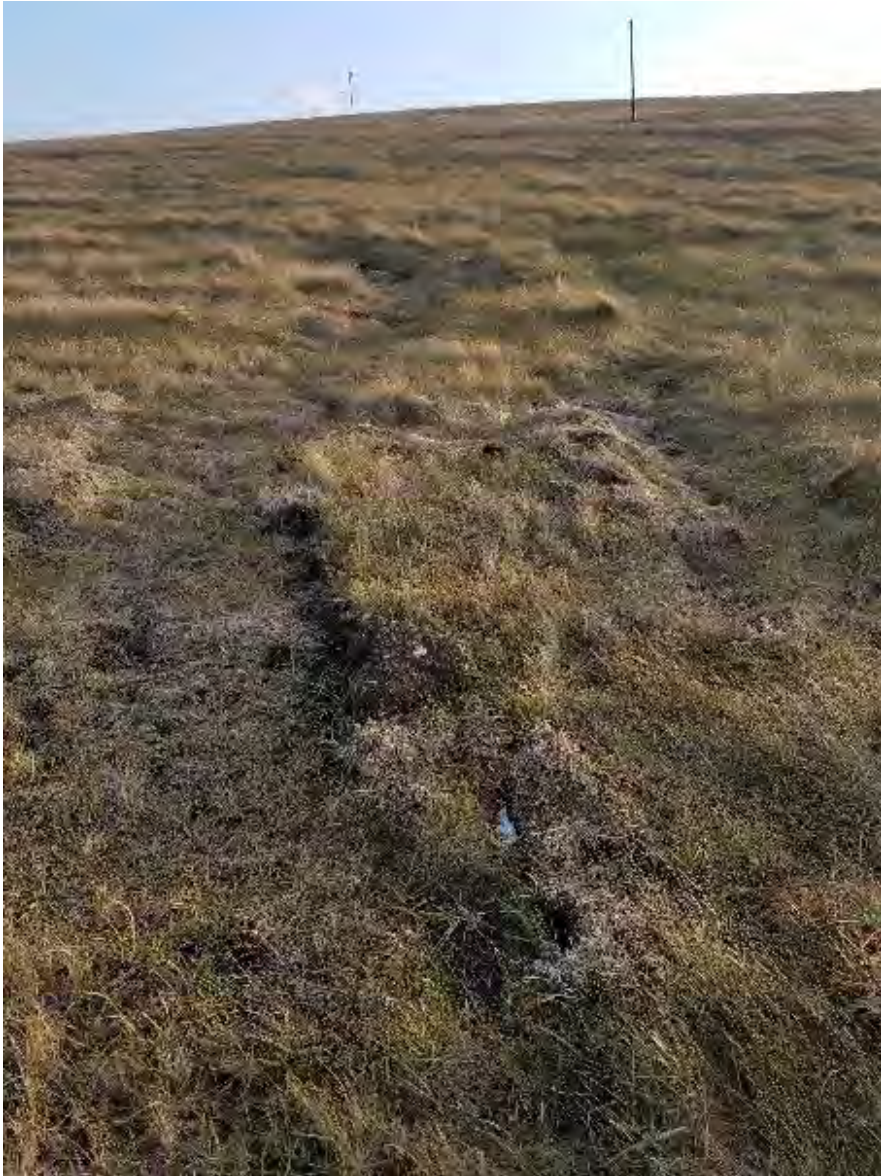
91. Slight erosion or tire tacks, looking S uphill towards GV-11

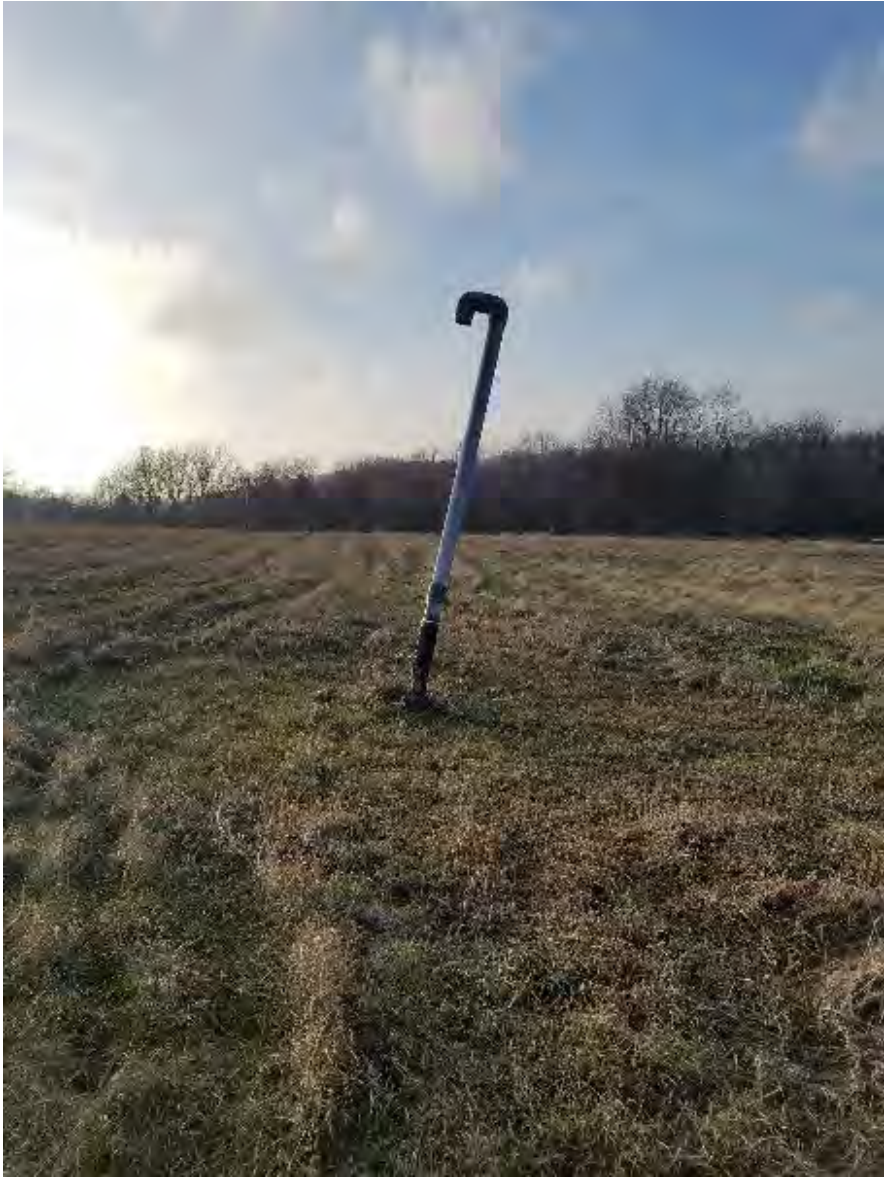
93. GV-13 tilting N, looking W

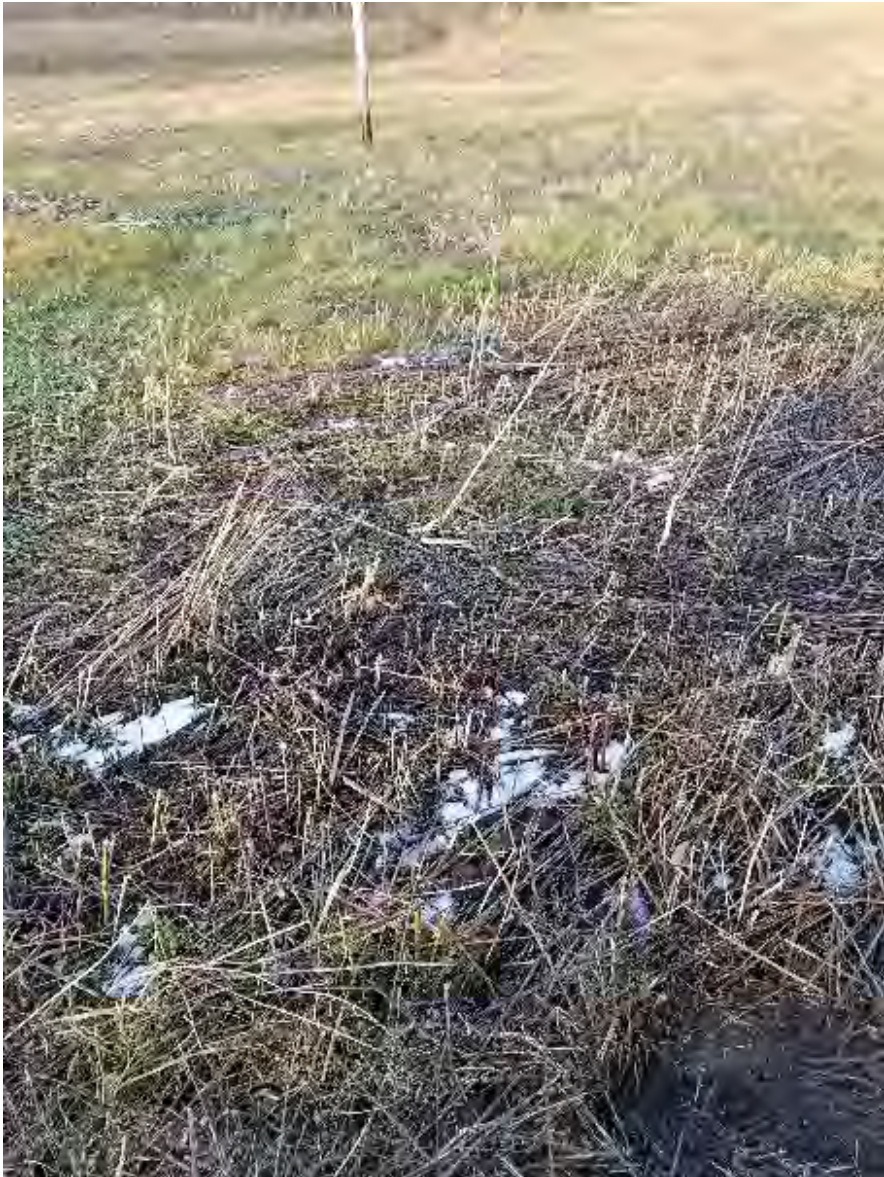
2. Soil stability (erosion control)		X		Erosion found on NE, N and SW hill faces, need repairs
3. Cover integrity (no exposed waste or ruts)	X			a piece of corrugated metal and a tire were found on the north face of the hill.

95. Bare spot with a piece of corrugated metal, looking N towards GV-36

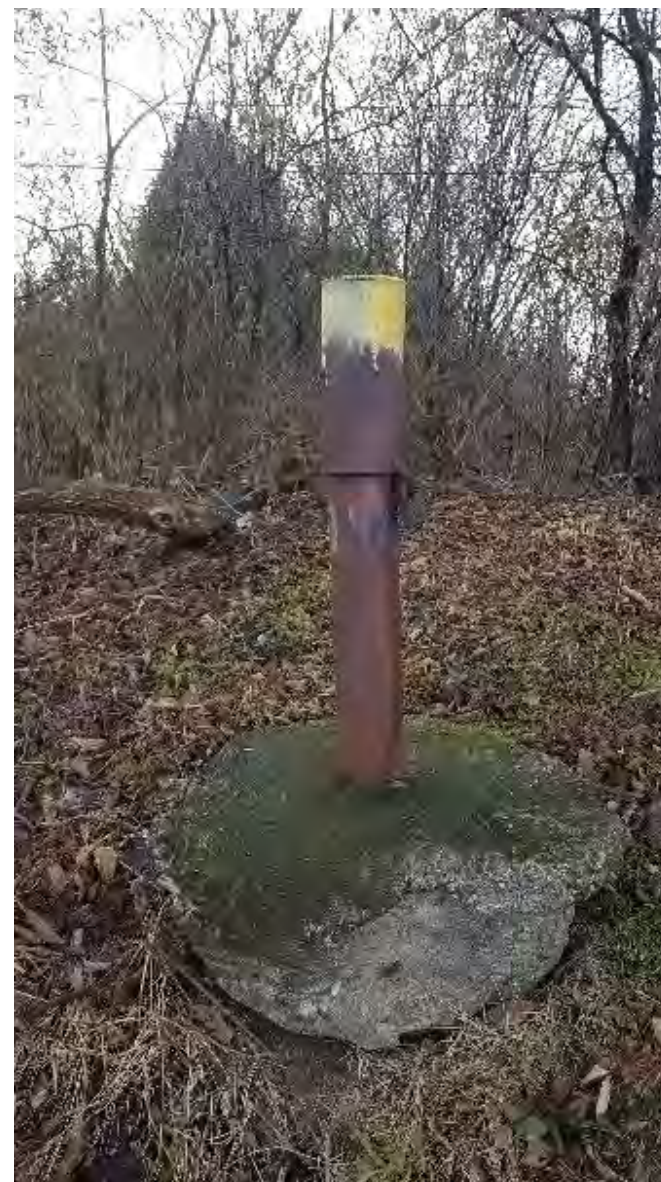
100. B-94-14A, looking W, erosion of soil around cement pad

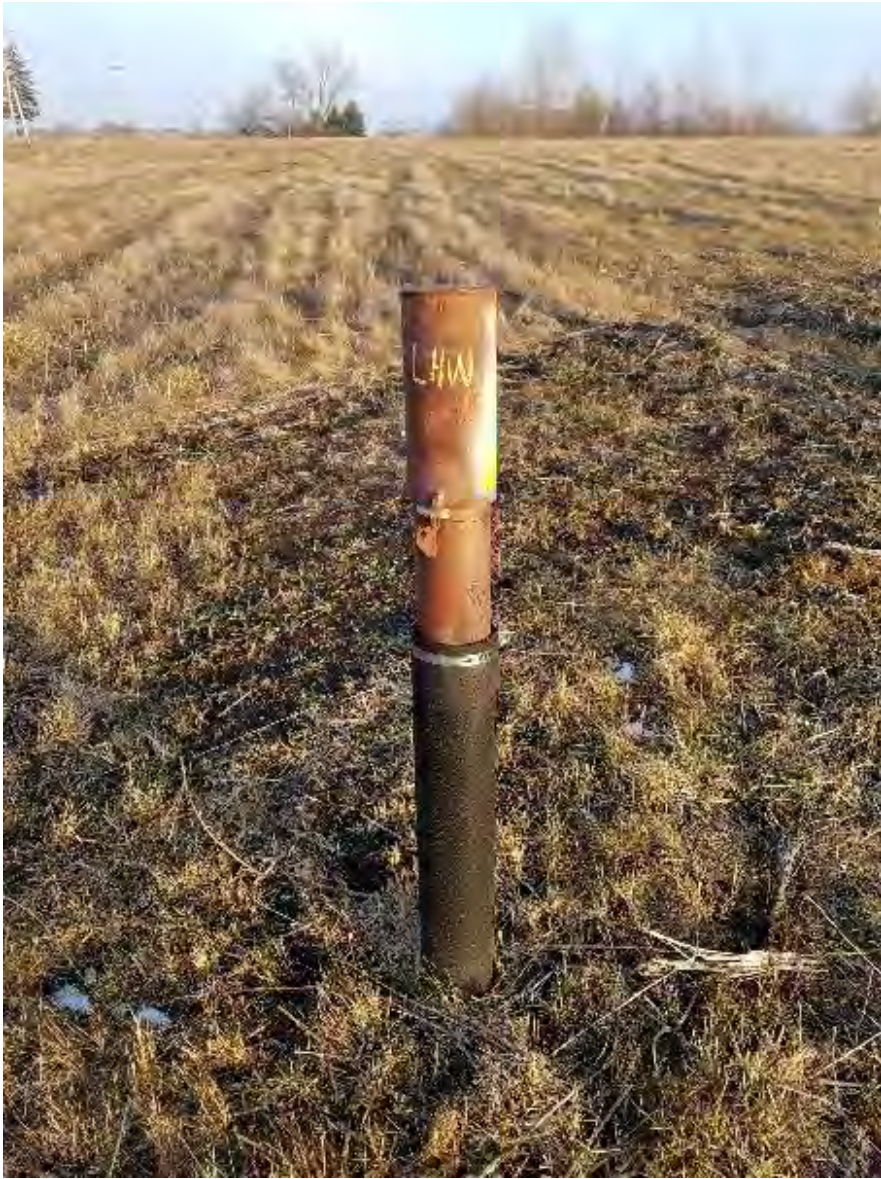
115. Un-numbered LHW E of GV-33, looking W

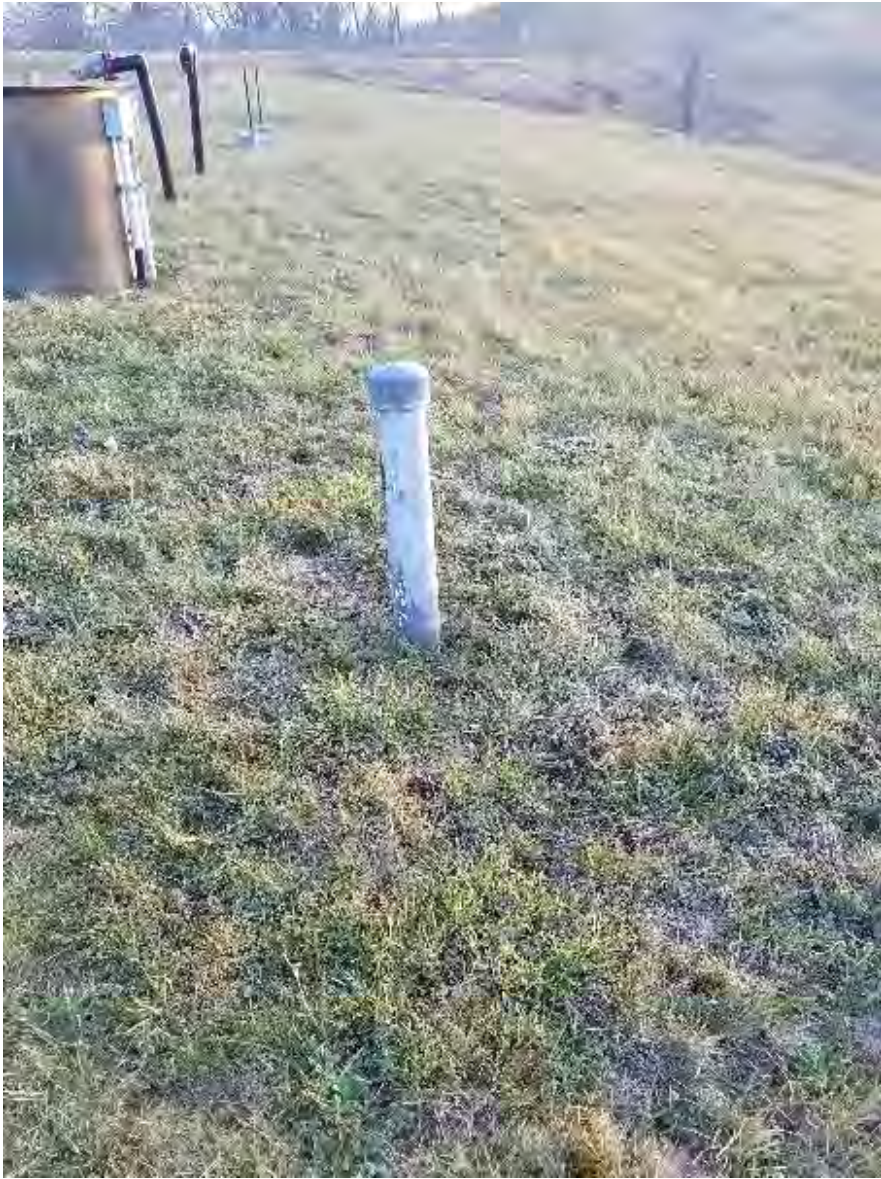
133. Possible LHW or GV, unmarked, looking S along leachate piping

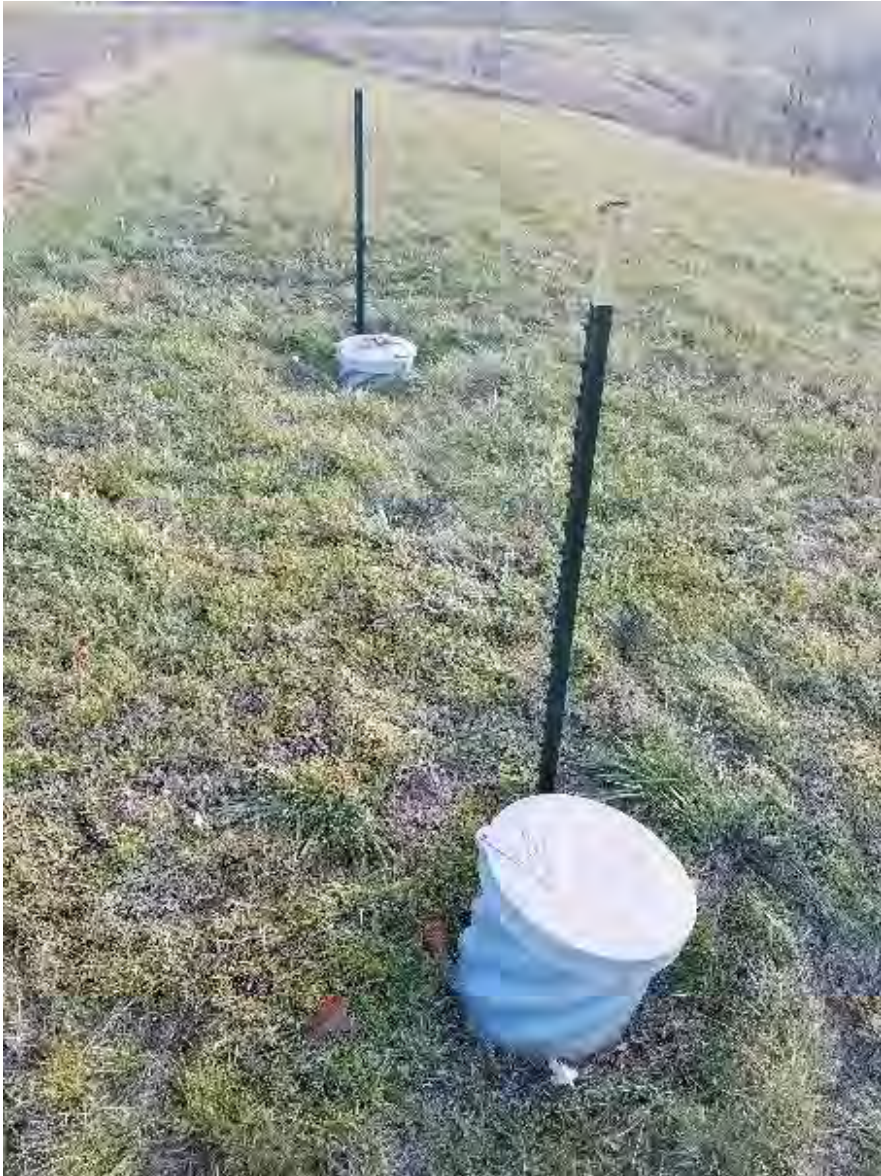
139. Possible LHW by leachate piping both unmarked, looking N

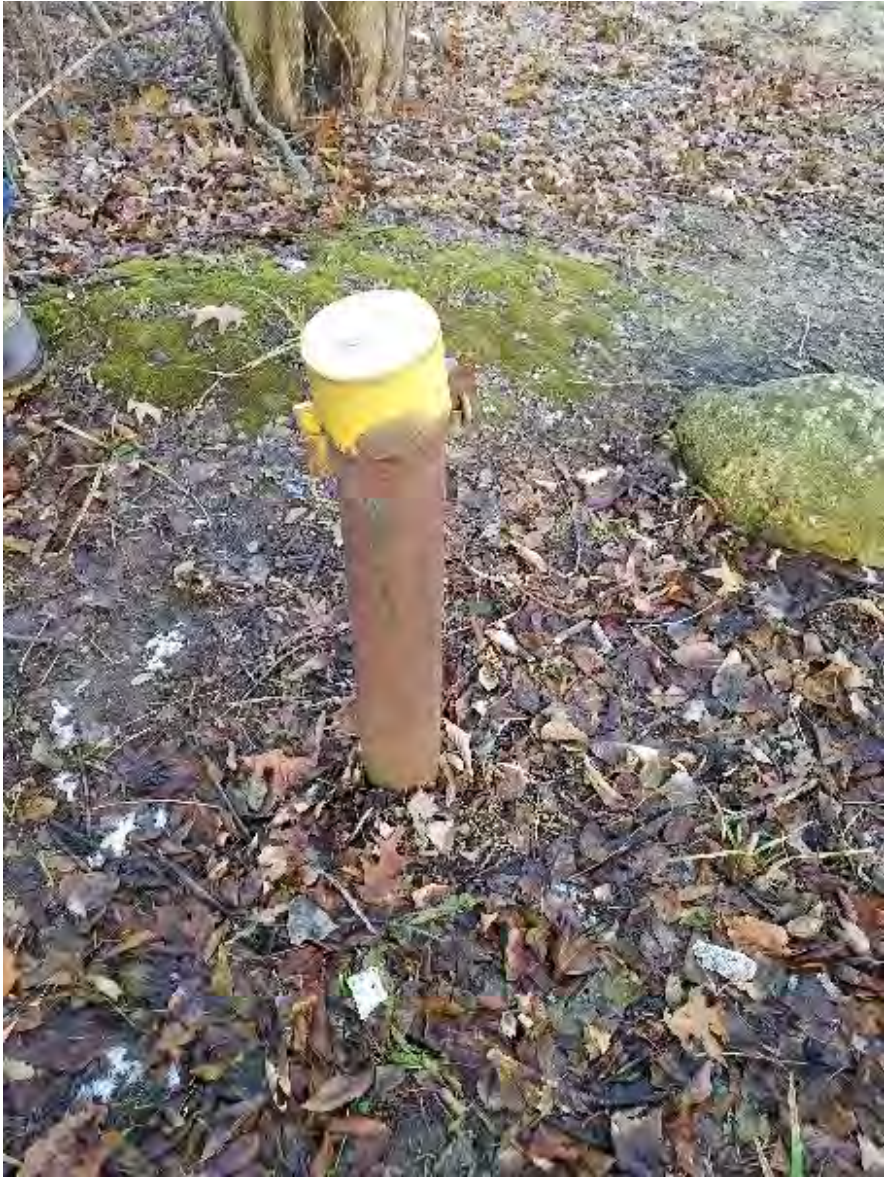
145. B-96-18A, looking NE
