# SEYMOUR ENVIRONMENTAL SERVICES, INC.

March 10, 2006

**Re: Investigation Update  
Former Highway Cleaners  
1509 Elm Street - Boscobel, Wisconsin**

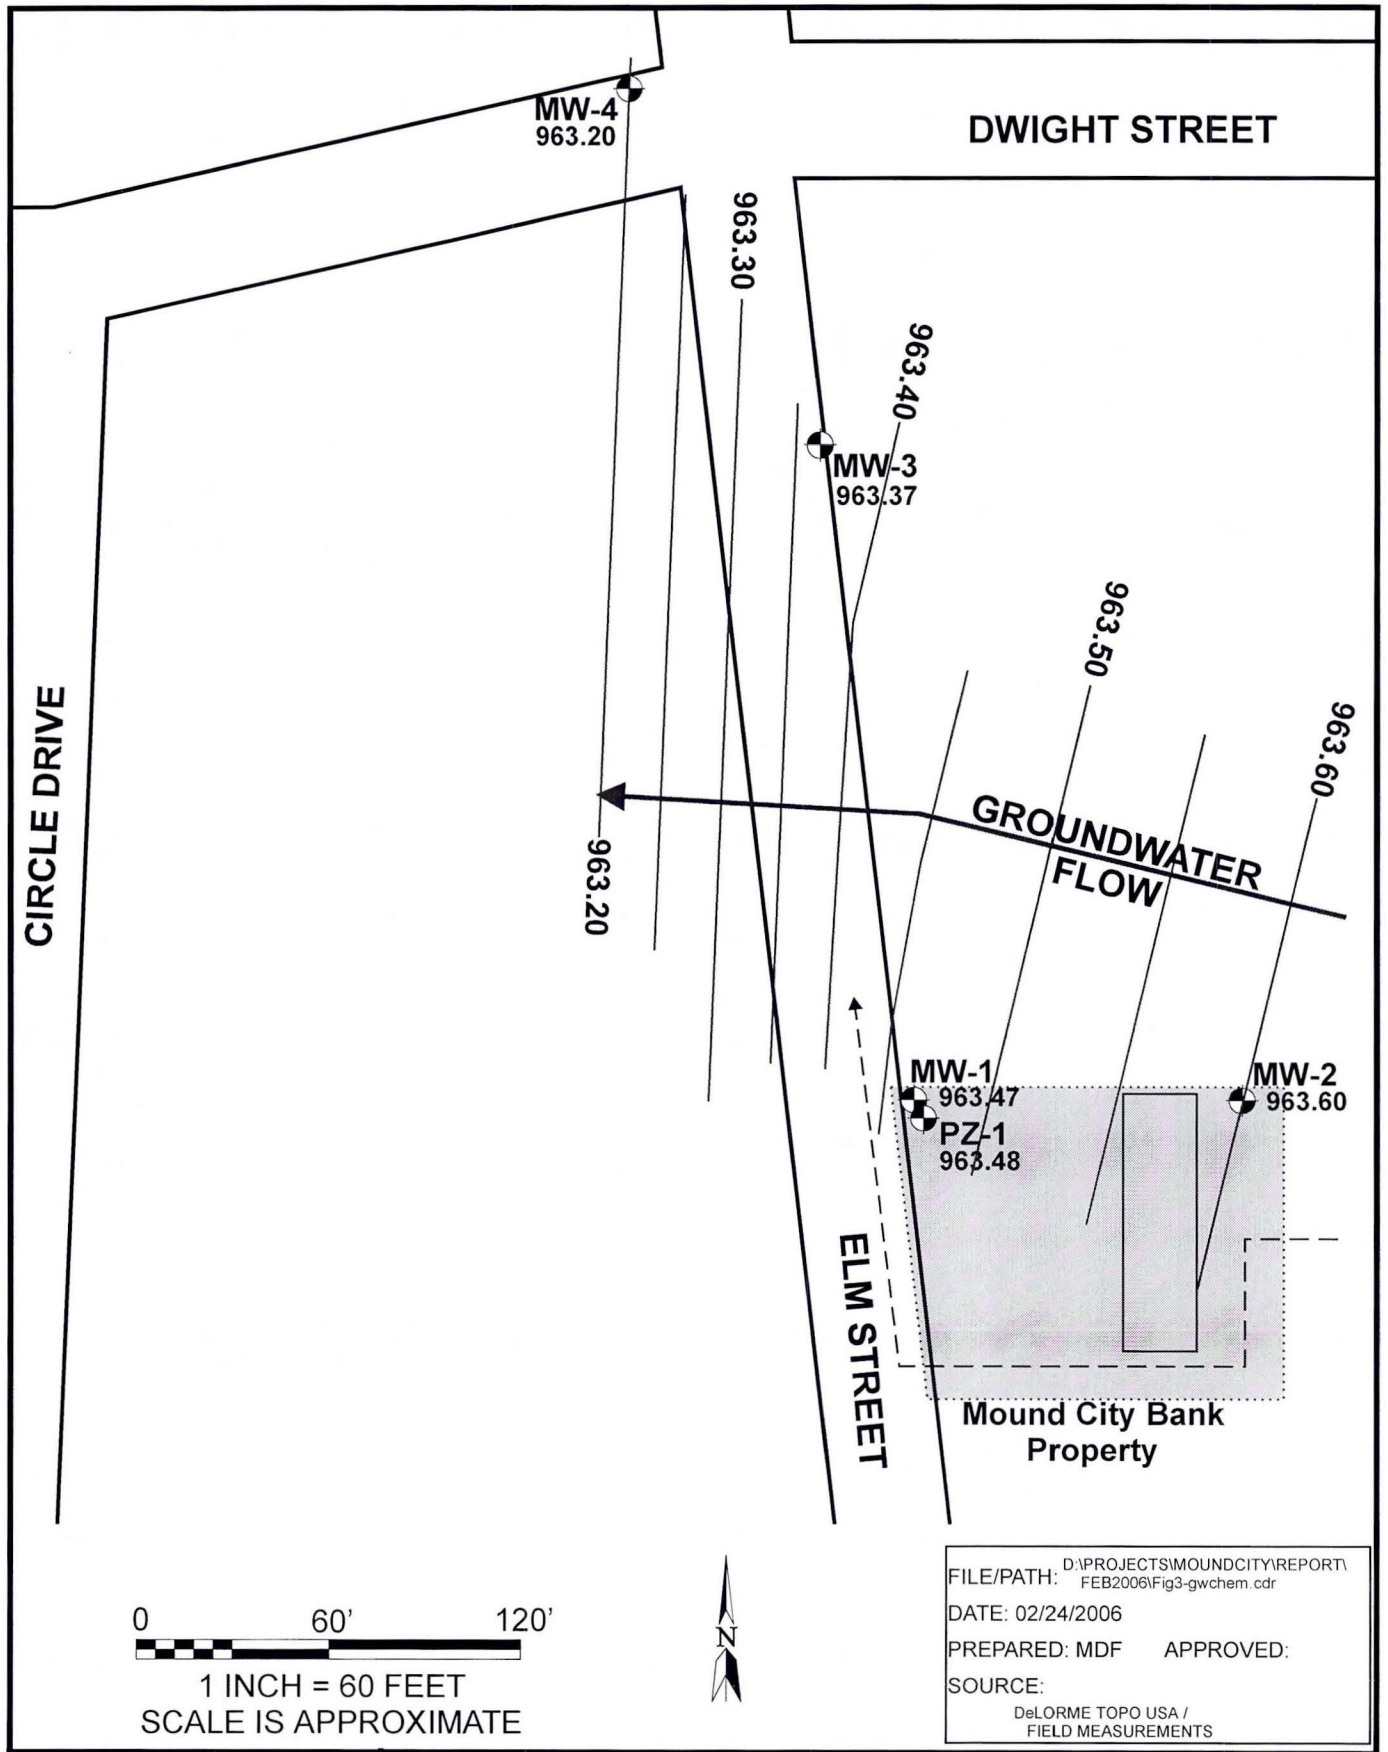
**FIGURE**  
**1**

Groundwater Flow (October 2005)  
 Mound City Bank Property  
 1509 Elm Street  
 Boscobel, Wisconsin
