Annual Inspection Report – 2015 Barrier Cap Maintenance Plan  
Skana Aluminum Co., 2009 Mirro Drive, Manitowoc, WI 54220  
VPLE # 06-36-556282  
WI DNR Environmental Repair Activity # 02-36-544601  
Facility ID # 436106110

Skana Aluminum has performed the required annual Barrier Cap Maintenance Plan inspection of the areas surrounding the 5C section facility and inside of the 5C section of the facility and is posting the results in the attached "Exhibit B".

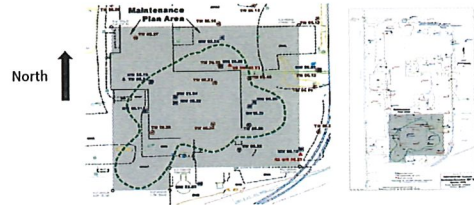
Item No  
#1 - East side of 5C Facility

Condition At Time of Inspection	Repair Conducted (if needed)
Only one 3' x 3' diameter pothole was found near the northwest corner of the parking lot

No repairs needed
