Summary of Site Investigation Results/ Evaluation of Exposure Risk Pathways

Clare Central
1003 and 1031 West Atkinson Avenue
Milwaukee, Wisconsin

August 24, 2020

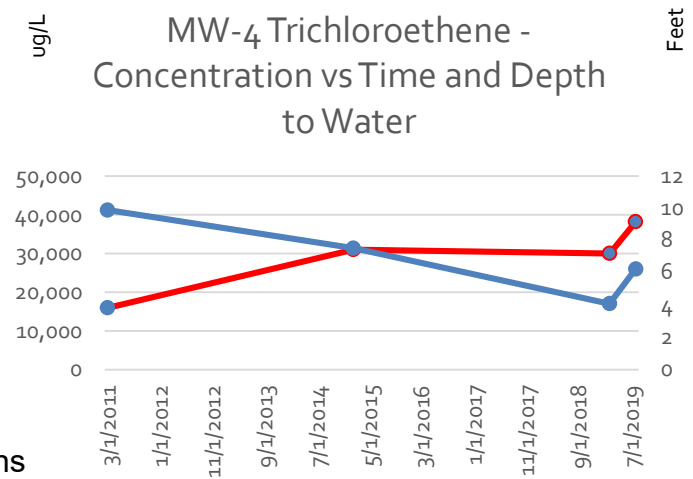
TCE Groundwater Distribution 8/26/2019

- Extent of TCE is limited to area around MW-4, near former building
- Low conductivity clay soils limit horizontal and vertical groundwater movement and contaminant migration
- Horizontal delineation complete
- Piezometer PZ-1 TCE concentration less the ES; vertical delineation complete
