Subject: Vapor Mitigation System Documentation and Maintenance Plan
Pilgrim Cleaners, 7475 Mineral Point Road #600, Madison, Wisconsin
BRRS #02-13-551995

Post Mitigation Report

Project: Pilgrim Cleaners, High Point Shopping Center

VAPOR MITIGATION SYSTEM MAINTENANCE PLAN
Pilgrim Cleaners, 7475 Mineral Point Road #600, Madison, Wisconsin

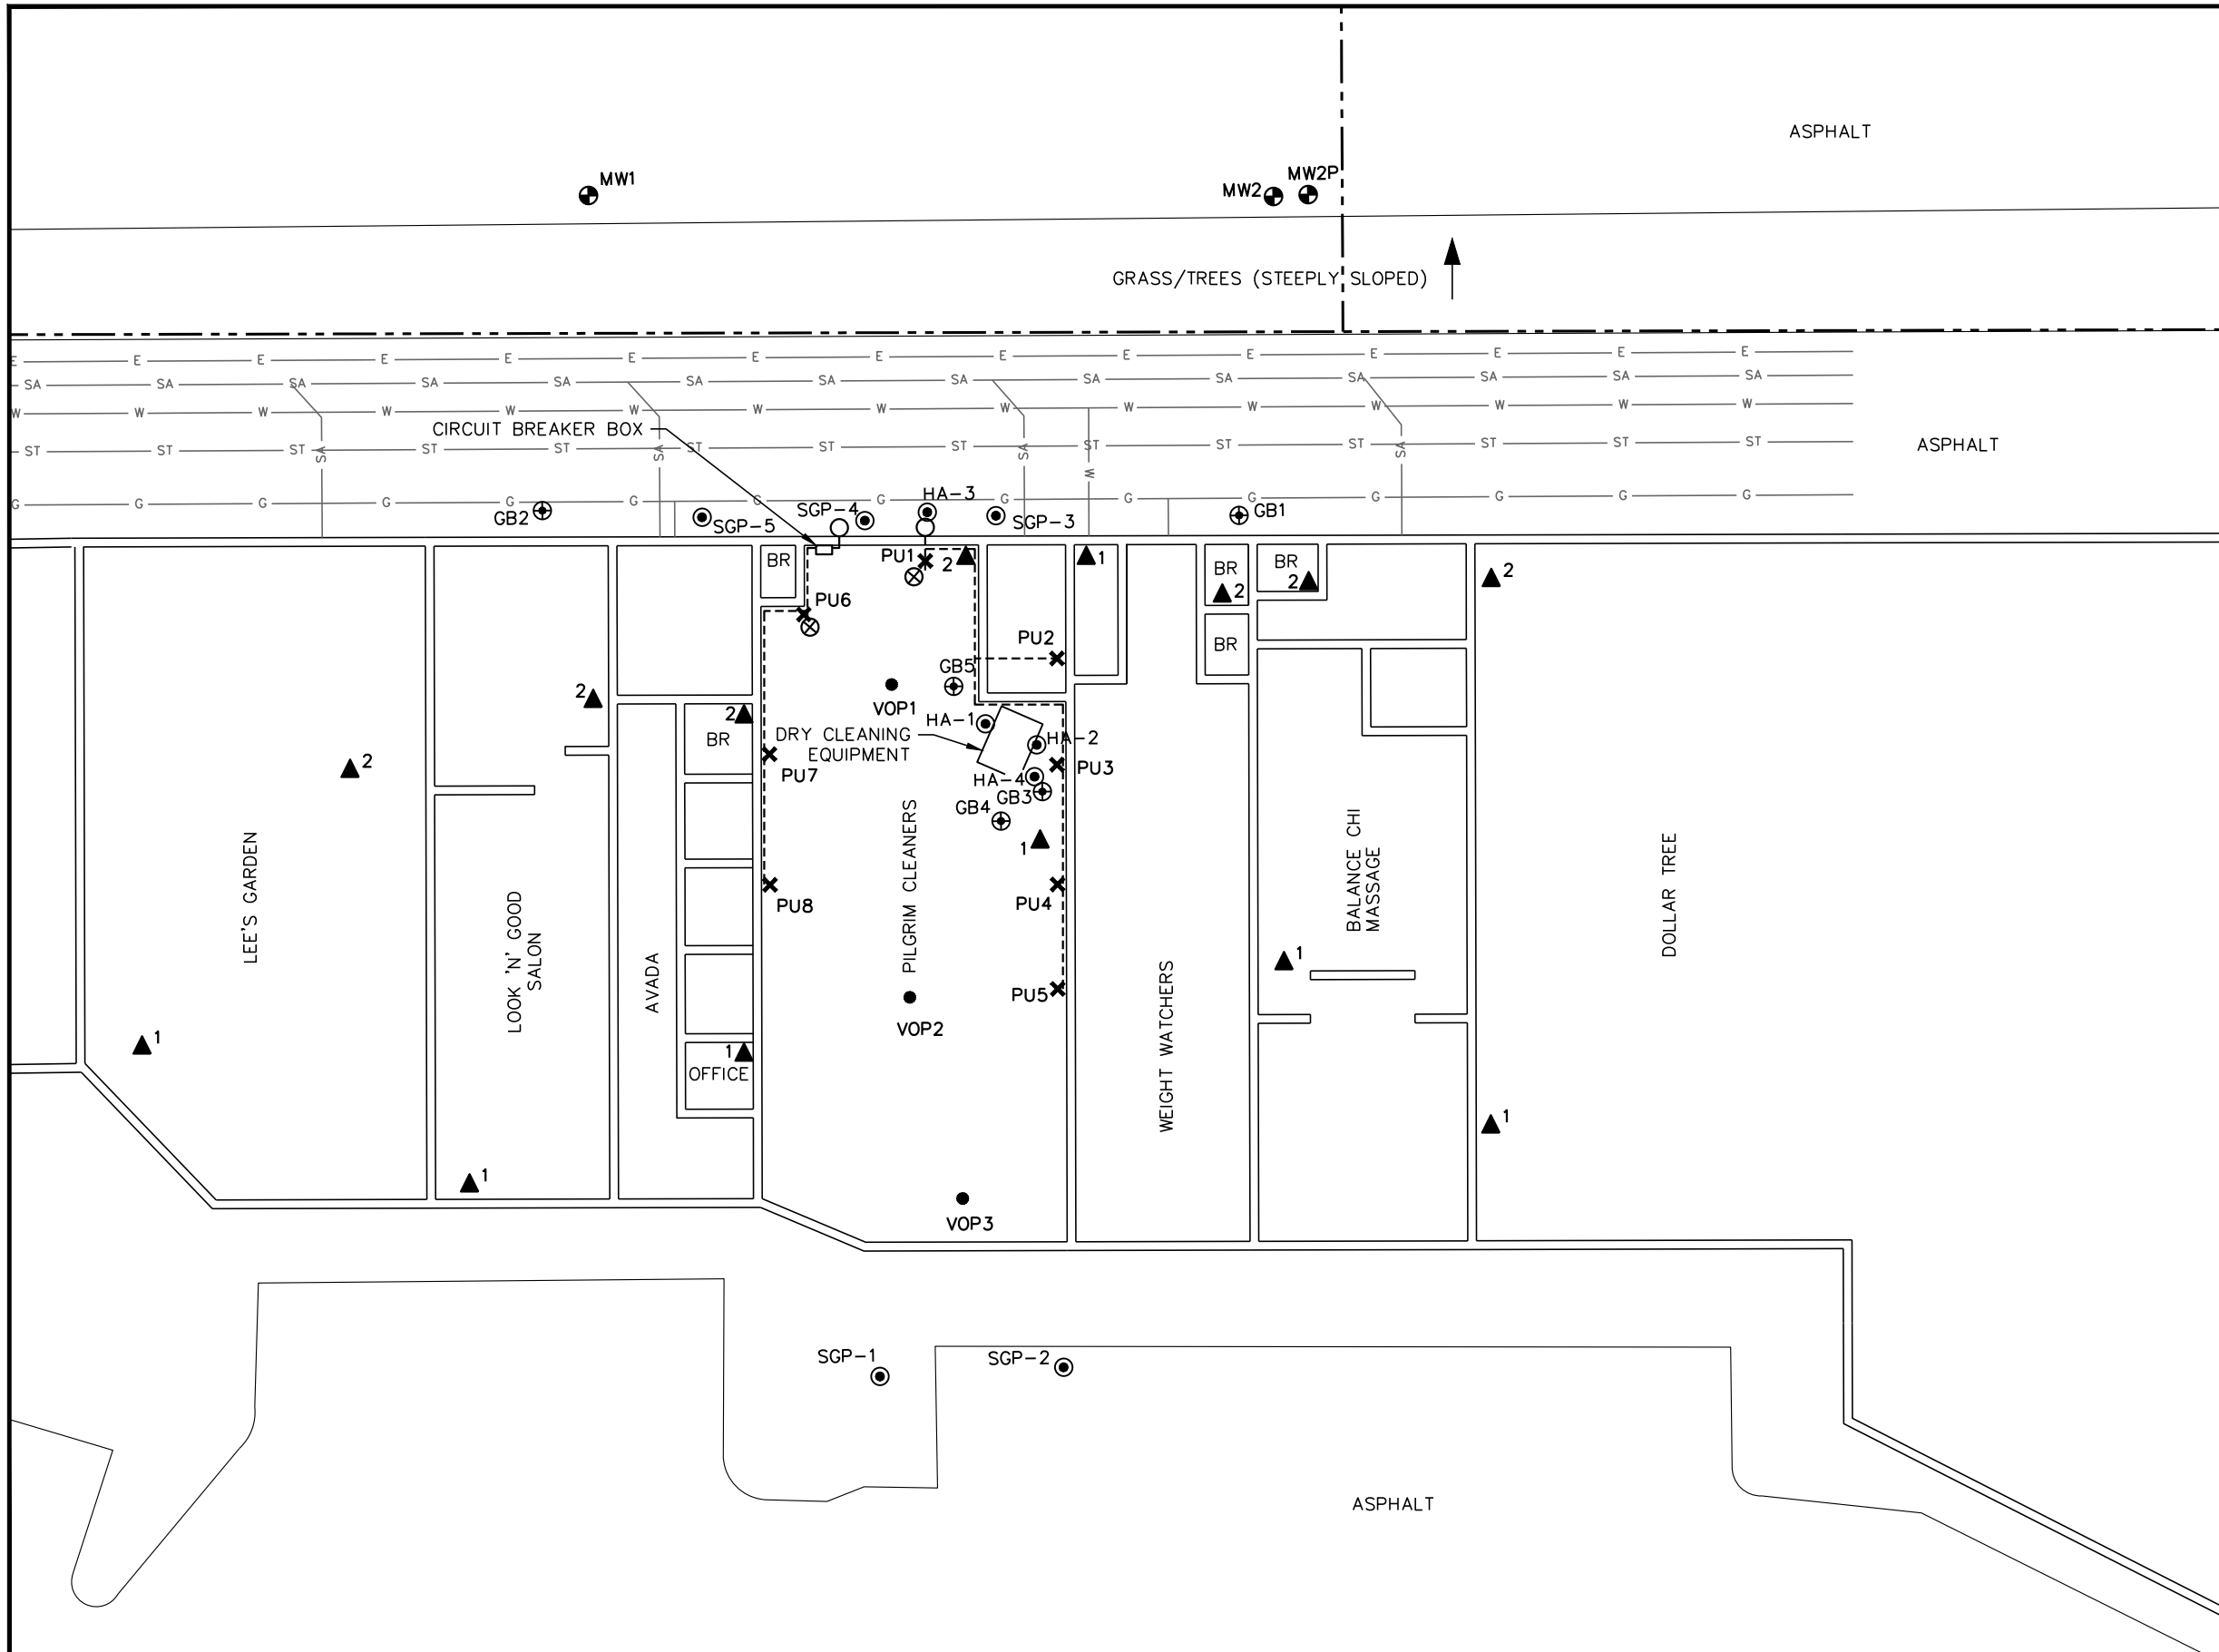
The VMS was constructed with eight vacuum pick up points at locations shown on **Figure 1**. Each pick up point was constructed with 3-inch diameter schedule 40 PVC pipe set in the sub-slab material. The PVC pipes were sealed into the floor to prevent leakage. Pick up points 1 through 5 were plumbed to 3-inch diameter PVC header pipe which runs along the south side of the dry cleaner unit. Pick up points 6 through 8 were plumbed to a separate 3-inch diameter header pipe which runs along the northern side of the dry cleaner unit. The header pipes extend through the east wall of the building. The gap between the header pipes and building wall was sealed.
