REMEDIAL ACTION REPORT

**Millennium Tiles LLC
550 East Centralia Street
Elkhorn, WI**

Report Date: September 7, 2007

NSEC Project: 07M02

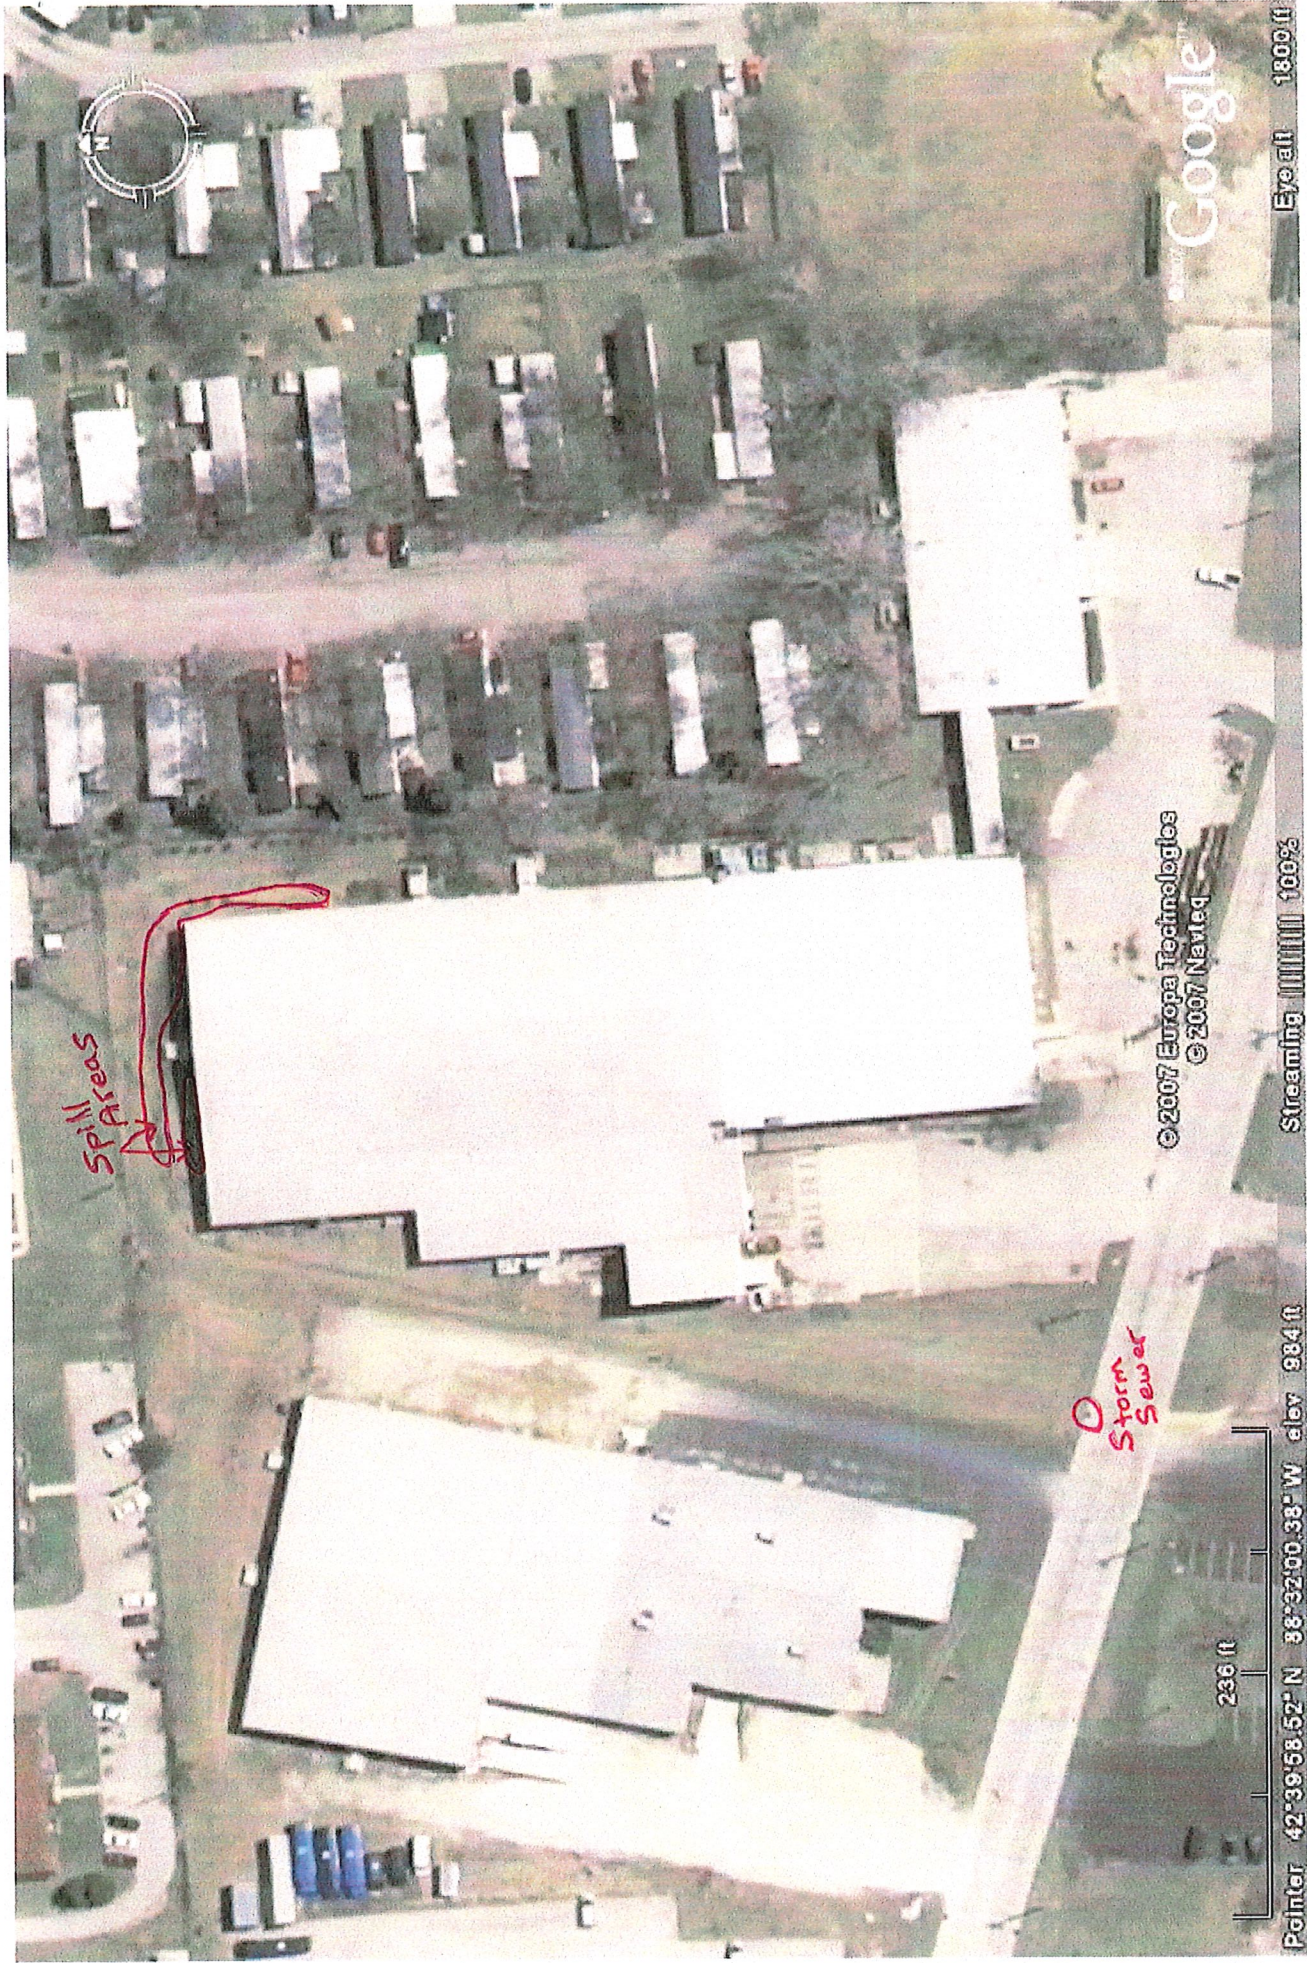
- Drains or Storm Sewers – The location(s) of the nearest drains or storm sewers to the spill, area are shown on Figure 1. The distance from the storm sewer catch basin to the closest point of the spill area is approximately 450 feet. Based on the distance of this spill to the noted drain or storm sewer, potential migration and impacts to these conduits are not believed to be an issue.

Spill Areas

Storm Sewer

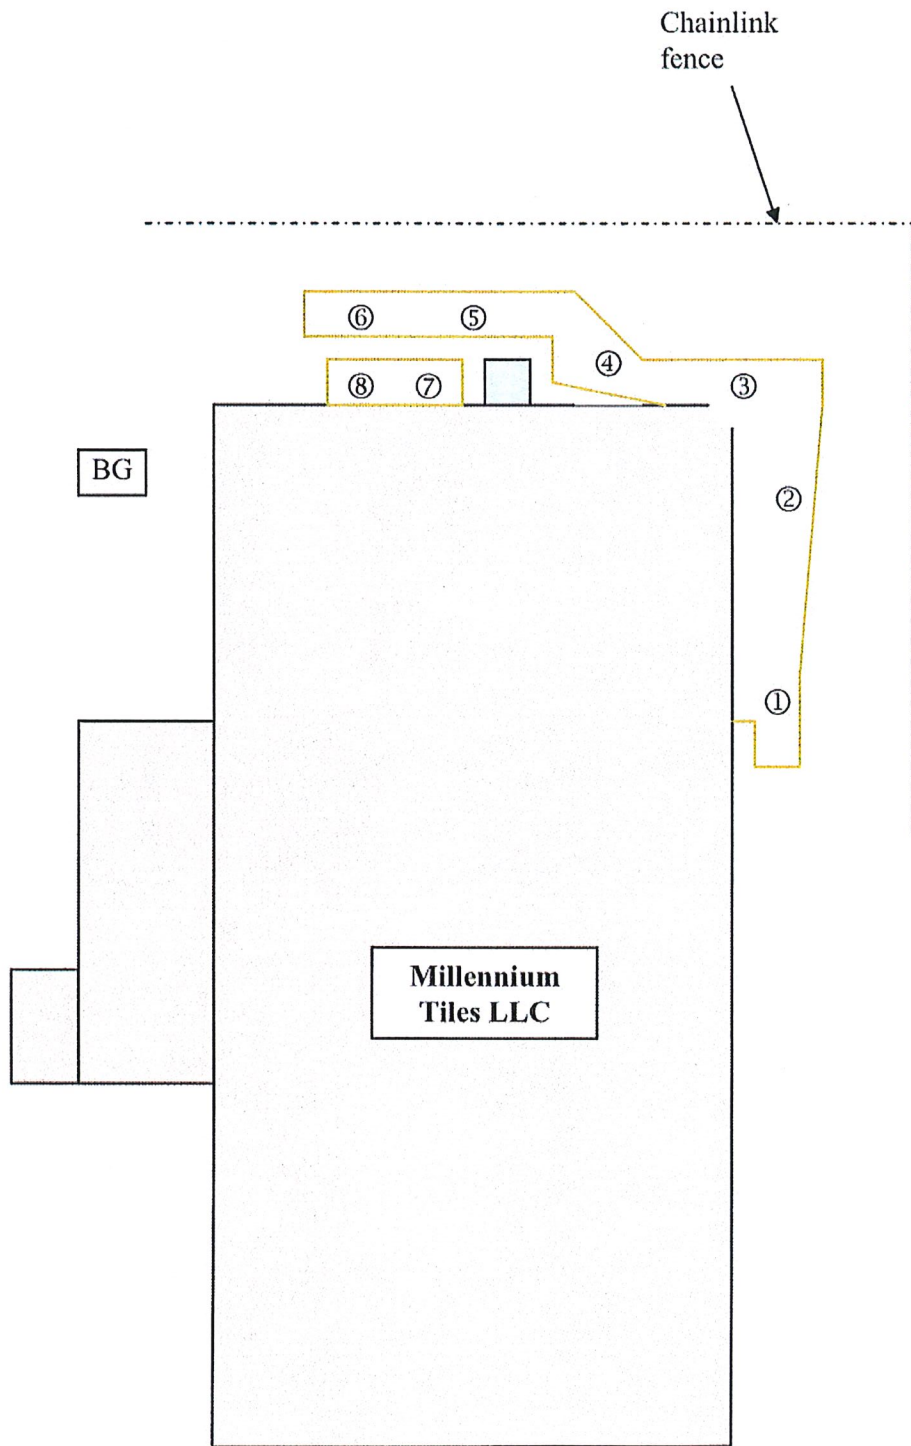
FIGURE 2

To confirm the adequacy of the response action, NSEC collected excavation base samples. A total of eight samples were collected at locations shown on Figure 2. The samples were placed directly into laboratory prepared containers, properly preserved and placed on ice. The samples were transported under a completed chain-of-custody to Accelerated Analytical in Milwaukee, Wisconsin for analysis of RCRA metals.

① = Sample location
BG = Background sample

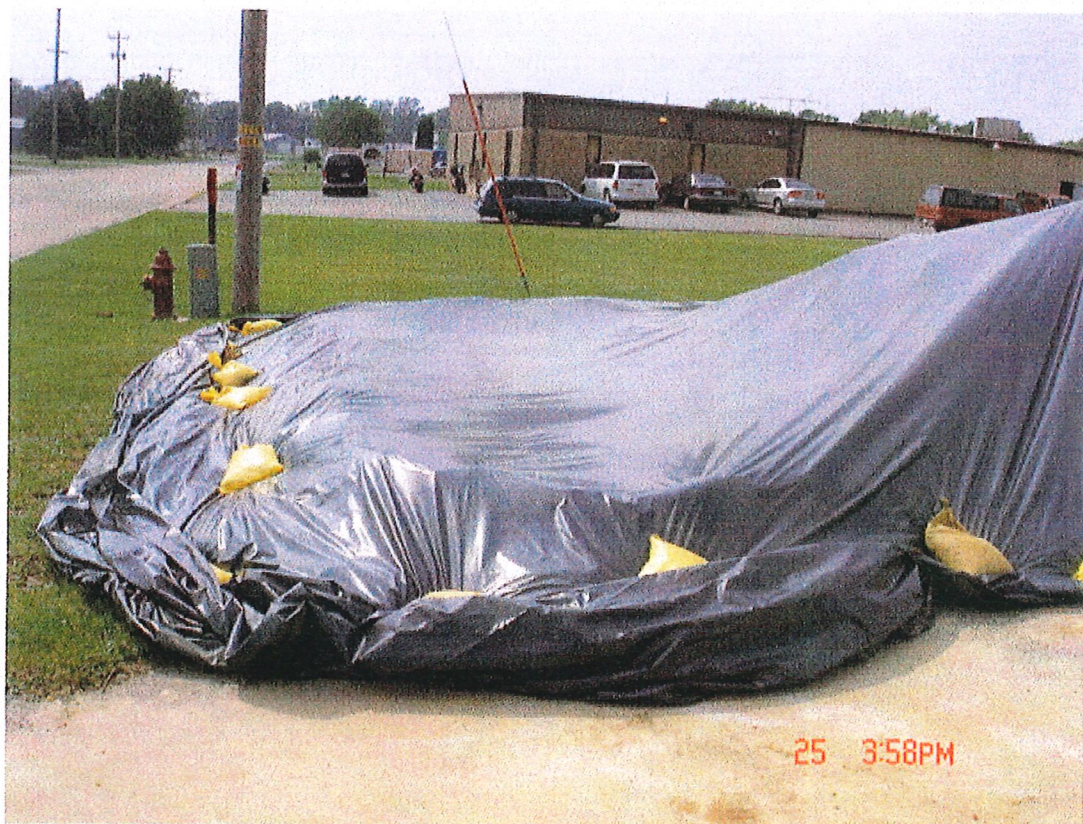
Excavated soil was stockpiled on liner, bermed and covered
