November 27, 2018
File No. 25211374.51

Subject: Summary of Pressure Field Extension Testing
Laundry Land Cleaners (former), Northgate Shopping Center
1131 N. Sherman Avenue, Madison, Wisconsin
WDNR BRRTS #02-13-552183

**Project: Northgate Shopping Center (Formerly Laundry Land Cleaners)
1131 N. Sherman Avenue, Madison, WI**

Communication (Connectivity) Testing & Design Mitigation Systems

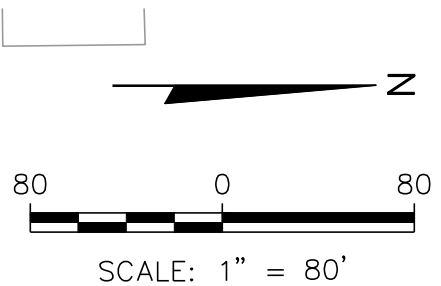
Figure 1

The PFE testing was conducted by Acura Services, LLC (Acura) in July 2018 under the supervision of SCS. Acura's summary report is included in **Attachment A**. The PFE testing was conducted within seven units of the shopping center, including Dream Bikes, Boomerangs, CSN, Naly's Floral Shop, H & R Block, Falbo Brothers Pizza, and UPS Store units (**Figure 1**)
