August 24, 2023
File No. 25222269.02

Subject: Inspection of Vapor Mitigation System
Sandie's Dry Cleaner & Laundry (Former) – BRRTS #02-45-55222
Off Site Residential Property – 135 W. Lincoln Ave

VAPOR MITIGATION SYSTEM INSPECTION

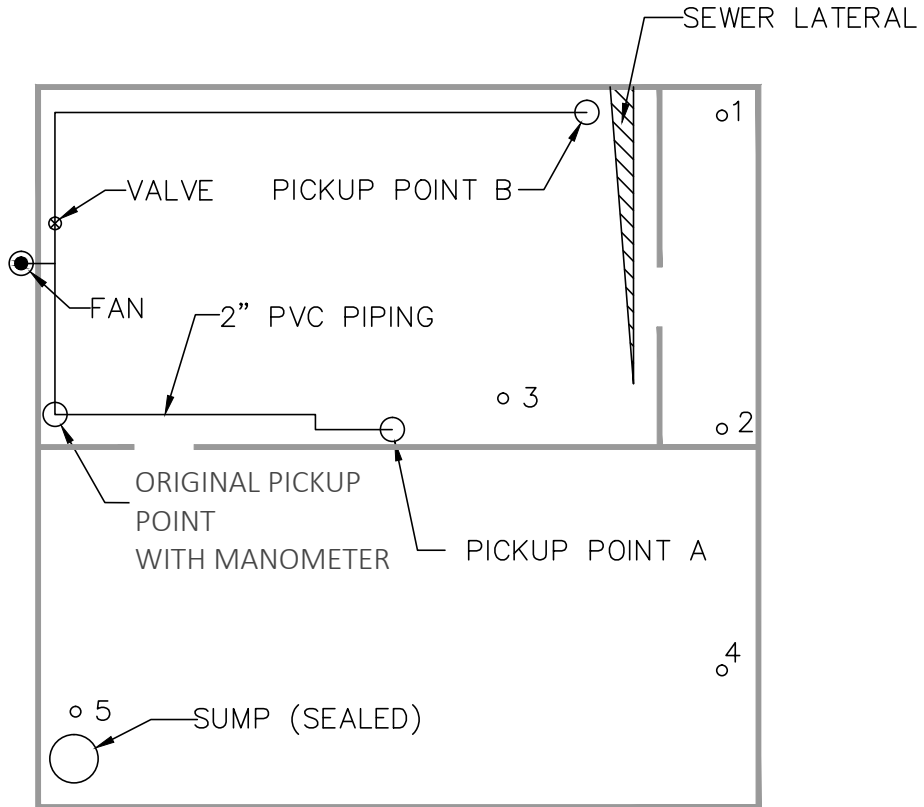
Figure 1
Sub-Slab Depressurization System

- 1 ACURA VACUUM MONITORING POINT, ASSUMED ABANDONED/ SEALED IN 2013 FOLLOWING SYSTEM UPGRADES.

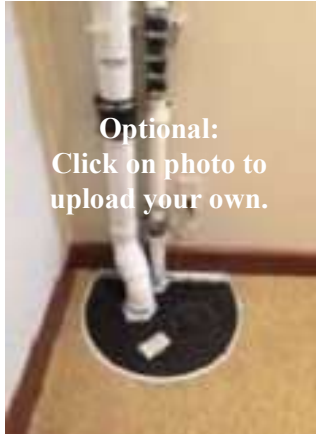
SYSTEM COMPONENT		Date of Inspection: 05/23/2023		
NAME	WHAT DOES IT DO?	WHAT DO I CHECK?	WHAT SHOULD I SEE?	WHAT TO FIX?
Sealed Sump w/Vent Pipe	<p>Sump Cover: Soil gases are collected in sump and the cover prevents soil gas from getting inside home.</p> <p>Vent Pipe: Pipe transports the soil gas from the sump for discharge to the atmosphere.</p>	Suction Point Seal	Seal is airtight to floor.	<p>Sump cover or vent pipe may need to be sealed or replaced if cracks or leaks appear.</p> <p>If any piping or sealing of the system is altered or replaced, the system should be evaluated by a plumber or a mitigation professional to verify effectiveness, which includes pressure readings.</p>
		Vent Pipe Seal Condition	Vent pipe is connected to the sump cover and is not cracked.	
PHOTO			<p>NOTES: (Identify specific building and location description:)</p> <p><input type="checkbox"/> Not Applicable</p> <p>The sump was not viewable at the time of inspection but will be inspected and documented at the time of fan replacement and active alarm installation.</p>
