Re: WDNR BRRTS #02-41-552537
Indoor Air Sampling and Sub-slab Vapor Sampling Results Report
Westwood Dry Cleaners
8731 W. North Ave
Wauwatosa, WI 53226

Indoor Air Sampling & Sub-Slab Vapor Sampling Results Report

Prepared For
Westwood Cleaners
(WDNR BRRTS#02-41-552537)
8731 West North Avenue
Wauwatosa, Wisconsin 53226

December 13, 2021

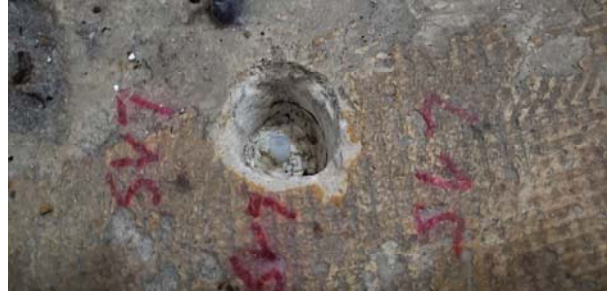
Sampling Port on Concrete Floor

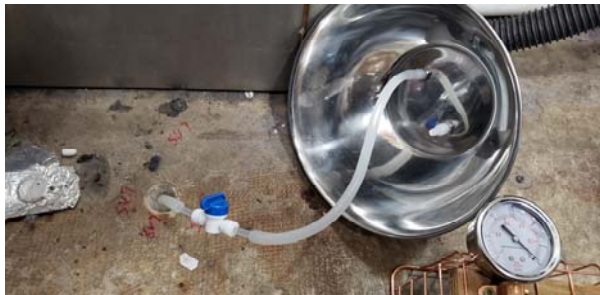
Connect to the Sampling Train

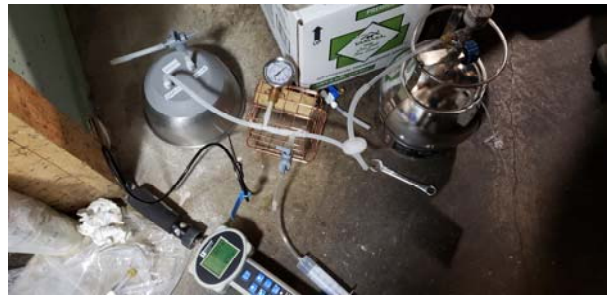
- Turn off Valve B and watch for Vacuum Gauge (A) to maintain the negative pressure without dropping. If there is a pressure drop, tighten the connections until steady pressure is observed for a minimum of 1 minute.

Shut-In Test for the Sampling Train

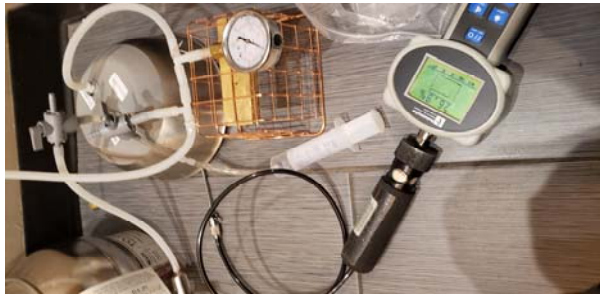
3. Helium Shroud Leaking Test
 - Turn on Valve A and place the tip of Helium Detector under the shroud near the sampling probe;
 - Turn on Valve D to supply helium to inside the shroud and watch the He concentration increase from 0 ppm to >30% with a He detector;

Supply Helium to the Shroud Covered on the Sampling Port

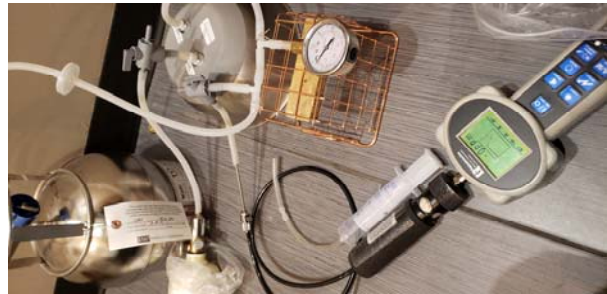
- Turn Valve B to connect Port 2 with the He detector to read the air inside the sampling train via Port 1. If the He reading is below 1% (generally <500 ppm) without increase, no leakage is present. Otherwise, tighten the connections and retest until very low concentrations of He are present in the sampling train.

Test the Sampling Train for Helium Leakage
