Re: WDNR BRRTS #02-41-552537
Indoor Air Sampling and Sub-slab Vapor Sampling Results Report
Westwood Dry Cleaners
8731 W. North Ave
Wauwatosa, WI 53226

Indoor Air Sampling & Sub-Slab Vapor Sampling Results Report

Prepared For
Westwood Cleaners
(WDNR BRRTS#02-41-552537)
8731 West North Avenue
Wauwatosa, Wisconsin 53226

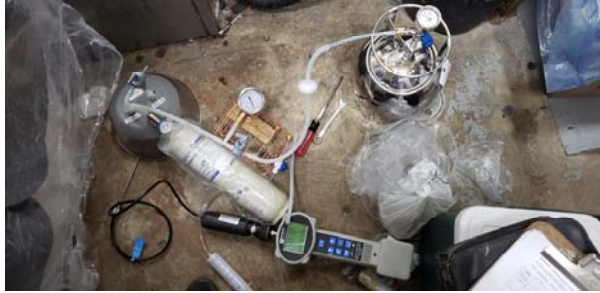
Configuration for Sub-Slab Vapor Sampling

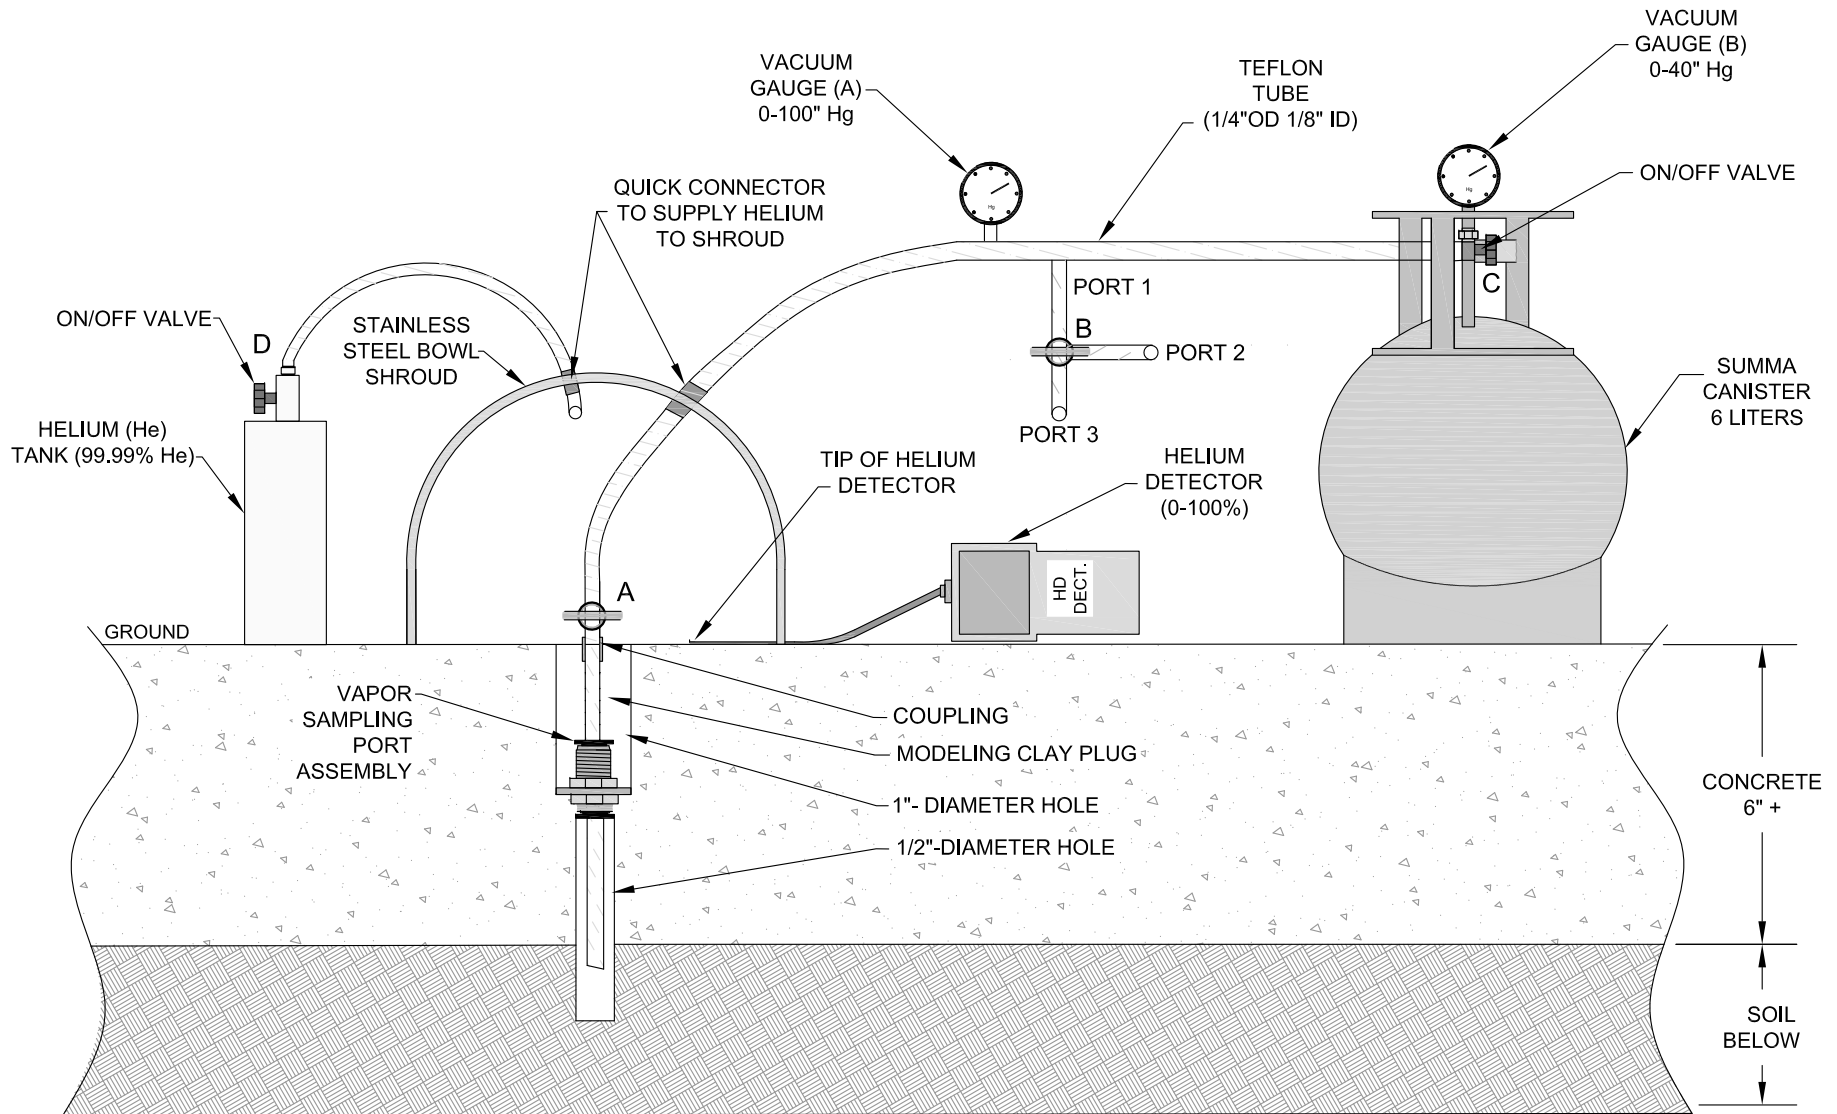
SITE NAME	Westwood Dry Cleaners (#02-41-552537)	FIGURE NO.	5b
FIGURE NAME	Sub-Slab Soil Gas Sampling Diagram		
ADDRESS	8731 West North Avenue, Wauwatosa, WI 53226

The configuration of the sampling train is illustrated in Figure 5b, and described as follows.

1. Tightly connect the sampling train to the sampling port on the concrete floor as shown in the Figure 5b, and keep valves A, B, C, and D in the off-position.
