Client:	SaberCor, LLC 8440 W. National Ave. West Allis, WI 53227	Property Inspected:	Landmark Credit Union 106 E. Main Street Beaver Dam, WI 53916
On-site Inspector:	Patrick Stearns	Inspection Date:	May 15, 2018

A site visit and visual inspection took place on May 15, 2018. Both Lots #9 & #10 were inspected. This report provides information regarding the current state of the pavement and our recommendations on how to best fulfill the required objective.

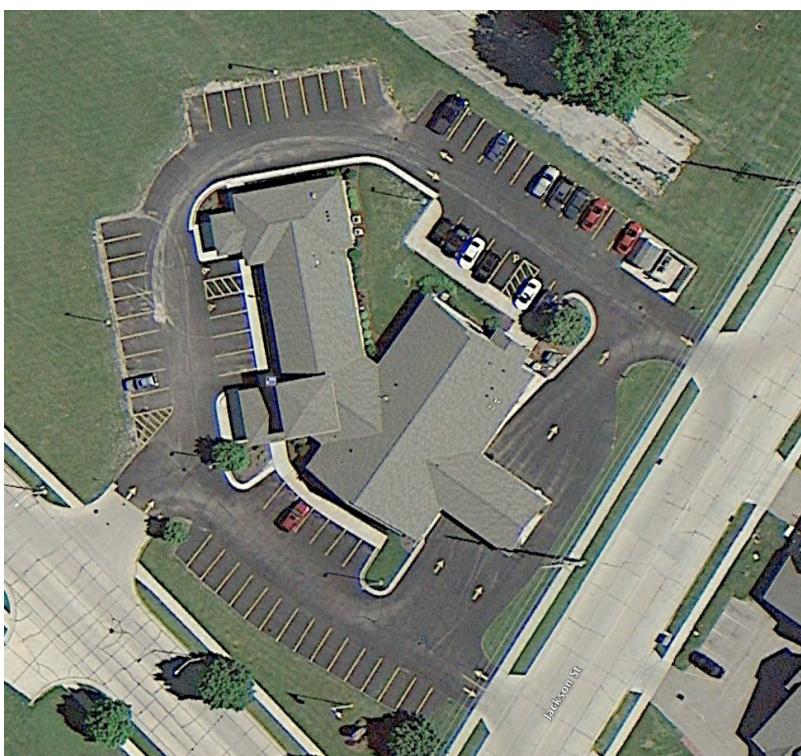
Total Size: 31,930 S.F. (Lot 9 & Lot 10)

The current (visual) condition of the parking lot would indicate the parking lot is approximately 6 -10 years old with a projected service life of 20-years (if properly and routinely maintained).

You'll notice from the photos below, the pavement is currently showing signs of minor structural cracking. This type of distress is considered normal and should be properly maintained by either a crack-filling *or* crack-sealing procedure. The pavement surface has been professionally seal coated within the past 3-years and there are no indications or signs of any surface failure. Overall, the pavement surface is in very good condition with only minor areas of thermal cracking due to cold weather conditions.

1. Clean & crack-fill longitudinal and transverse thermal cracks that are ¼- inch wide or wider, by either simple band-aid method or standard recessed & band-aid method, to ensure water is kept out of the pavement sub-grade and sub-base.
