**From:** DiMaggio, Janet H - DNR  
**Sent:** Tuesday, October 18, 2022 1:38 PM  
**To:** DiMaggio, Janet H - DNR  
**Subject:** FW: Former Carriage Trade, 5710 Raymond Road, Madison, WI - VMS audit documentation

Address Being Inspected (e.g., 123 N. Main St.): 5712 Raymond Rd Madison WI 53711 Date of Inspection: 10/14/2022

Inspection Performed By (Name & Title/Company): Brian Thompson Lifetime Radon Solutions

### Vapor Mitigation System Inspection Log

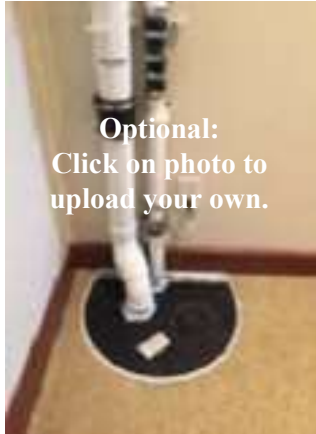
SYSTEM COMPONENT		Date of Inspection: 10/14/2022		
NAME	WHAT DOES IT DO?	WHAT DO I CHECK?	WHAT SHOULD I SEE?	WHAT TO FIX?
<b>Sealed Sump w/Vent Pipe</b>	<b>Sump Cover:</b> Soil gases are collected in sump and the cover prevents soil gas from getting inside home. <b>Vent Pipe:</b> Pipe transports the soil gas from the sump for discharge to the atmosphere.	Suction Point Seal  Vent Pipe Seal Condition	Seal is airtight to floor.  Vent pipe is connected to the sump cover and is not cracked.	Sump cover or vent pipe may need to be sealed or replaced if cracks or leaks appear.  If any piping or sealing of the system is altered or replaced, the system should be evaluated by a plumber or a mitigation professional to verify effectiveness, which includes pressure readings.
PHOTO			<b>NOTES:</b> (Identify specific building and location description:)

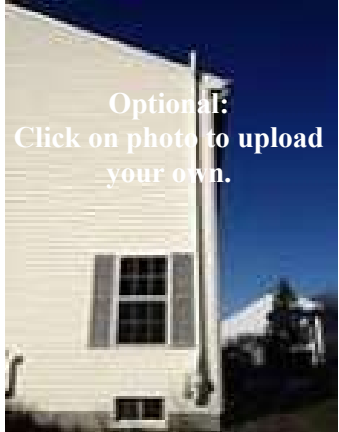
SYSTEM COMPONENT		Date of Inspection: 10/14/2022		
NAME	WHAT DOES IT DO?	WHAT DO I CHECK?	WHAT SHOULD I SEE?	WHAT TO FIX?
<b>Outdoor Vent Pipe</b>	Pipe transports the soil gas from beneath the foundation for discharge to the atmosphere.	Vent Pipe Condition  Vent Pipe Location	Vent pipe remains connected to fan. End of pipe free from obstructions. The exhaust is more than 15 feet from windows or air intakes.	Vent pipe may require replacement, or cleaning to remove ice or debris.  If any piping or sealing of the system is altered or replaced, the system should be evaluated by a mitigation professional to verify effectiveness, which includes pressure readings.
PHOTO			<b>NOTES:</b> (Identify specific building and location description:)

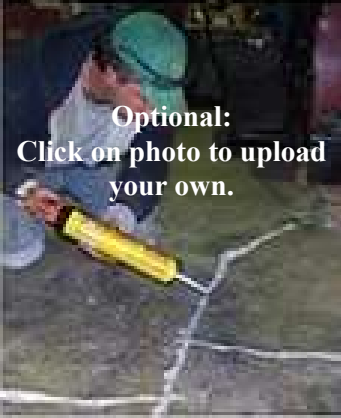
SYSTEM COMPONENT		Date of Inspection: 10/14/2022		
NAME	WHAT DOES IT DO?	WHAT DO I CHECK?	WHAT SHOULD I SEE?	WHAT TO FIX?
Foundation Floor	Foundation is a barrier that minimizes soil gas entry into building, and helps fan to work efficiently.	Foundation Condition	No penetrating cracks or holes in foundation.	Seal cracks or other penetrations as you would to prevent water from entering.
		Foundation Footprint	Check if there have been alterations or additions to building or footprint.	If building floor plan has changed, notify DNR and contact a mitigation professional to evaluate if modifications to the vapor mitigation system are necessary.
PHOTO			<b>NOTES:</b> (Identify specific building and location description:)

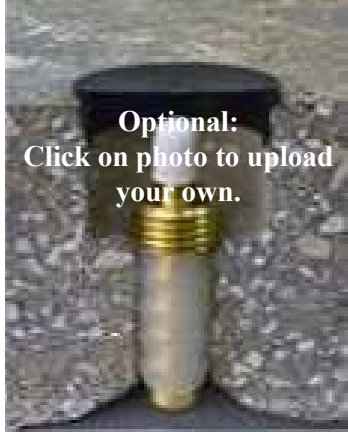
SYSTEM COMPONENT				Date of Inspection:	10/14/2022
NAME	WHAT DOES IT DO?	WHAT DO I CHECK?	WHAT SHOULD I SEE?	WHAT TO FIX?	
Sub Slab Vapor Port	This is a sample port to measure vacuum or take sample of soil gas if needed. It needs to remain sealed when not in use to prevent soil gas entry into the home.	Port Seal/Cap	If able to measure the vacuum with a micromanometer, the pressure differential should be at least 0.004 inches of H <sub>2</sub> O or at least one Pascal.	Repair or replace the seal and cover as needed.	
		Port Condition	Port is sealed and capped when not in use.	Permanently seal hole if sample port is ever removed.	
PHOTO			<b>NOTES:</b> (If taken, record the pressure differential reading. Identify specific building and location description:)
