FILE REF: Allyn Property
BRRTS # 02-31-564071

SUBJECT: Indoor Air Sampling at 109 Steele Street, Algoma, WI

SUBJECT: Initial Basement Evaluation at 109 Steele Street, Algoma, WI

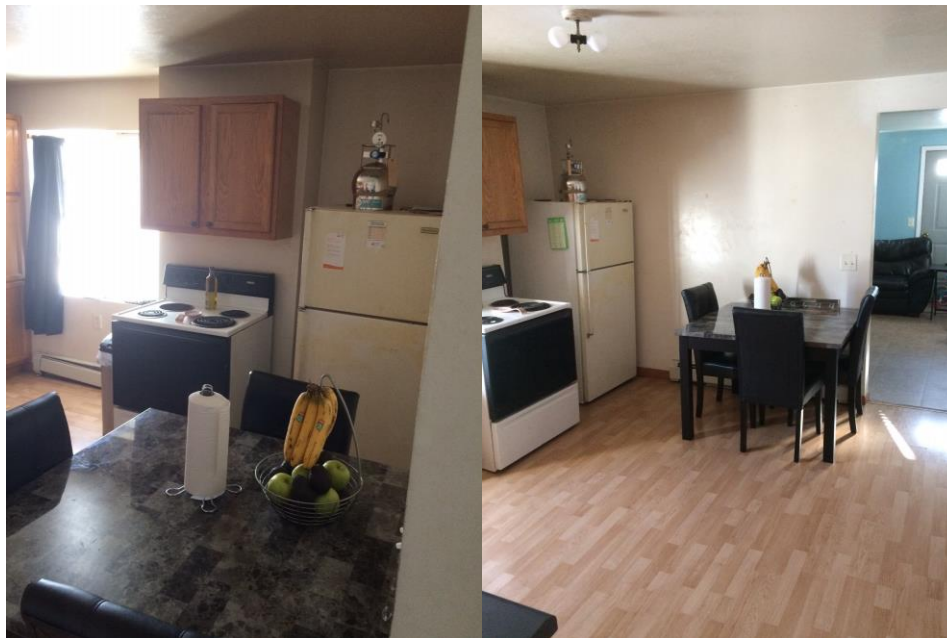
Picture 1 – left: looking east across apartment unit. The Summa canister is on top of the fridge.

Picture 2 – right: looking south-southeast across apartment unit, Summa canister in middle interior portion of the apartment unit on top of the fridge.

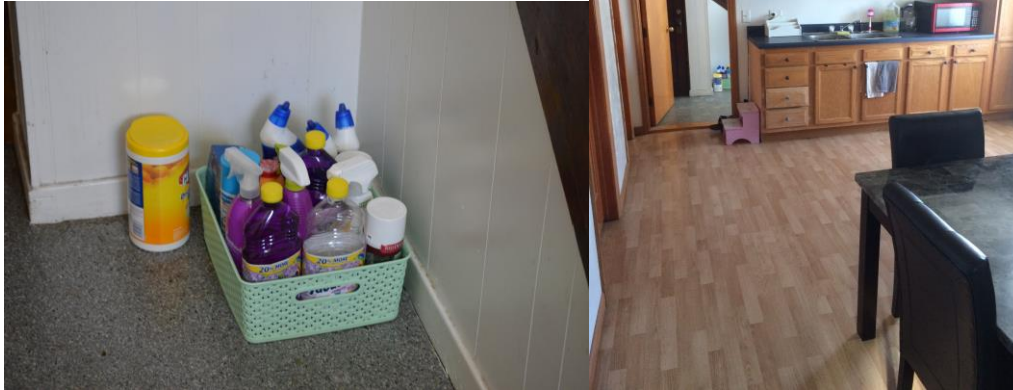
Picture 3 – left: Household materials removed on December 21, 2016.

Picture 4 – right: looking north across the apartment unit.

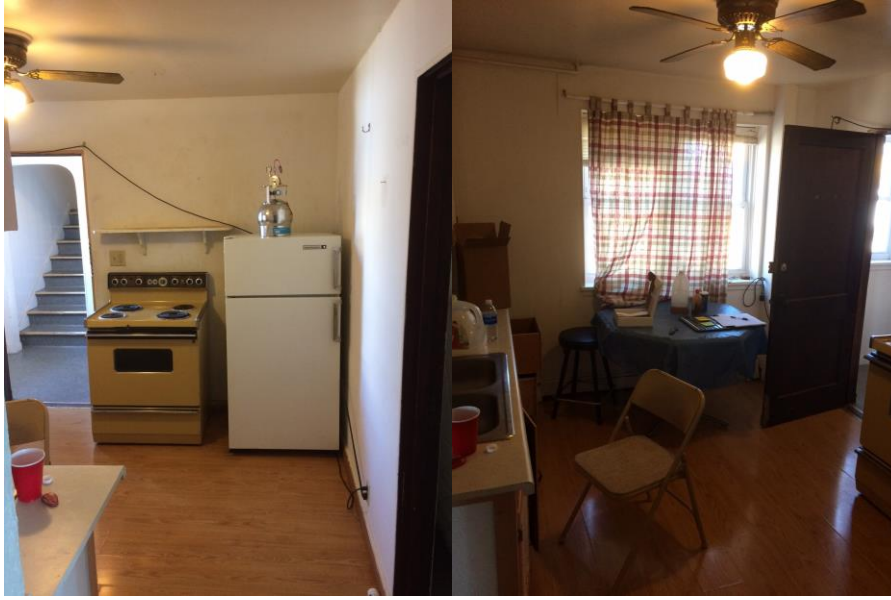
Picture 1 – left: looking north across the apartment unit. The Summa canister is located on top of the fridge. Entry to bedroom shown on right side of photo.

Picture 2 – right: looking west across the apartment unit. There were three other vacant rooms in the unit.

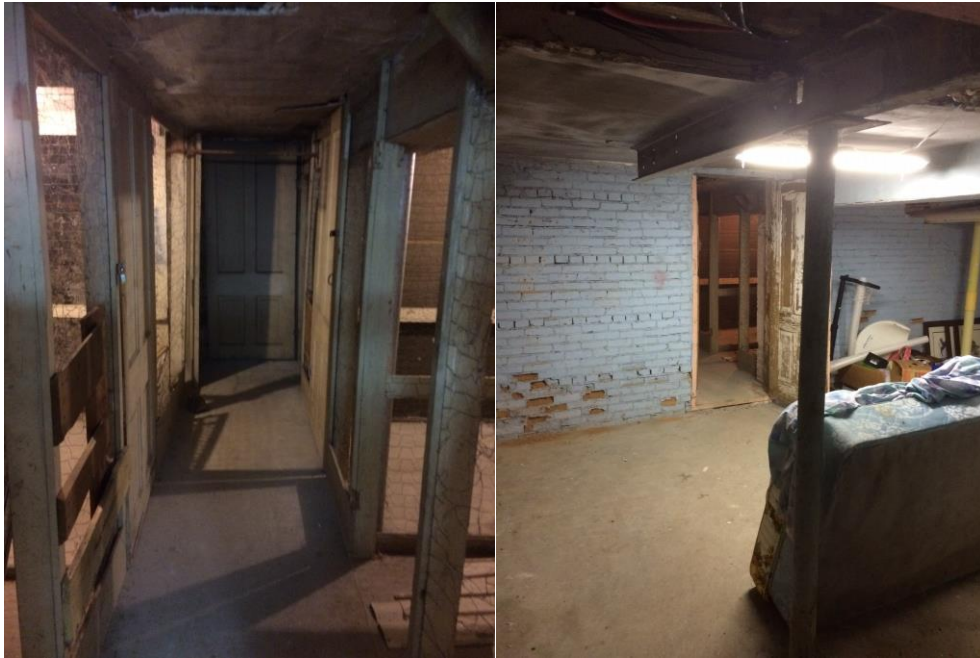
Picture 1 – left: Looking south at southernmost storage room, individual storage unit setup.
Picture 2 – right: Looking south-southwest at doorway to individual storage unit room and next storage room to the north.

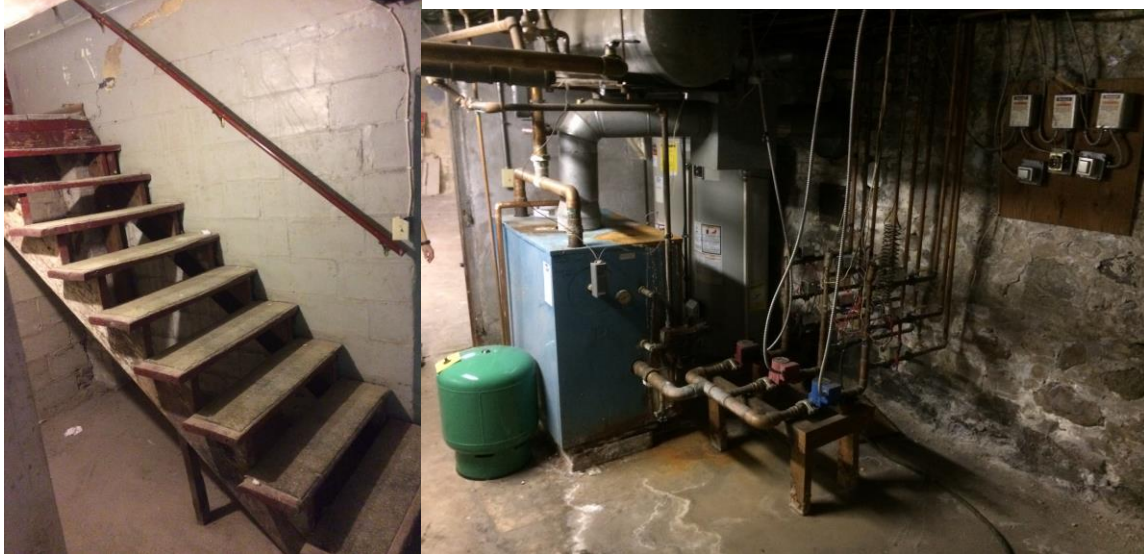
Picture 5 – left: Southern stairway entry

Picture 6 – right: Looking to the north-northeast at boiler room

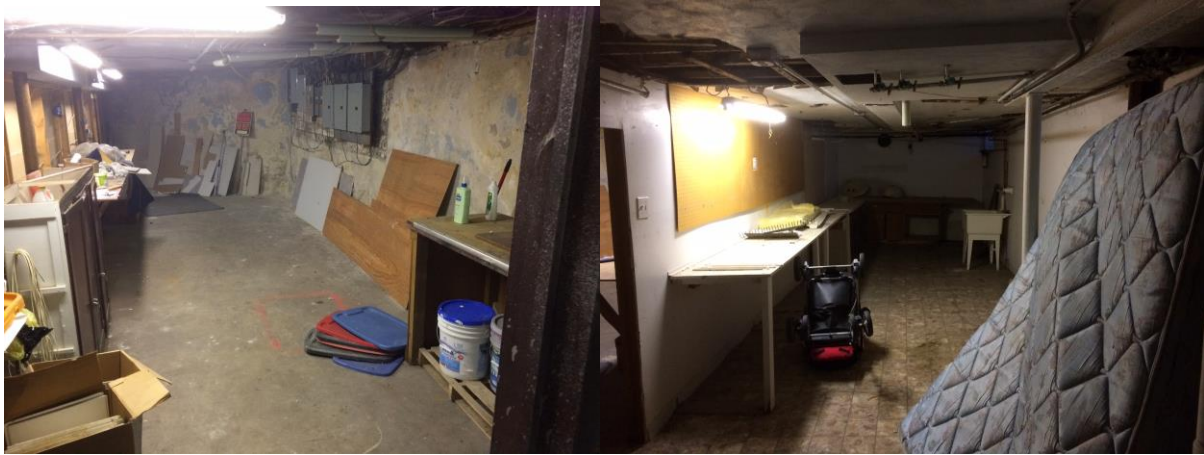
Picture 9 – left: Looking from north entry of boiler room to the north across the northeast storage room. The wall (slanting to the northwest) at the back of the photo is the north wall of the building.
Picture 10 – right: Looking from the north stairway entry to the south across the northwest storage room. Entryway to northeast storage room shown on left side of photo.

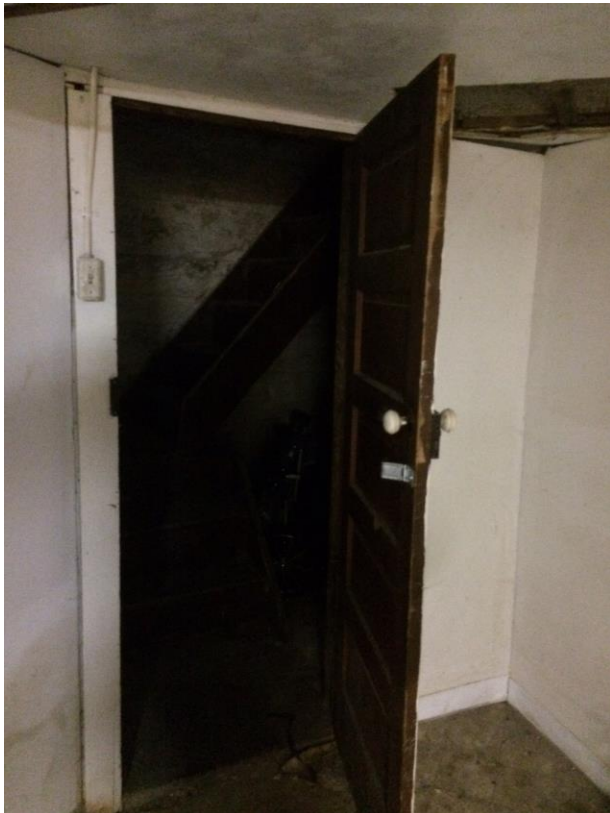
Picture 11 – Looking north at the entryway to the north stairway access. The wall behind the stairs is the north wall of the building.
