Subject: Addendum to Site Investigation Report

BMO Harris Bank Property

900 E. Main Street Merrill, Wisconsin

PSI Project No. 00541993 BRRTS No. 02-35-584409

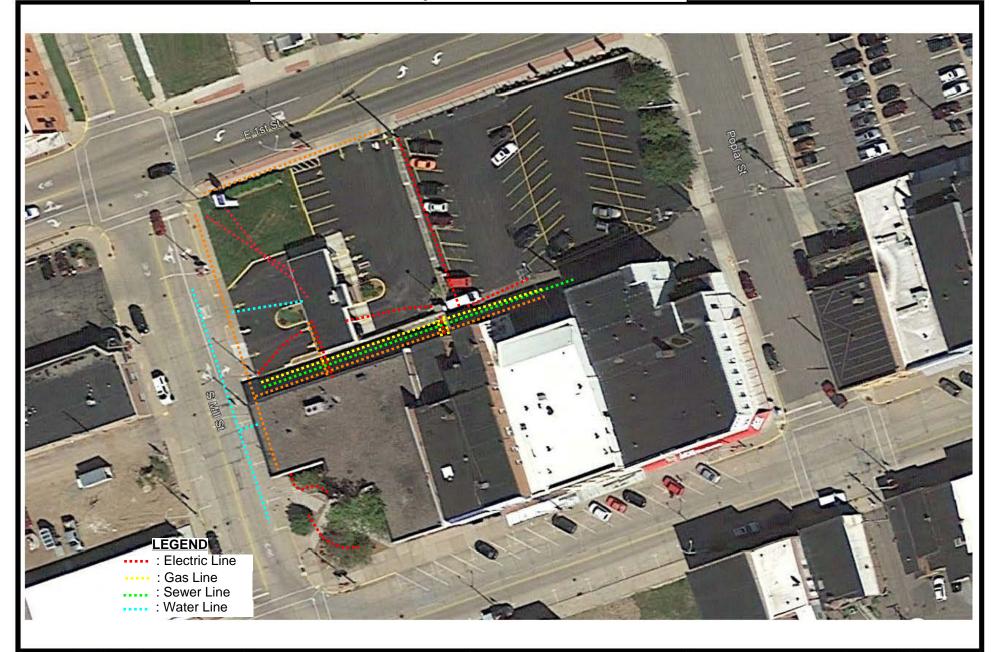
BURIED UTILITIES DIAGRAM PSI Project No. 00541993

The email indicated that it was needed to identify if any nearby public or private potable wells were in the area of the Subject Property and show the locations of utilities on and nearby the parcel. PSI had prepared a utility line location diagram, which was unintentionally not included in the Site Investigation Report. A copy of the buried utilities diagram is included herein. It indicates that the only utilities that cross the area of residual soil contamination are shallow private electrical lines. PSI also contacted the City of Merrill Water Department to inquire about the presence of public city wells and private potable wells in the area of the Subject Property. The representative indicated that the nearest public city well is about 2 miles to the west of the Subject Property. The representative indicated that no private potable wells are allowed in the City of Merrill. As such, no private potable wells are near the Subject Property.
